## THE PROBLEM WITH THE ZINC COATING DIVERSIFICATION OF THE HOT-DIP GALVANIZED STEEL

Sylwia WĘGRZYNKIEWICZ

BELOS-PLP SA, Bielsko - Biała, Poland, EU, [sylwia.wegrzynkiewicz@belos.com.pl](mailto:sylwia.wegrzynkiewicz@belos.com.pl)

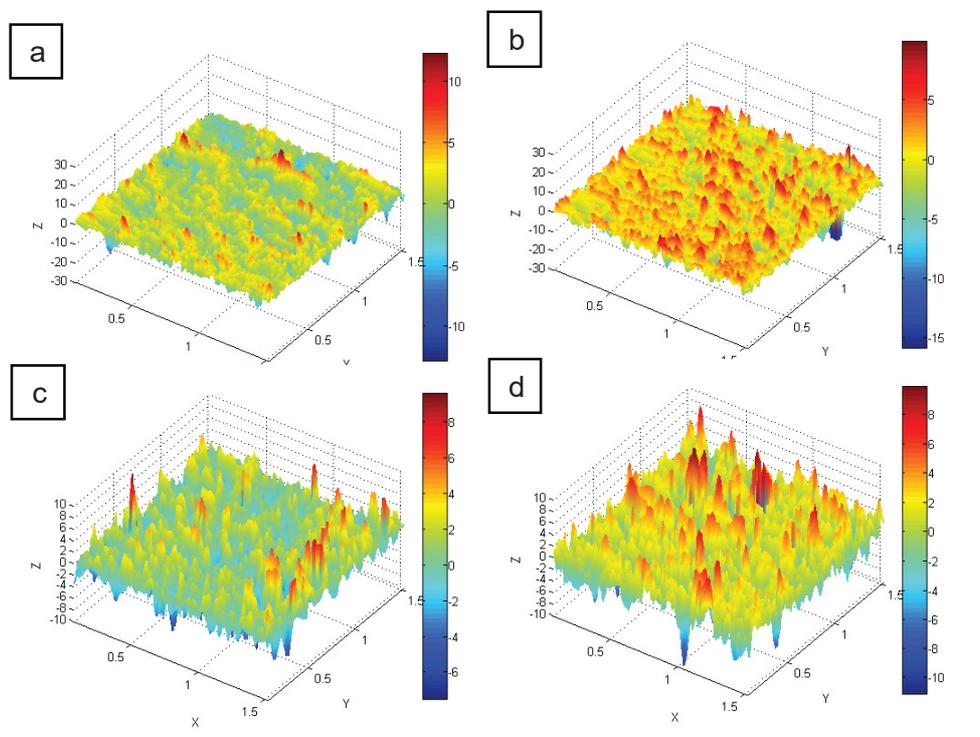
**Fig. 2** Surface topography of links: a,b - the flat surface (after rolling), c,d - the side surface (after cutting); a, c - before shot-blasting, b, d - after shot-blasting

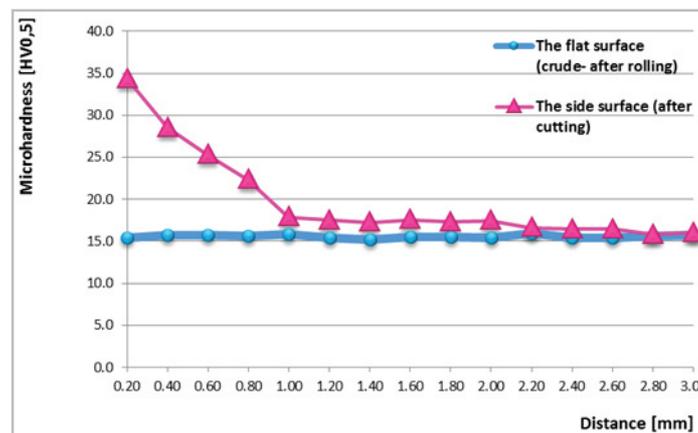
In the first stage the hardness (HV10) of flat and side surface was measured. The measurement was conducted perpendicularly to cutting plan. The average values from a dozen places of the measurement were as follows: on the flat surface - **155 HV10**, on the side surface - **356 HV10**.

**Fig. 3** Results of hardness measurement (HV0.5) on the flat and side surfaces of link in direction from cutting edge to the sample core

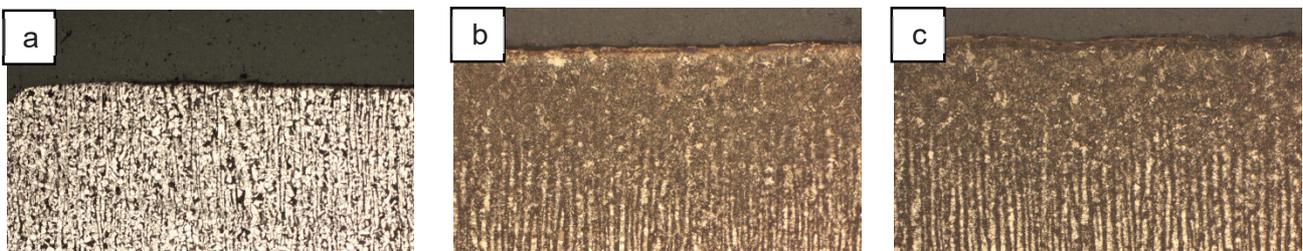
**Fig. 4** The S355JR steel structure: a - the flat surface (rolled), b - the side surface (after OAB cutting), c - the side surface (after OAB cutting) and shot-blasting

The structure of the material in the initial state was a little bit anisotropic, mainly ferritic with small amount of perlitic. **Fig. 4 a** presents a dark perlite area and a light ferrite area. In the observed HAZ zone the needle shape structure appeared - lower bainite, martensite (**Fig. 4b, c**) created as a result of undesirable quenching treatment caused by cutting. The HAZ area boundary is running parallel to cut edge. Its width in the analyzed area amounts to about 800 μm. After OAB cutting it is necessary to use mechanical treatment - shot-blasting in order to remove scale, which has an influence on the surface roughness. In this case, a layer of about 30 μm scale (**Fig. 5**) was removed. Roughness observed on the examined surface resulted from the steel shot used during the treatment before galvanizing. The more stress steel surface after shot-blasting than after OAB cutting is presented in **Fig. 4c**.

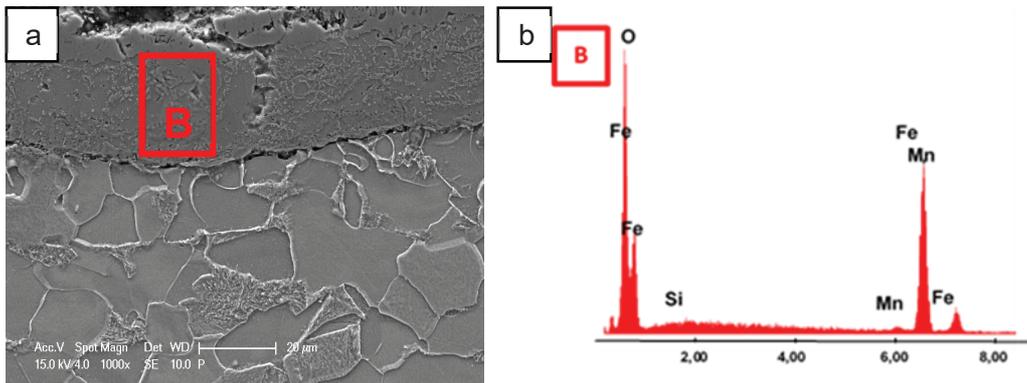
In order to fully identify the particular phases occurring in the surface layer after OAB cutting, an examination by scanning microscope PHILIPS XL30 with X-ray analyzer was conducted. The cross section of the steel structure observed after OAB cutting before shot-blasting and hot dip zinc galvanizing is shown in **Fig. 5a**, together with typical EDS graph of the oxides layer generated by thermal impact (**Fig. 5b**).

**Fig. 5** The analysis of selected micro area in the surface layer after OAB cutting: a - the place of examination, b - EDS graph in micro area B

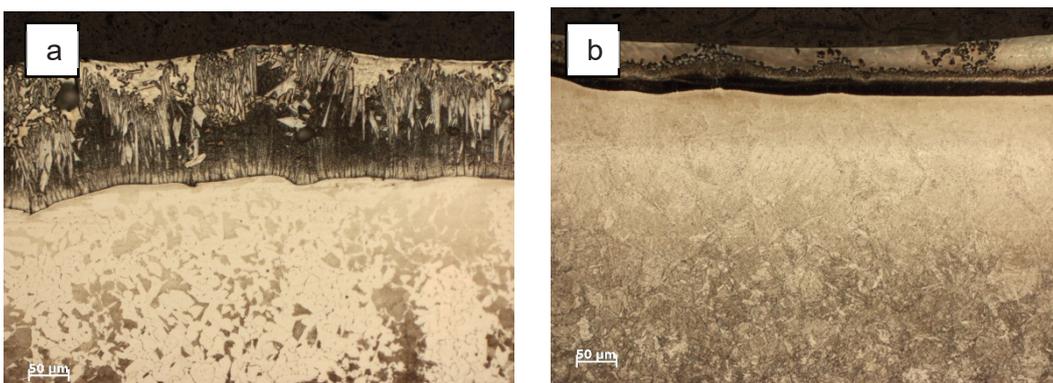
Metallographic examination were made for link after hot dip galvanizing and also confirms the diversification of zinc coating thickness and its structure. The measurement of Zn coating thickness was made for all samples after galvanizing. The average values from a dozen places of the measurement on flat and side surfaces are **158 μm (Fig. 6a)** and **59 μm (Fig. 6b)**.

**Fig. 6** The zinc coating structure: a - on the flat surface of link, b - on the side link surfaces of link

The zinc coating structure diversification. The Zn coating put on the flat surface (after rolling) reveals typical structure for this grade of steel - composed of phases:  $\Gamma$ ,  $\delta$ ,  $\zeta$  and  $\eta$  (Zn) (**Fig. 6a**). Layers created by iron diffusion ( $\delta+\zeta$ ) occupy the greater part of the coating thickness (135 $\mu\text{m}$  - 84 % of total thickness). The coating growth was not disturbed/hindered by the heat affection results of cutting (there is no HAZ) and the application of shot-blasting before galvanizing additionally supported proper process course. In case of Zn coating created on the side surface (after OAB cutting) the observed structure is quite different: the alloyed area is much thinner (40 $\mu\text{m}$  - 57 % of total thickness) - the rest is occupied by pure zinc.

- using different cutting methods (laser and water-jet cutting)- thanks to that eliminating OAB cutting from the production of difficult fittings or
- using an additional treatment after OAB cutting for example normalizing annealing or grinding.

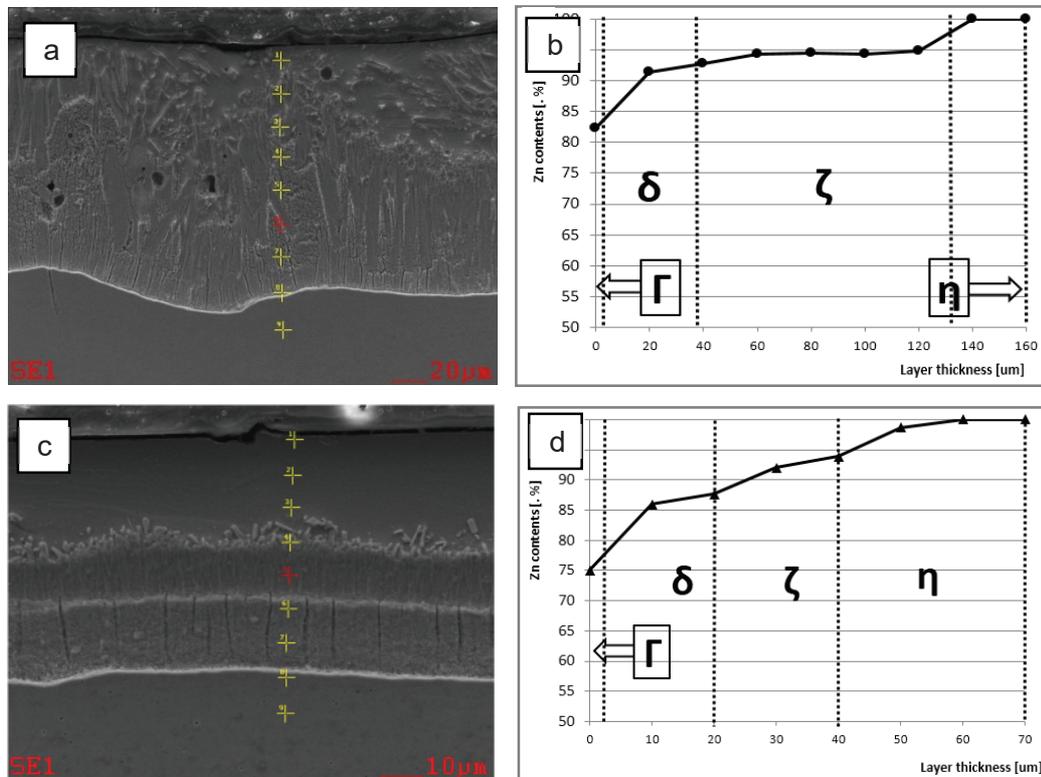
The cross section of the zinc coating structure on the flat surface of link is shown in **Fig. 7a**, together Zn distribution at the cross section of the coating (**Fig. 7b**). The cross section of the zinc coating structure on the

side surface of link is shown in **Fig. 7c** together Zn distribution at the cross section of the coating (**Fig. 7d**).

**Fig. 7** The microstructure and Zn distribution at the cross section of the coating created on link: a, b - flat surface; c, d - side surface
