## **STRUCTURAL DEGRADATION OF STEAM PIPE BEND MADE OF 0.5Cr-0.5Mo-0.3V STEEL AFTER LONG-TERM CREEP EXPOSURE**

KUBOŇ Zdeněk, ROŽNOVSKÁ Gabriela, KOSŇOVSKÁ Jana, PEKAŘOVÁ Lenka

*Material and Metallurgical Research, Ostrava, Czech Republic, EU*

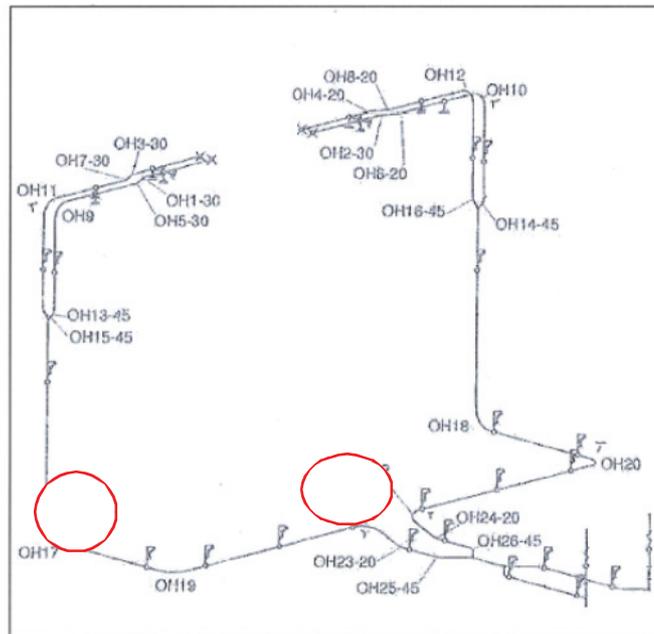
**Fig. 1** Scheme of left and right branch of the steam pipeline with damaged bends

Damaged areas with cracks on the outer surface of two pipe bends were found during the planned inspection of the steam pipeline of a 200 MW boiler in a coal-fired power plant (see circles in **Fig. 1**). The steam pipeline

was made of pipes  $\varnothing$  324 x 48 mm of steel grade 15 128.9 and was operated at 540 °C with a steam pressure of 17.3 MPa for more than 240,000 hours. In the case of bend No. 17 there was a large area affected by a mesh of cracks, while in the case of bend No. 21 the defective area was only local. In both cases the damaged areas were adjacent to the outer fibre of the bend, but did not directly lie on it.

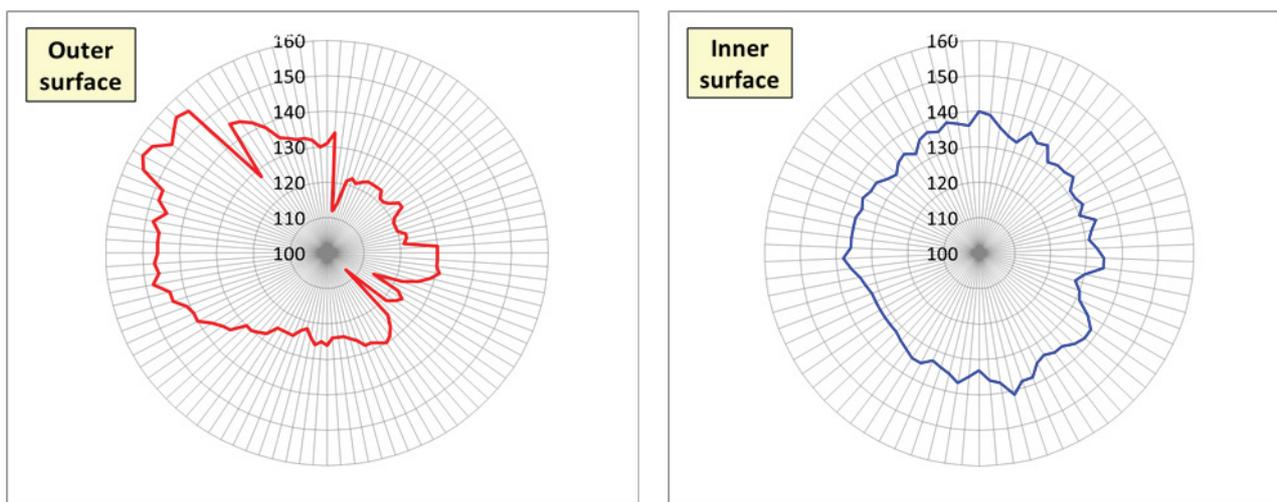
**Fig. 2** Hardness profile HV 30 on the outer and inner surface of the pipe bend

Hardness profile was also measured in the area of maximum damage of the bend either around the pipe circumference either through the wall thickness. Circumferential hardness measurement (HV 30) was carried out in three lines: close to the outer surface, in the middle of the wall thickness and close to the inner surface, in all cases with a distance 10 mm between the individual indentations. The results of the hardness measurement made in the outer and in the inner surface are shown in **Fig. 2** and the local decrease in hardness in the area of defects on the outer surface is evident, while the hardness on the inner surface seems to be uniform around the whole pipe.

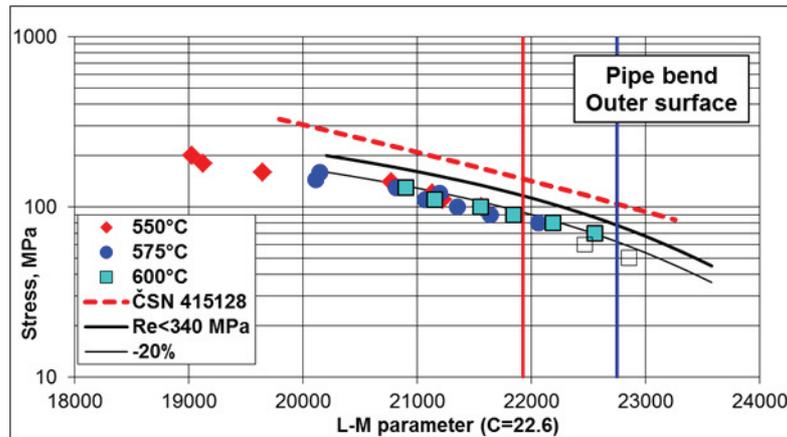
**Fig. 3** Comparison of the results of creep tests with the values of CRS of the steel 15 128 for Re<340 MPa

In order to determine the actual creep characteristics of the pipe bend, creep rupture specimens were machined from the material close to the outer surface of the pipe in the area adjacent to the cracks. Creep testing program was performed at temperatures 550, 575 and 600 °C. Although so far completed creep tests do not reach long times to fracture, the results being at disposal already allow an evaluation of creep rupture strength for at least 10,000 hours. For comparison of the obtained creep testing results with the standardized data of the mean creep rupture strength  $R_u$ , the results of individual creep tests were converted into Larson-Miller parameter  $P_{LM}$  [5]. The results showed that the actual value of creep rupture strength (CRS) at 550 °C for 10,000 hours is 87 MPa, while the median standard value of  $R_u/550$  °C/10<sup>4</sup>h for the 15 128 steel grade equals 146 MPa and the median  $R_u/550$  °C/10<sup>4</sup>h value of heats having yield point below 340 MPa drops down to 115 MPa. Thus, the actual CRS of the steam pipeline material is lower of about 40 % and 24 %, respectively, compared to the above stated values - see **Fig. 3**. Open symbols in this figure represent still running creep.

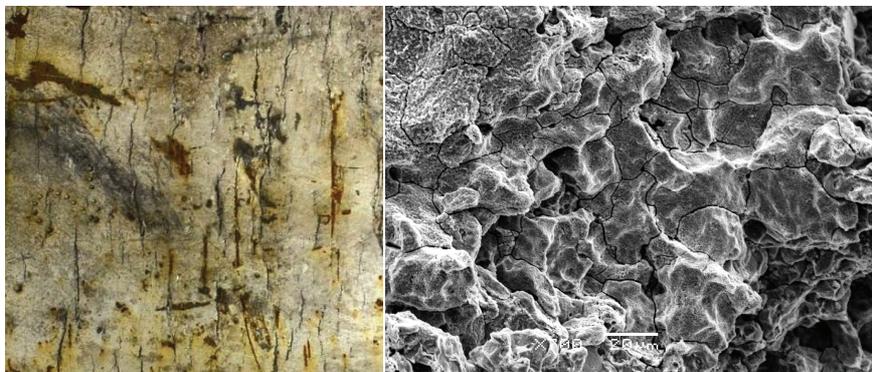
**Fig. 4** Network of cracks on the outer pipe surface and fracture surface morphology

**Fig. 4** illustrates the appearance of the outer surface of the pipe and the fracture surface of the principal crack in the defective area. These cracks were numerous and were oriented principally in the axial direction of the pipe bend. The appearance of the cracks confirmed their creep origin. The cracks originated on the outer surface and propagated in the intergranular manner from the outer surface of the tube in the direction approximately perpendicular to the surface of the pipe.

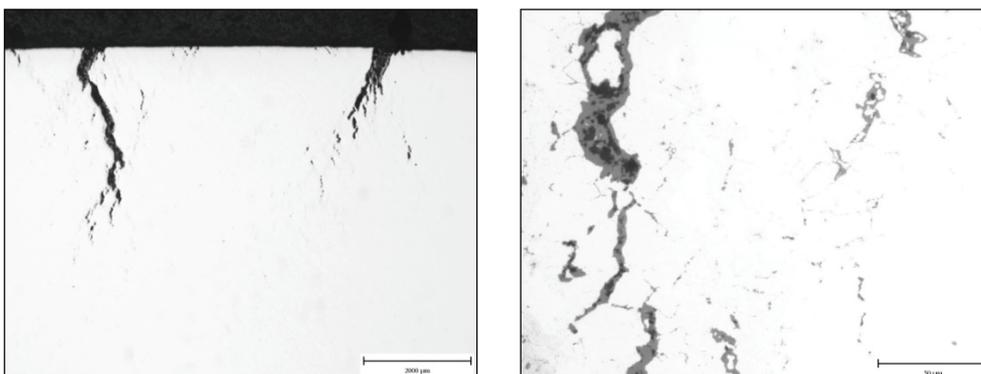
**Fig. 5** Cracks partly fulfilled with oxidizes on the outer surface of the pipe

Crack surface was covered with the iron oxides on the outer surface of the pipe bend and during propagation towards the inner surface the branching of the cracks was observed, also covered with films of iron oxides. The total depth, in which the cracks propagated, was up to 7 mm below the outer surface, **Fig. 5**.

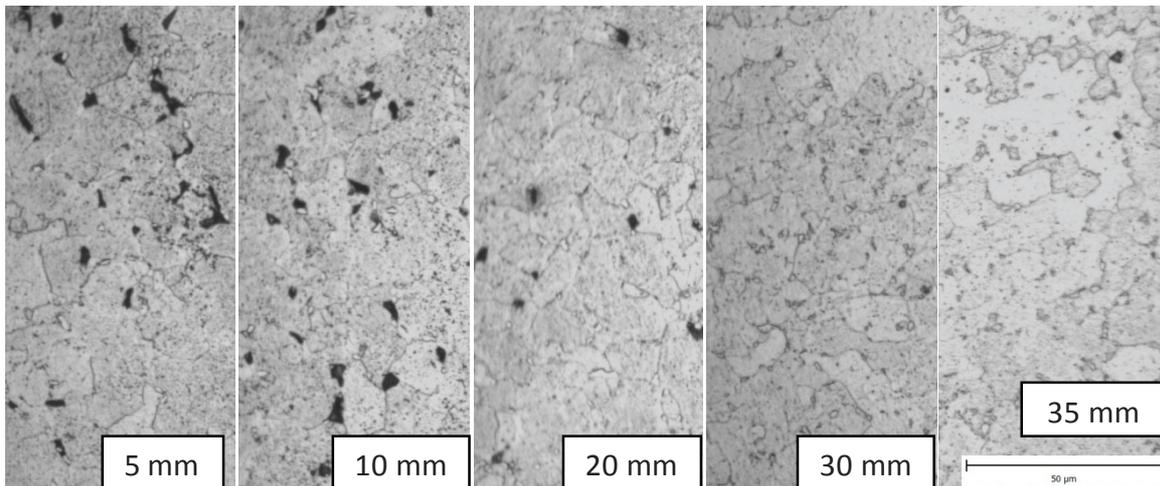
**Fig. 6** Range of cavitation damage from the outer to the inner surface of the pipe bend

Microstructure in the area of creep cracks was fine-grained with tempered, ferritic-carbide structure in the inner surface of the pipe the microstructure had features of tempered bainite. Beneath the outer surface was observed significant cavitation damage and its frequency decreased towards the inner surface - **Fig. 6**. 5 mm below the outer surface were found both coarse and isolated cavities and also cavity chain with the length up to 139 microns. 10 mm or more from the surface there were observed only isolated cavities. With further increasing distance from the outer surface, the proportion of cavities and also their size decreased - **Fig. 6**.

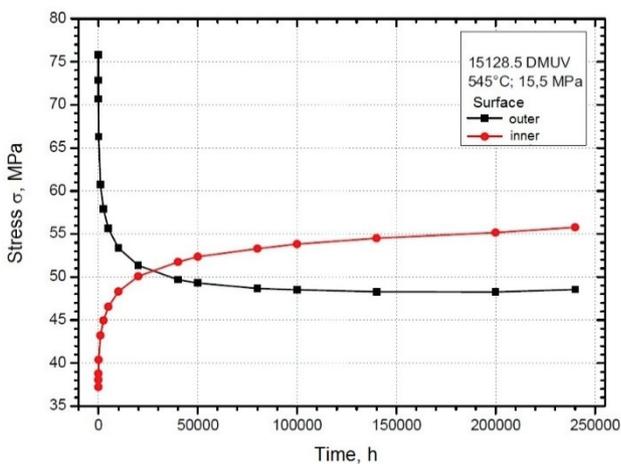
**Fig. 7** Redistribution elastic stress during bending operation

Calculation of the redistribution of initial elastic stress during operation of the evaluated bend was carried out by finite element method for the actual geometry of the pipe bend and the material with lower strength and deformation properties (DMUV material with the default yield strength under 340 MPa) [7]. The calculations showed very rapid stress redistribution in the initial state and localization of maximum tangential stress at the outer surface of the pipe bend. It means that the initiation of creep cracks can be expected on the outer surface and there is, therefore, a good chance to find them during the regular inspections - see Fig. 7.

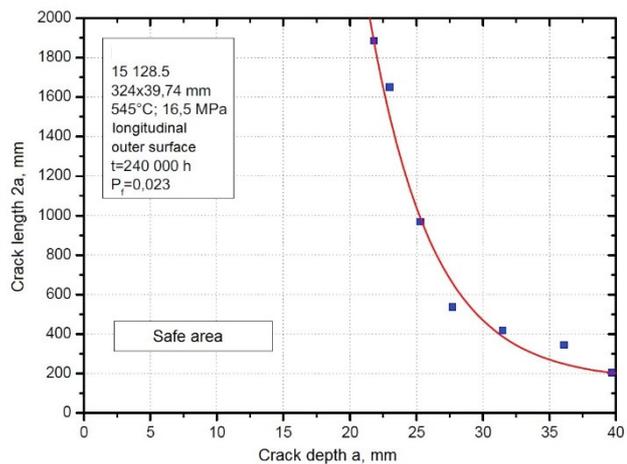
**Fig. 8** Relation between depth and length of the critical crack for sudden fracture

The critical crack depth for the initiation of the final fracture was determined for the actual values of the yield strength, ultimate strength and fracture toughness of the bend at 550 °C. The calculation was made for a considerable length of longitudinal cracks extending from the inner and outer surface of the bend depending on the risk of failure. Even for a low probability of fracture ( $P_f = 0.001$ ) is the ratio of critical crack depth to the actual minimum wall thickness greater than 0.5, which means that the only cracks with a depth exceeding one half of the wall thickness can be regarded as dangerous - see Fig. 8. This result supports optimism about the safe operation of the steam pipes, as we can expect that the crack would be detected before it grows to this length.
