ANALYSIS OF THE DAMAGE OF FUNCTIONAL BASED ON THE COBALT-RESISTANT ABRASION LAYERS

KRAUS Martin, BYSTRIANSKÝ Jaroslav

VSB-Technical University of Ostrava, RMTVC, Ostrava, Czech Republic, EU, martin.kraus@vsb.cz

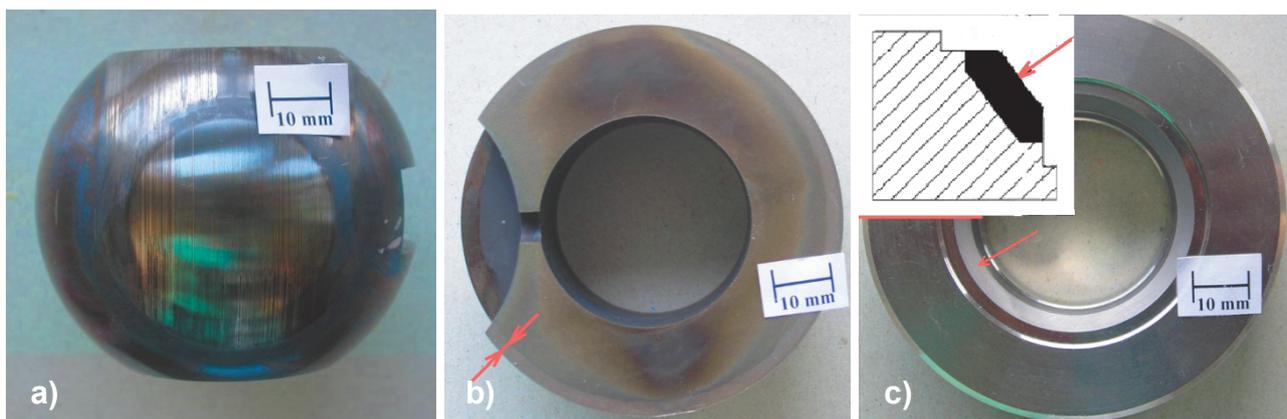
The problem for research was a significant damage to the surface of the ball of the ball valves, after a very short operational exposition - approx. 12 months at approx. 50 cycles of changes the position. After this time, there were signs of leakage of valves and these have been dismantled. The valves worked in an environment of superheated steam at temperature 550 °C and pressure 10 MPa. There were three balls (with marking A, B, C) with a diameter of 72 mm (A, B) and 112 mm (C) and one piece valve seat E (**Fig. 1**). Basic material of balls was steel AISI 316, welding surface Stellite 6, at seat next P 91 vs. Stellite 712. Standardized chemical composition and hardness of both welded materials is in the **Table 1** [1, 3]. Surfacing was realized by OFW technique. After the surfacing is done finish and lapping surface. The declared thickness of the weld layer was approx. 3 mm.

Fig. 1 Ball valves; a) - ball B - outlet side; b) - cross section of ball A cutting by electro-erosion method; c) - valve seat; Stellite welding layers are marked with red arrows

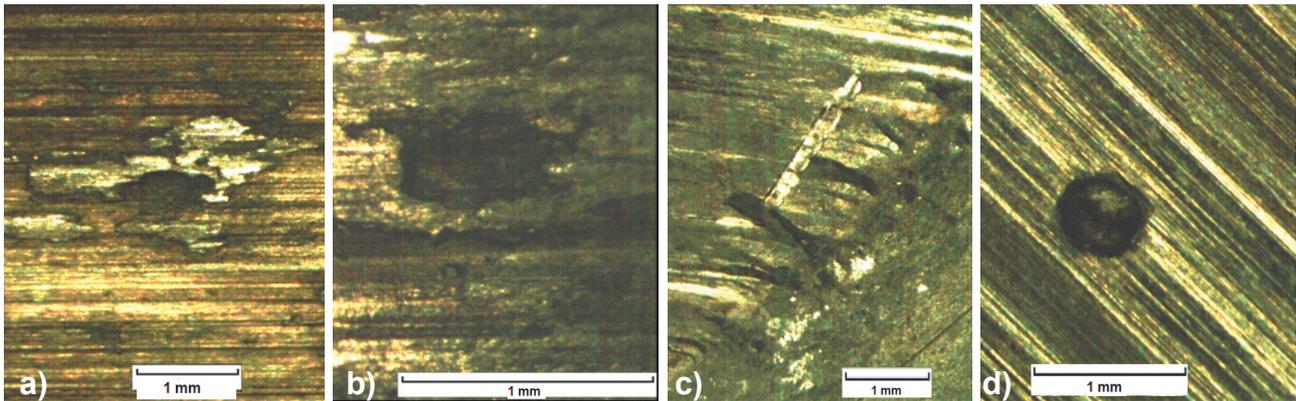
Due to the damage character has been done thorough documentation supplied parts of the ball valve with an emphasis on damaged areas by digital camera. These areas were also documented by optical stereomicroscope Olympus SZX12 at a magnification of up to 20 × whereas several types of damage were found, including posts that suggest that their rise was by separation (peeling) of upper part of welding layer (**Figs. 2a, 3a**), including probably initiation points. Most was the damage caused by erosion of the free particles (**Fig. 2d**), which is significant by grooves rise. In addition, were detected marks of foreign material adhesion on the ball surface also (**Figs. 2b, 3b**). In places the damage of lapped sealing surfaces were found to have marks of damage by flowing steam and erosion attack (**Fig. 2c**), that could be the cause of the detectable leakage of the valve.

Fig. 2 Balls of ball valves - damage examples by stereomicroscope; a) - unstuck part; b) - adhesive particle; c) - damage by steam; d) - round depression

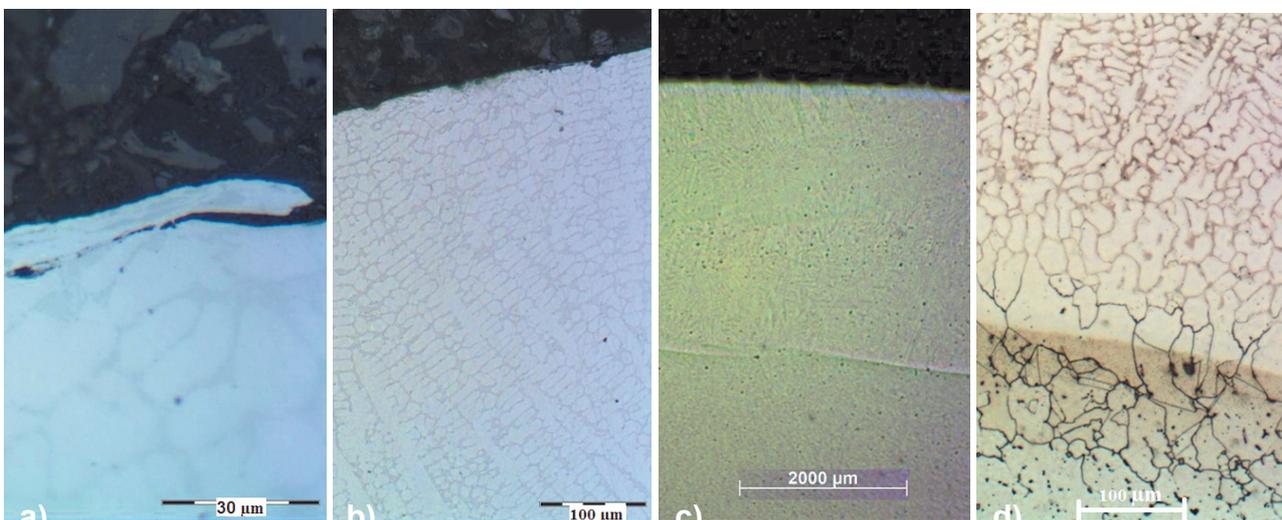
Fig. 3 Metallography of balls; a), b) - types of surface damage; c), d) - cross section of welding layer

The metallographical evaluation was found to be the thickness of the welding layer in the range of 2 till 3 mm, for all of the components equipped with surfacing (A-C, E). Metallographic analysis (**Fig. 3 c, d**) on the basic material expected standard austenitic microstructure with equiaxed grains, with a fairly homogeneous distribution of size. This one then connect in buttering layer, which gradually „ingrowing“ into the Stellite weld deposit. The microstructure of has the character of a cast "two-stage" structure with light dendritic formations (matrix) and interdendritic areas with darker contrast. Structure, with relatively high purity (micropurity), even with the occasional occurrence of particles based on carbides and nitrides is also characterized by a high „effort“ to the preferred orientation of dendrites, often perpendicular to the geometric centre of the sphere. On parts with the greatest degree of surface damage seems to be subsurface and surface layer volumic richer on dendritic phase. Are also evident damage with stripped layers character and "foreign" adhesion layers (perhaps with oxide-corrosion origin). In the evaluation of the damaged surface areas have been identified heterogeneities that are likely to arise when creating or finishing welded layer.

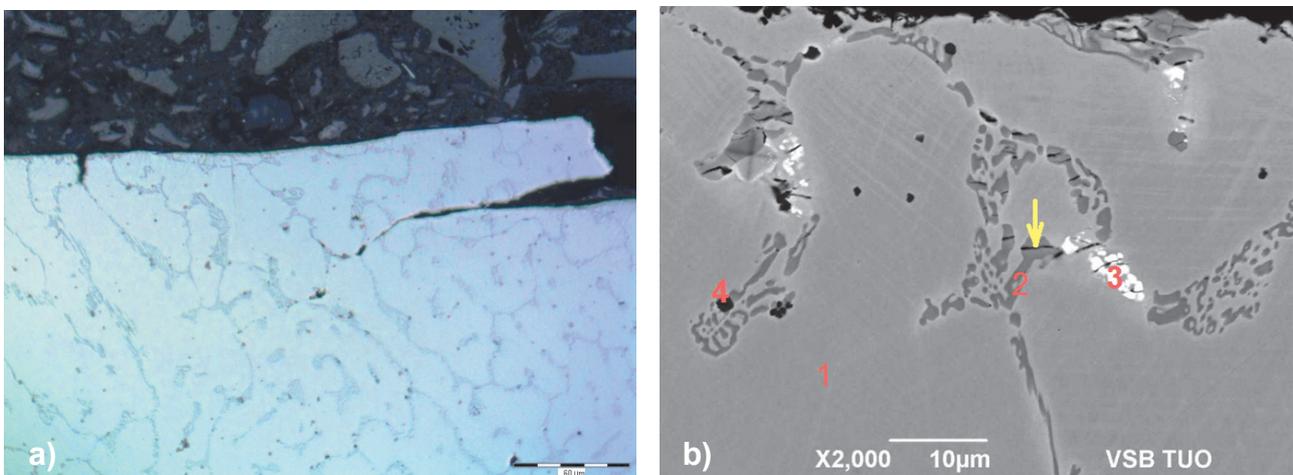
In the cross section of functional area of the valve seat was observed similar microstructure, as for balls. Only the thickness of the welding was somewhat less. An important finding is the fact that the place was found with significant damage (unstuck) of the surface layer with a unique initiation cracks in the area of eutectic interdendritic structure. It creates the significant large loose segments of the welded material, which may damage functional contact faces (**Fig. 4a**). From the fractographical viewpoint was in the valve seat confirmed the assumption that to cracking the brittle interdendritic eutectic structure occurs, see **Fig. 4b**. SEM analysis of valves seat more or less copies the others metallographic findings. In addition to the analysis of the basic phases were also detected by the minority particles of carbides and nitrides occurring in both phases (**Table 2**).

Fig. 4 Damage to the brittle structural components of seats welding layer, cracks in the eutectic phase; a) optical metallography; b) SEM analysis - the crack is marked with yellow arrow

The welding layer of the valve seat was somewhat thinner (< 2 mm), however, they were detected in structural components with extreme hardness up to 1076 HV_{0.01} - by analogy with the ball C. Their presence greatly limited their ability to transfer of the deformation. On microstructure pictures (**Fig. 4**) and around indentations (**Fig. 7**) were noticeable cracks that extend across from these phases (on subsurface layer), connect with and finished at the open surface. From the character of the deformation damage in and around the indentations (movement of the slip bands) can be concluded on a very "intensive" stress-strain relations in the welded layer material, in particular eutectic phase (**Fig. 7**). Of course, this problem deserves further study [8, 9].

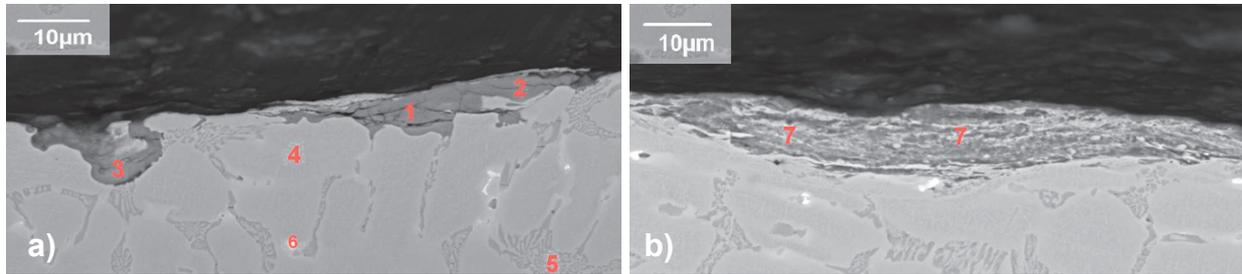
Evaluation of the surface showed the presence of "adhesion" units based on particular (complex) oxides of iron, chromium and cobalt plus depressions also (**Fig. 5a, b**). Their chemical composition is on the **Table 3**. SEM analysis of the composition of the welded material was confirmed standard chemical composition of

Stellite significantly diluted with iron (in comparison with the standards requirements) for dendritic formations a qualitatively similar, but quantitatively richer by chrome, composition of interdendritic eutectic structure, see **Fig. 5**. The look and composition of buttering layer documented **Fig. 6** and **Table 4**.

Fig. 5 Adhesive particles on the surface of Ball A

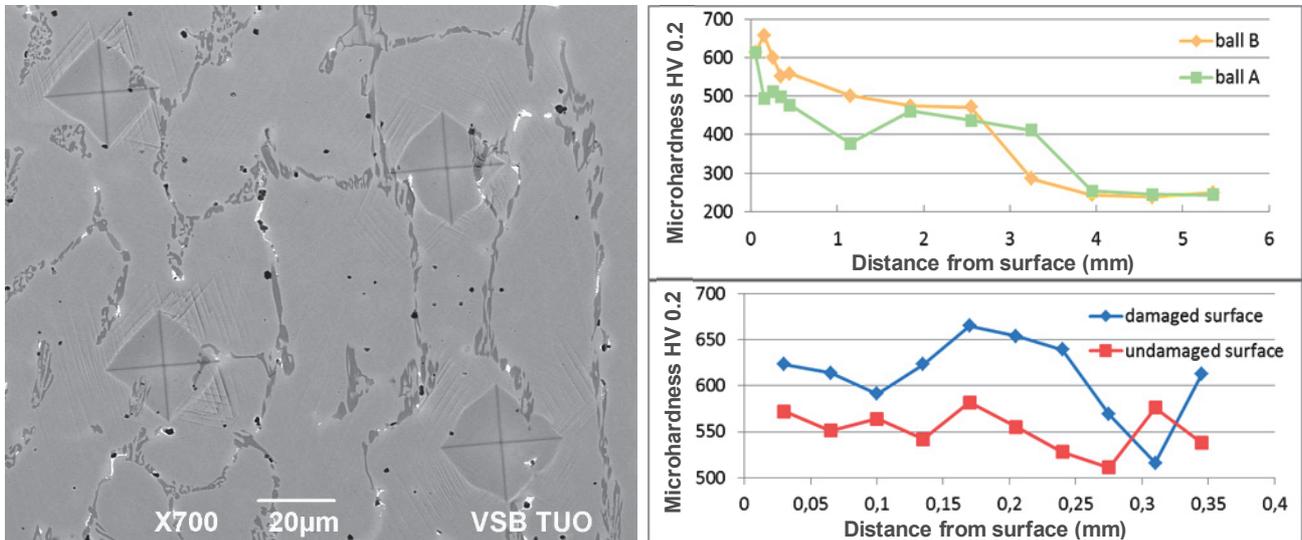
Measurement of microhardness in subsurface area of the working surface of the ball shows for values to around 580-620 HV_{0.01}. The average hardness of welding to a depth of 0.3 mm from a functional surface was 525 vs. 545 HV_{0.2} for undamaged vs. a damaged surface (ball A), see **Fig. 7**.

Fig. 7 Welding layer of valve seat - deformations near microindentations with cracks in eutectic phases (left); microhardness HV_{0.2} of welding and buttering layer - comparison of ball A and B (above); hardness comparison of damaged and undamaged surface - ball A (below)
