CRACKING OF FERRITIC STAINLESS STEEL TUBES DURING PRODUCTION PROCESS

MAJTÁS Dušan¹, KREISLOVÁ Kateřina², VIANI Alberto¹, PÉREZ-ESTÉBANEZ Marta¹,
GEIPLOVÁ Hana²

¹Centre of Excellence Telč, ITAM AS CR v.v.i., Telc, Czech Republic, EU

Abstract

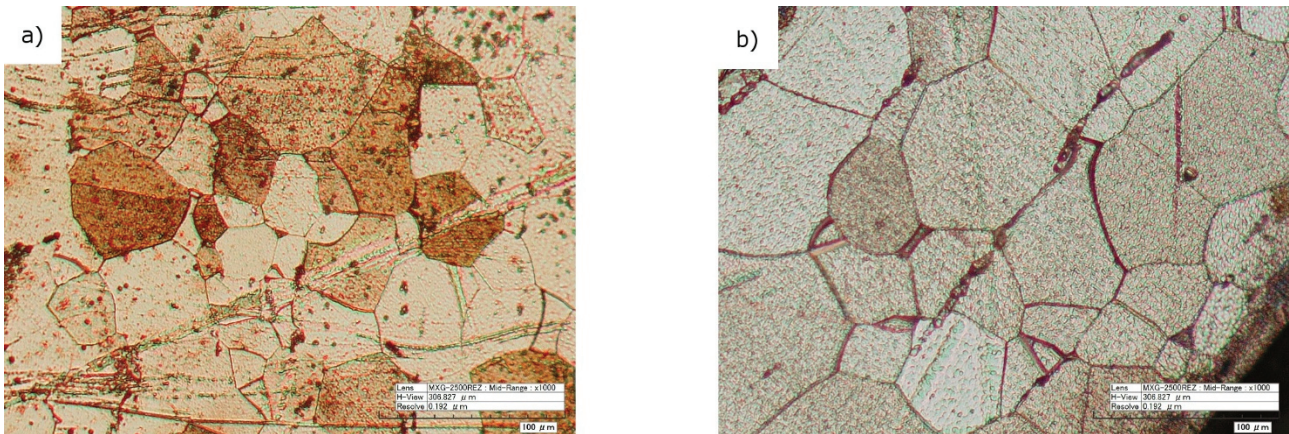
Primarily used Nital etching solution has proven itself to be insufficient to render the grains so the hydrochloric and nitric acid mixture was used (of 1:3 ratio) which proven to be able to render the grains. In addition needle-like structures were also shown on the etched cross sections, not originally present on the cross sections itself (as shown on **Fig. 1**). In addition it was also found, the deformation of the structure has only short range effect on longer distance (600µm and more) the grains were not deformed at all. This is clearly visible in the **Fig. 2**

Fig. 1 Cross section of the material showing needle-like structures and 1b

According to the literature studied [2-7] the needle-like structures seems to be delta ferritic structures. With one exception, the delta ferrite is present in austenite steels but should not be present in ferritic matrix, where the delta and alpha ferrite should be distinguished from one another, as these are generally same phase. To assure the material examined is ferritic and not austenite as might result from this semi-conclusion. The X-Ray diffraction of these samples was made.

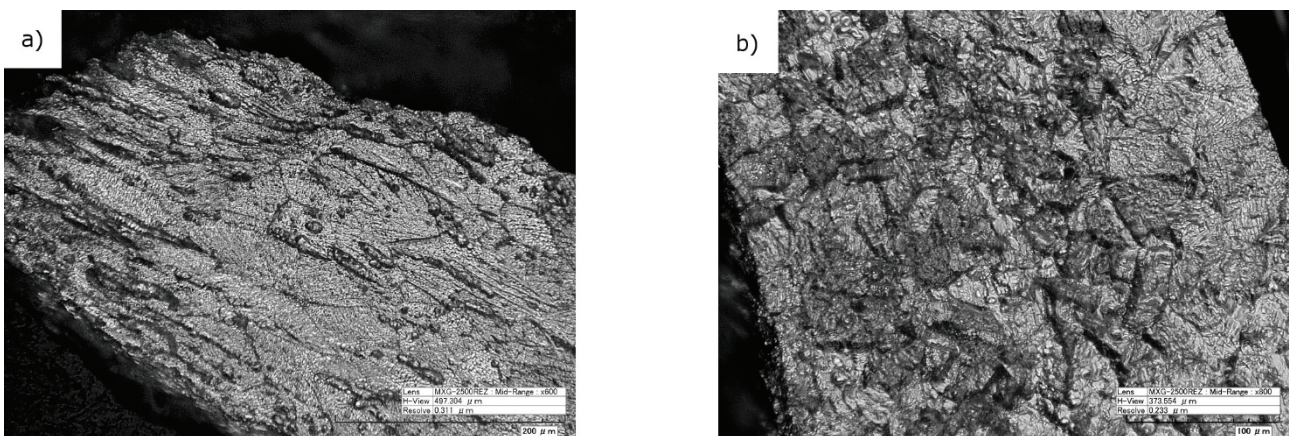
Fig. 2 Cross section of the failed tube showing elongation of the grains (2a) in near vicinity of the defect but 600 µm away there is no sign of deformation (2b)

- Needles were not produced during the tube shaping process. Material was thermally treated after the tube was weld to remove remaining stress in the structure and grains do not show any deformation

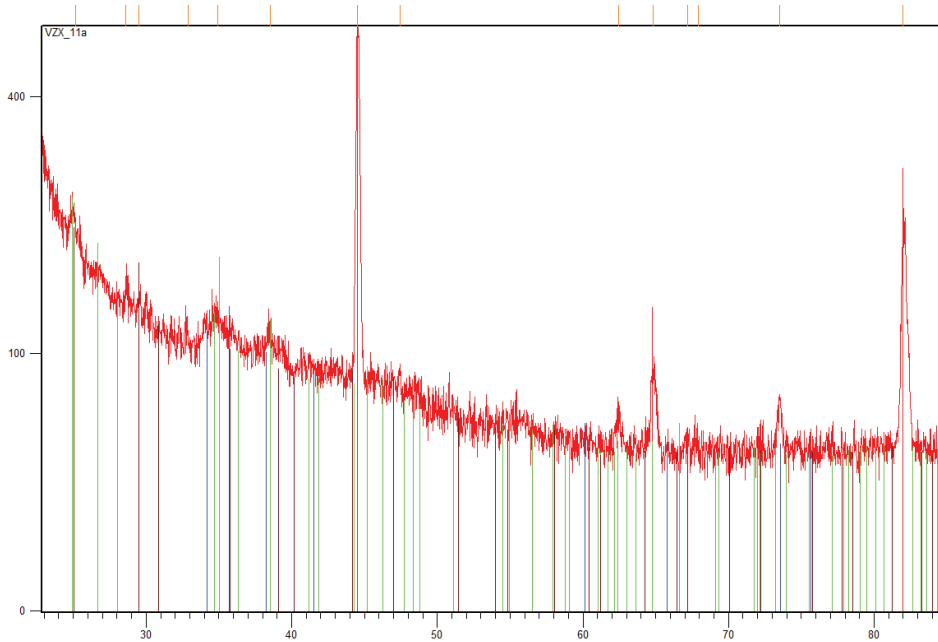
Using the XRD material was identified as AISI 434L which is similar in composition to AISI 444 as it was declared by manufacturer (XRD scan shown on the **Fig. 3**, whereas the compositions are shown in **Tables 1** and **2**). At this point should be noted, the producer of tubes is not a producer of steel sheet. As shown in tables below, the composition of those two ferritic steels varies slightly and the misinterpretation of the given material is more likely caused by inhomogeneity in the material in combination with the capabilities of the used method.

In addition to ferritic steel (red lines), presence of silicon carbide (green lines) was found in the samples. This is no doubt caused by the presence of SiC, however this should be handled with caution, as the XRD scan contains some noise and also the SiC was used during the sample preparation (grinding and polishing) among other agents.

Fig. 3 XRD scan of the material

We suppose there is some small amount of SiC present in the structure, but its exact amount, and thus the amount of carbide in the structure, should be determined by other method, to overcome the possible false positive identification caused by the noise (and also using different grinding materials if applicable).

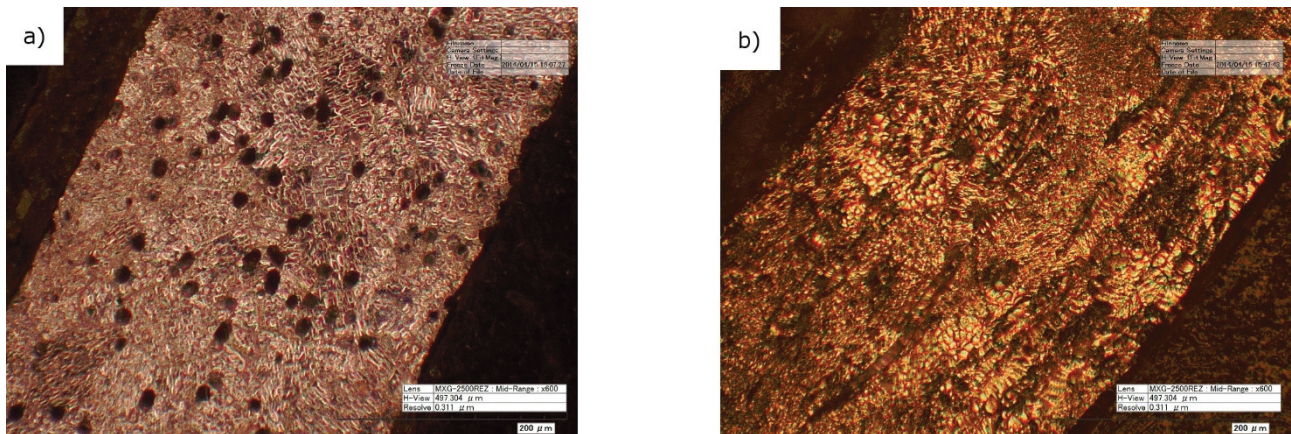
Also additional interesting fact was found during the optical microscopy (as shown on **Fig. 4**). The needle-like structures are oriented parallel to the axis of rolling. On the cross section parallel to the axis the structures seems like scratches, on perpendicular like holes drilled into the material. Also on the parallel cross section the needles seem to copy the shape of the sheet, when the sheet was bent, the needles bend in appropriate direction.

Fig. 4 Cross section parallel (4a) and perpendicular (4b) to the rolling axis

The simulated bending was not sufficient to induce cracking of those needle-like structures, and thus the crack propagation was not observed on cross sections. But the overall behaviour of the failed material exhibited similar drop in mechanical properties as austenite steels containing delta-ferritic needles, compared to same material without the delta ferrite. However this does not solve the problem how delta ferrite can exist inside alpha ferritic matrix.
