THE EXAMINATION OF THE CAUSES OF THE OCCURRENCE OF PROTRUSION DEFECTS IN A CAR BONNET PANEL

Abstract

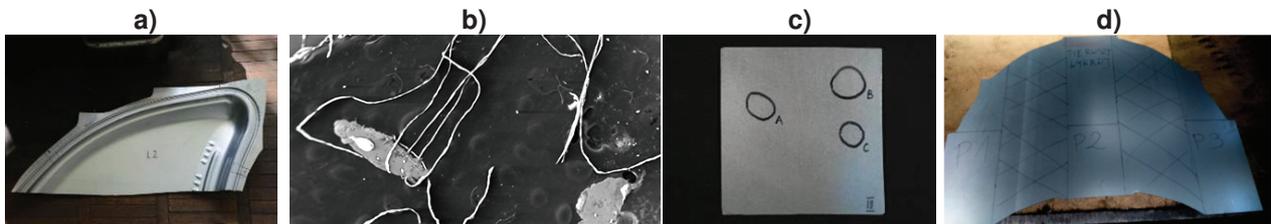
- The fragments of car bonnet panel after press forming (**Figure 1a**).
- Non-woven fabric which was used for cleaning the surface of the dies, containing the particles, the presence of which on the surface of the dies was considered as the cause of protrusions (**Figure 1b**).
- The fragments of panel cut out in the spots where defects, i.e. protrusions, were found (**Figure 1c**).

- The fragments taken from the die impressions before press forming. The fragments of the sheet taken from the start of a coil, in the center of a coil and from the end of a coil and also from the left side, center and the right side of the panel (**Figure 1d**).

Figure 1 Exemplary material for investigations

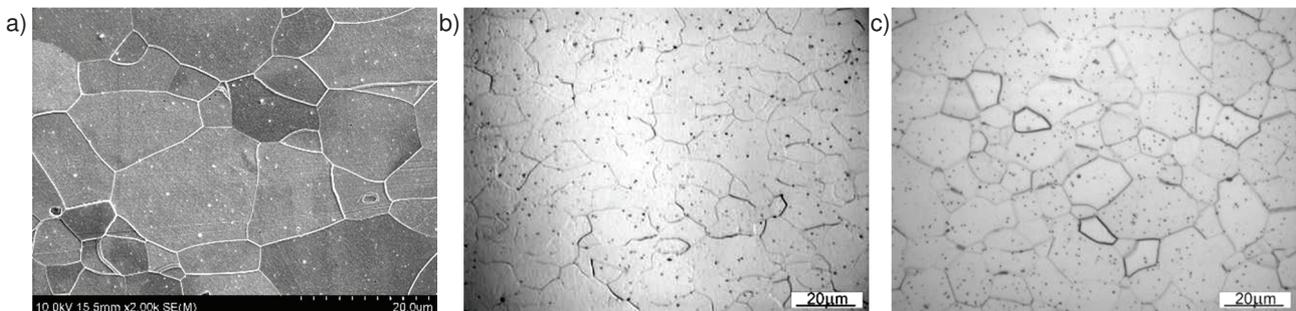
Figure 2 The microstructure of steel sheet: a) material I - SEM, b) material II - LM, c) material III - LM

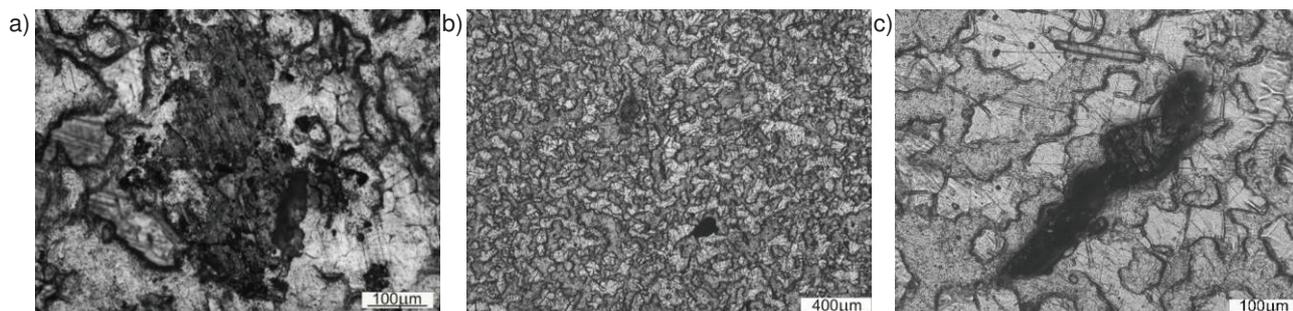
Local cavities on the lower surface of the deep drawn steel sheet can be observed (**Figure 3a, b**). Loose fine particles were also observed on this surface (**Figure 3b, c**). The size of these particles corresponds to the size of the occurring cavities. Similar particles were found on non-woven fabric used for cleaning the stamping dies. Bigger particles were identified as the fragments of deep drawn steel sheet (**Figure 4**). The microanalysis of fine particles (occurring in a much larger quantity) showed, that they came from zinc layer (**Figure 5**). While large particles are likely the fragments formed during the shearing operation, fine particles spalled from the surface of the processed steel sheet. The exemplary area of such zinc spallation is shown in **Figure 6**. As can be noticed, decohesion of the zinc layer propagates to the surface of the steel sheet.

Figure 3 The areas of the occurrence of the protrusion defects (a, b) and particles causing such defects (c) on the surface of steel sheet after stamping: a) material I, b, c) material III

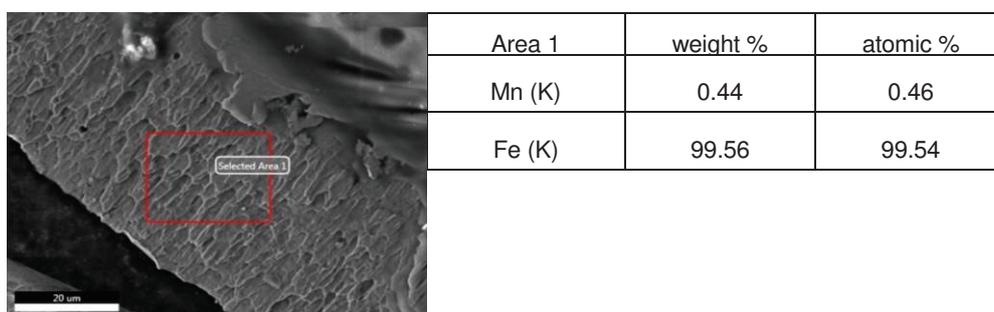
Figure 4 The result of the microanalysis of big particle taken from the stamping die surface

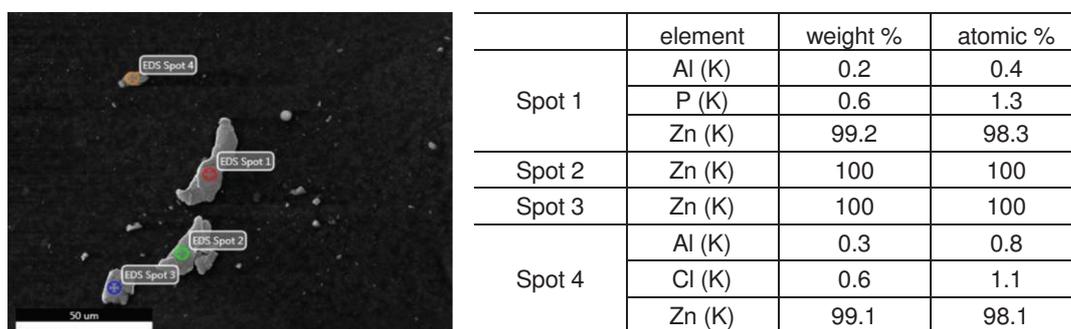
Figure 5 The result of the microanalysis of fine particles taken from the stamping die surface

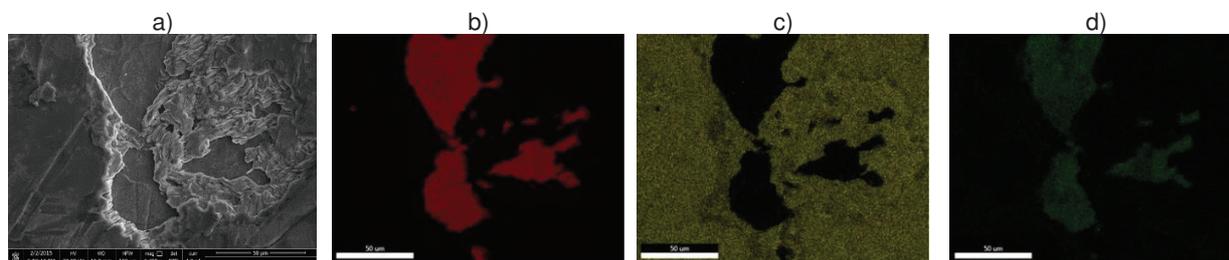
Figure 6 The analysis of chemical elements distribution in the area of spallation occurred on the surface of steel sheet I after stamping: a) SEM image, b) Fe, c) Zn, d) Al

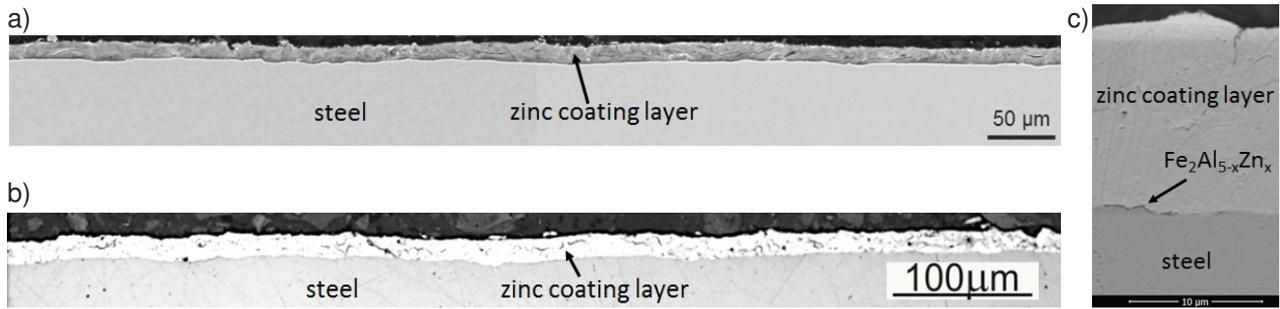
The morphology of zinc coating on steel III is shown in **Figure 7**. As can be observed, the continuity of interlayers between zinc coating and steel sheet cannot be noticed in this case. The analysis of chemical elements distribution in coatings on steel sheets II and III showed the presence of interlayer rich in Al (**Figure 8**). Moreover, in the case of steel sheet II this interlayer maintains its continuity.

Figure 7 The morphology of zinc coating on steel sheet III: a) SEM image, b) light microscope, c) SEM image

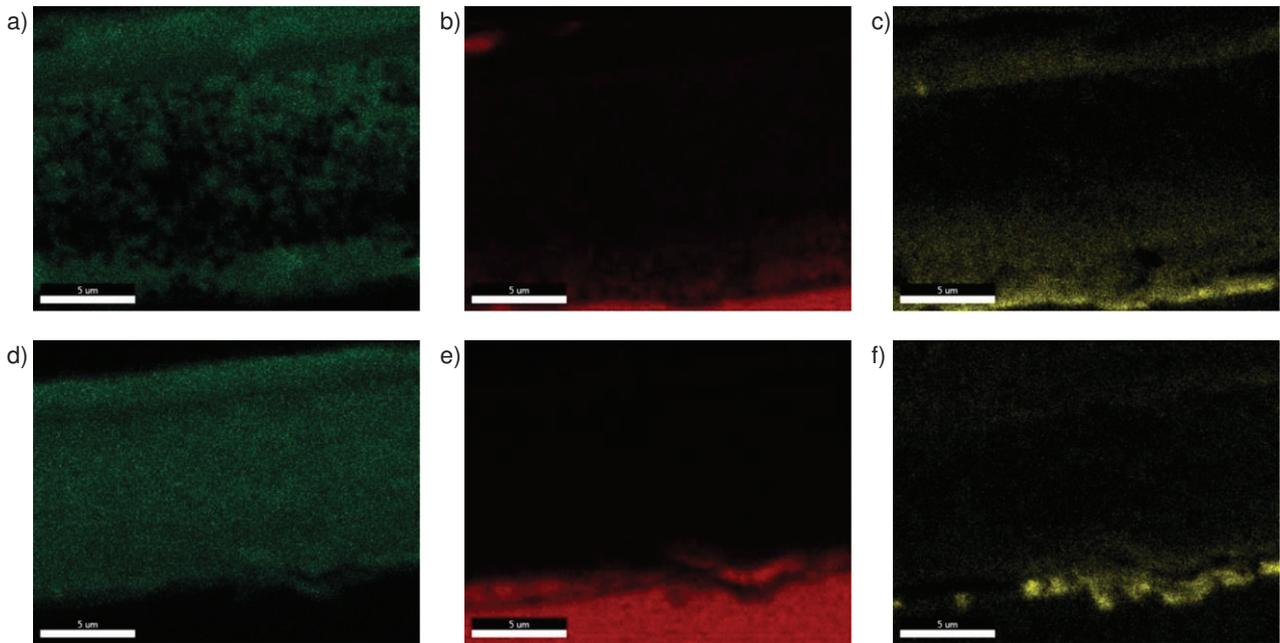
Figure 8 The analysis of the chemical elements distribution (a, d - Zn, b,e - Fe, c,f - Al) on the cross-section of zinc coating on the surface of steel sheet II (a-c) and III (d-f)

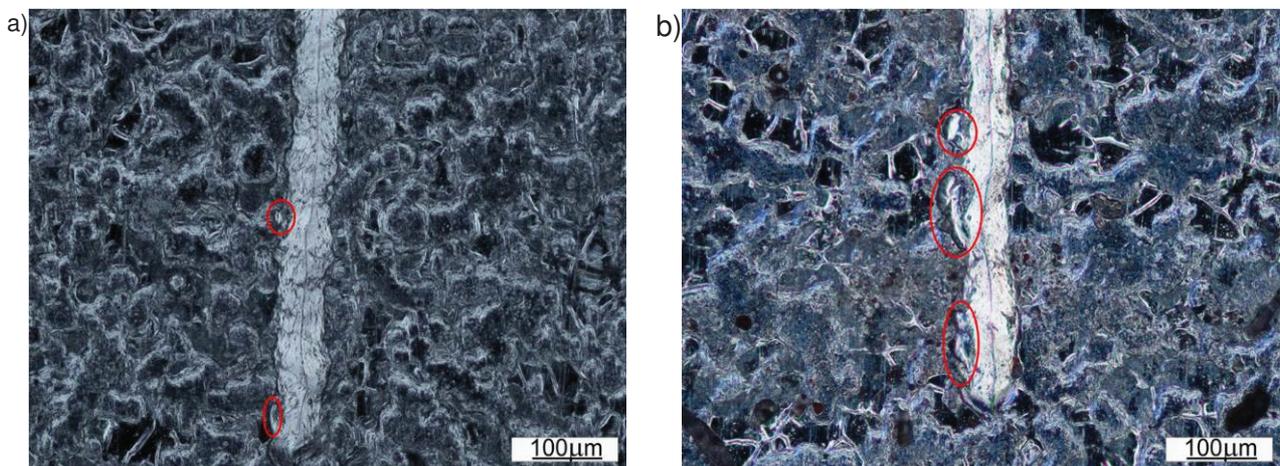
The chemical composition of steel sheets and continuity of interlayer rich in Al result in better resistance of steel sheet having continuous interlayer and lower Si and P content to spallation during the performed scratch tests (**Figure 9**). The content of Si in steel sheet III is different in various areas of steel coil (**Figure 10a**). It influences the spallation of the zinc coating during Erichsen tests (**Figure 10b** - dotted line).

Figure 9 The results of the scratch tests for: a) material II, b) material III. The areas of spallation were marked.

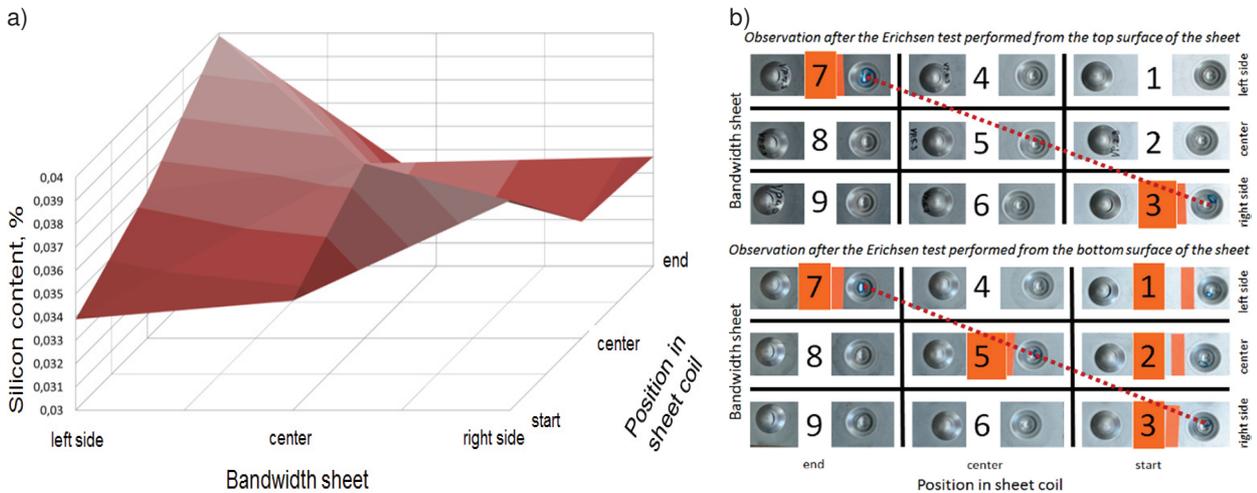
Figure 10 Distribution of Si content (a) in steel sheet III and corresponding location of zinc coating spallation (coloured) after Erichsen test (b)

- 2) The increased Si and P content in steel sheet as well as local lack of continuity of rich in Al interlayer facilitate spallation of zinc coating.
- 3) It is necessary to control the chemical composition of steel sheets delivered for the stamping process so it should not exceed 0.03% of Si.
- 4) It is necessary to clean the steel sheet (e.g. by means of air stream) before press forming, including the cutting edge in particular.
- 5) Due to high probability of formation of protrusions caused by an impact of conglomerates of fine particles spalled from the zinc coating, it is necessary to resign from cleaning the surfaces of the dies by means of a soaked unwoven fabric. It should be replaced by the methods which do not introduce agents

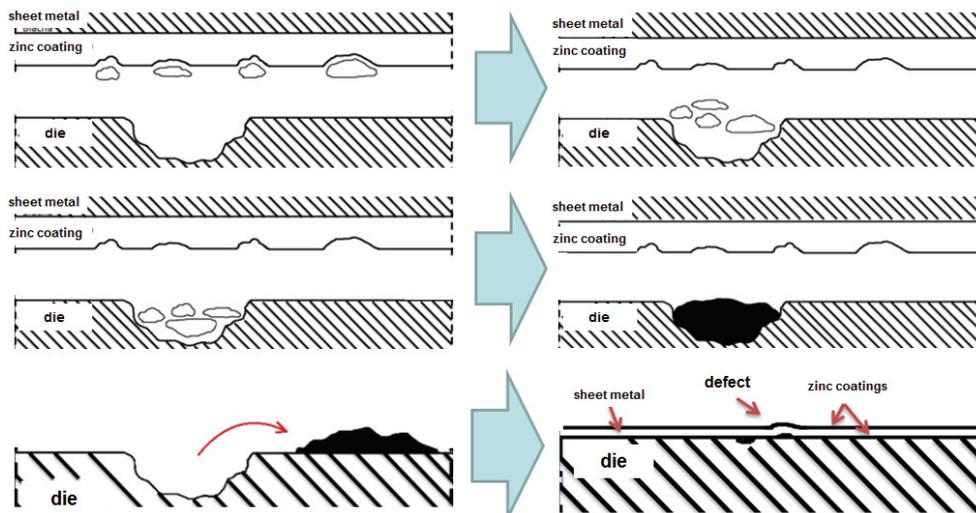
- 1) Particles causing protrusions were identified as steel fragments, most likely originating from the edge of the die sheared sheet, and also fragments of spalled zinc coating (most likely in the form of conglomerates, mainly originating from drawbead areas - **Figure 11**).

Figure 11 Schematic representation of the subsequent stages of protrusion defects formation

facilitating formation of the above mentioned conglomerates. At this point it is necessary to pay attention to the occurrence of protrusion defects on the surface of a die, where particles of zinc coating may accumulate, and next relocate to the die shaping surface, which finally results in formation of protrusions on the sheet being formed. This mechanism of formation of protrusions is characterized by the difficulty in determining which of the shaped materials was defective, because the defects may be revealed only after shaping the material with proper adhesion of zinc coating.
