CHANGES IN STRUCTURE AND PHASE COMPOSITION IN THE SURFACE OF TRAM RAIL

ŠVÁBENSKÁ Eva¹, ROUPCOVÁ Pavla¹, SCHNEEWEISS Oldřich^{1,2}

¹*Institute of Physics of Materials, Academy of Sciences of the Czech Republic, Brno, Czech Republic, EU, svabenska@ipm.cz*

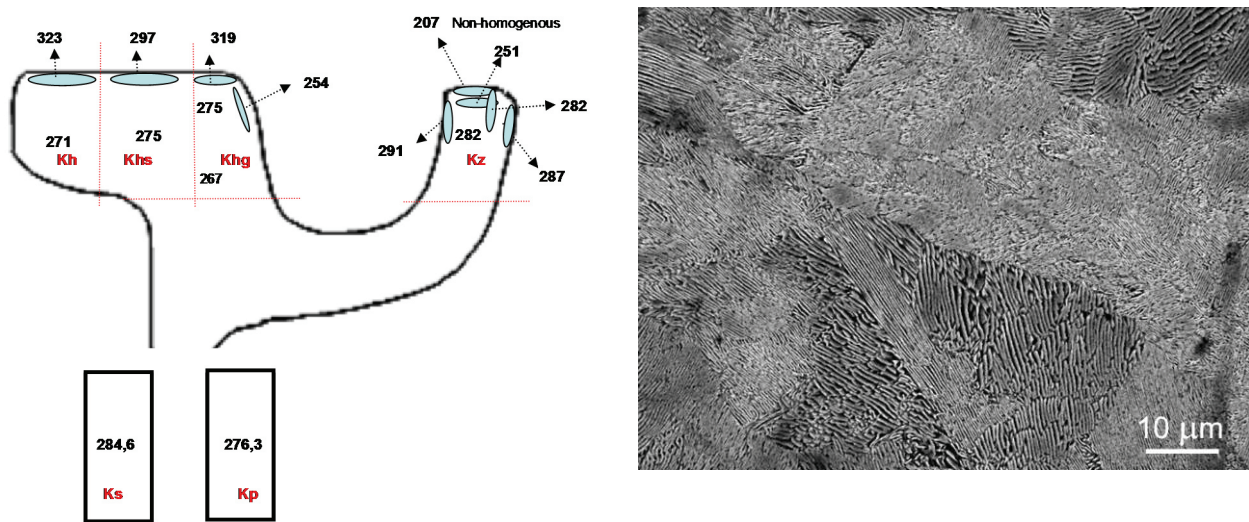
The rail evinced only the change over the working period. The cracks were not observed in the investigated part of rail. The rail head showed the plastic deformation of pearlitic microstructure (**Figure 2**), where interlamellar spaces have been blended, broken and deformed. The zone with plastic deformation which was influenced by traffic, have around 60-80µm according to their position on the rail head.

Hardness was observed close to surface of the rail head and approximately 15 mm below this site. The detail place of hardness measurement was shown together with an arithmetic mean of a value for each place in **Figure 2**. The values of hardness close to the surface are higher than in bulk material [3]. Increase value of hardness was observed closely to running surface that could be impact of decreasing of interlamellar space create by working condition. Approximate range of hardness observed at a running surface was higher than a value 260 to 300 HBS presented by Lukašič [7].

Figure 2 Left: Place and value for measurement of the micro hardness.
Right: fully pearlitic microstructure of the rail

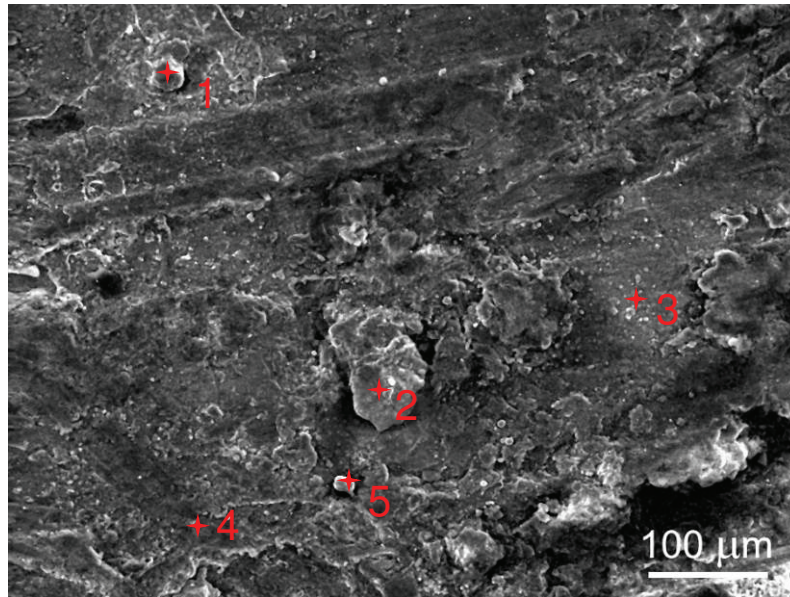
The SEM image (**Figure 3**) shown very diverse surface of the rail head. The surface layer containing by EDX analysis mainly iron, oxygen, carbon, silicone, aluminium, cooper and zinc in variable concentration. This result corresponding with XRD analysis, where the main component were α -Fe (60 wt. %), lepidocrocite γ -FeO(OH) (23 wt. %), graphite (13 wt. %), quartz SiO_2 (2 wt. %), goethite FeO(OH) (1.5% wt) and very low concentration (> 1% wt) of hematite Fe_2O_3 . The XRD analysis as well as find out another impurity the Copper Acetate Hydroxide Hydrate, which structure model are not available for further quantitative analysis. The potential source of this compound could be brake pads of tramway which contained around 11 wt. % of cooper. The XRD determined in the original material of the rail the ferrite and carbides only.

Figure 3 Surface of the rail head with data of EDX analysis. Chemical analysis showed various concentration of Fe (85 - 16%wt), O (27-3 wt. %) and C (17 - 9 wt. %, 0 for point 4) at all point. Other element was also observed: 1 -S and Cl (~1.5 wt. %), 3, 4 - Si (2.7-4.5 wt. %), 5 - Al (1.3 wt. %), Cu (54 wt. %), Zn (11.2 wt. %)

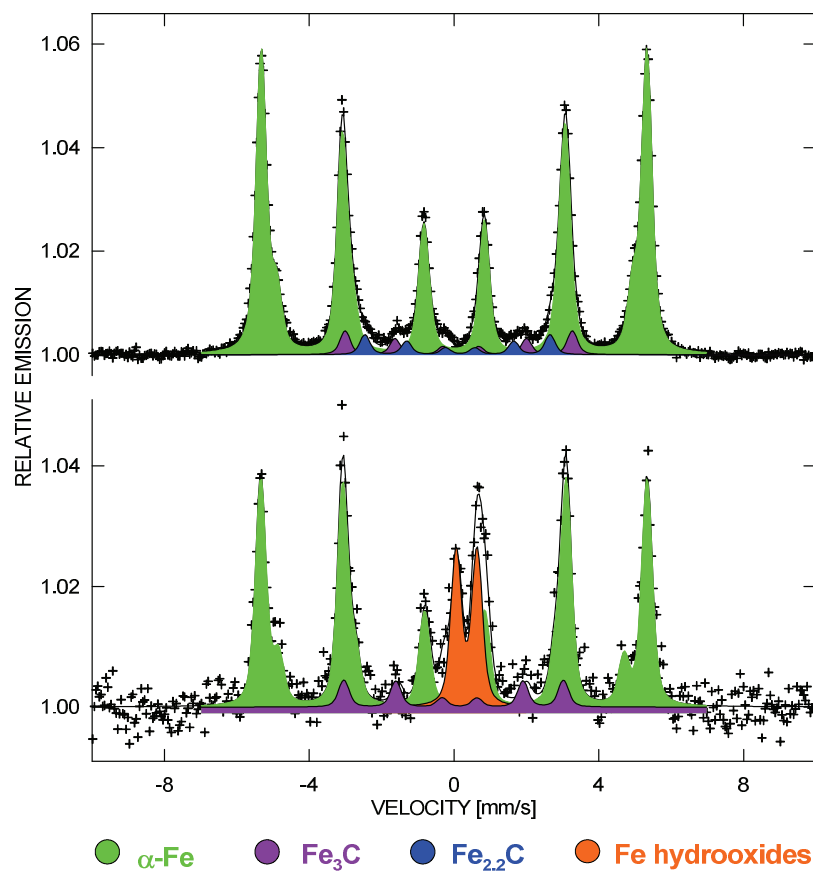
Mössbauer spectra of the surfaces (~20 micrometer thick) of the original material and the used rail are shown in **Figure 4**. The original material contains ferrite and carbides (Fe_3C and $\text{Fe}_{2.2}\text{C}$) and also XRD shows the presence the two types of carbides Fe_3C and $(\text{Fe}_{1.8}\text{Mn}_{1.2})\text{C}$ which is in good agreement with the pearlite structure showed on metallography pictures (OM+SEM). The phase composition of the surface after using in traffic is changing. Content of carbides is decreasing from 9.7 to 6.6 (in at. %) due to diminishing portion of $\text{Fe}_{2.2}\text{C}$ carbides. On the other hand the content of alloying elements in ferrite is slightly increasing which can be the result of a partial dissolving of the carbides. In agreement with XRD components belonging to the hydroxides can be found there.

Figure 4 Mössbauer spectra of the surfaces (~20 micrometer thick) of the original material and the used rail

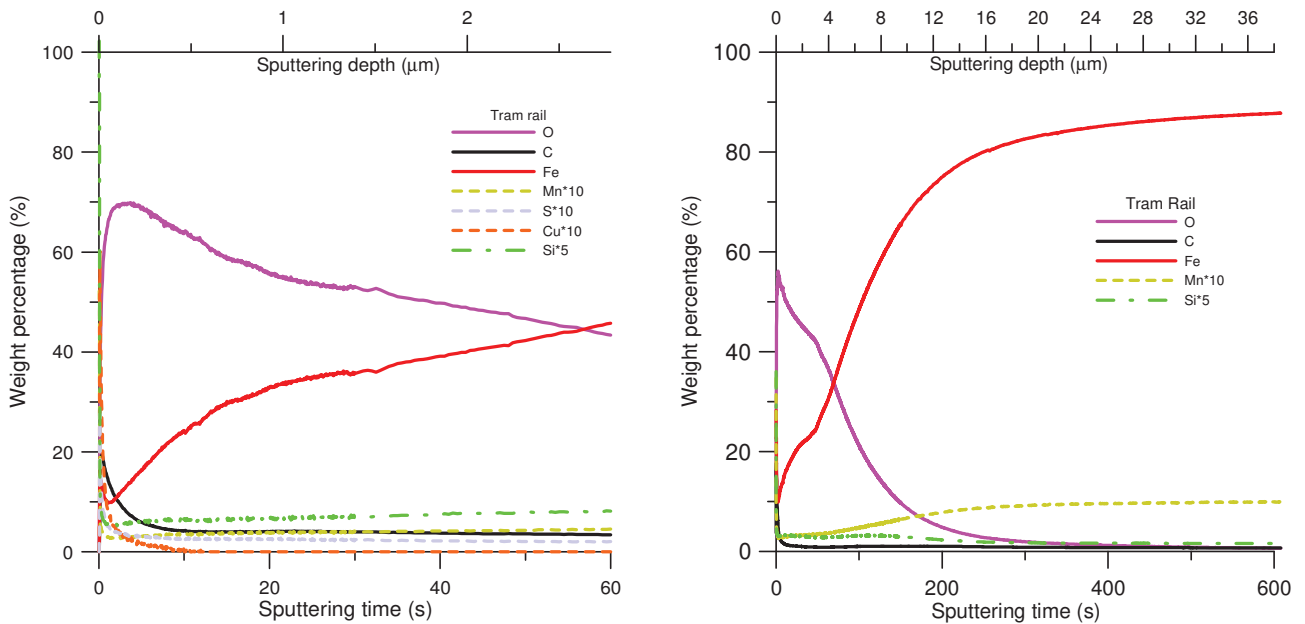
Beside bulk analysis by GDOES also depth profiling was performed. These results have shown change of concentration for chemical elements from surface to depth of material. **Figure 5** had shown the decrease concentration of oxygen (oxides on the surface) with increasing sputtering time. The higher concentration of silicone and carbide was observed close to running surface at depth profile and also by a confirmed by SEM/EDX analysis of surfaces. It could be explaining as contamination from city surroundings.

Figure 5 Depth profile from running surface to bulk of the rail head. Left - detail situation at interface running surface and surroundings. Right - longer profile to depth (depth calculate by GDOES software). Concentration of some element was multiply by five (Si) or ten times (Mn, S, Cu) for better recognition.
