## STUDY OF CORROSION CAUSE ON EVAPORATOR TUBES IN THE COMBUSTION CHAMBER OF THE STEAM BOILER

The paper solves the cause and character of the damages of tubes, or evaporator tubes made of refractory carbon steel L290NB, used for the evaporators of combustion chambers of steam boilers used for production of steam, and necessary for subsequent production of electricity. Based on the evaluation of steel samples defected by perforation with incrustation deposit, the mechanism degrading the material of evaporator boiler tubes was discovered. The higher temperature in the combustion chamber, higher content of alkalizing solution of P<sub>2</sub>O<sub>5</sub> and presence of copper ions are the cause of such degradation.

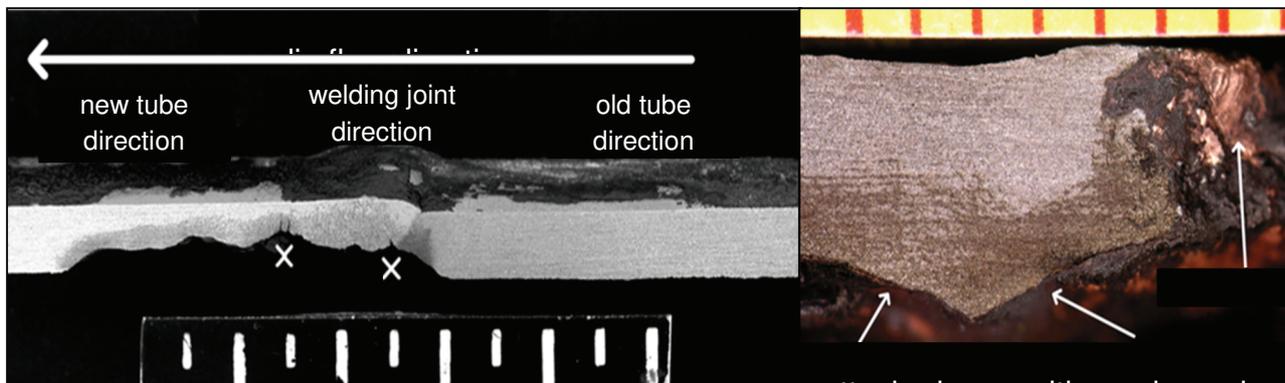
Spectral and mass analysis showed the rate of corrosion damage to the wall of the tube walls in form of mesh cracks with significant deposits of copper at the site of damage. Damage is always detected in the area of the

tube wall surface inhomogeneity, i.e. in the place of welded joint with localization in the direction of media flow, behind the welded root.

**Figure 1** Photos of damaged tubes, enlarged 4x/8x [3]

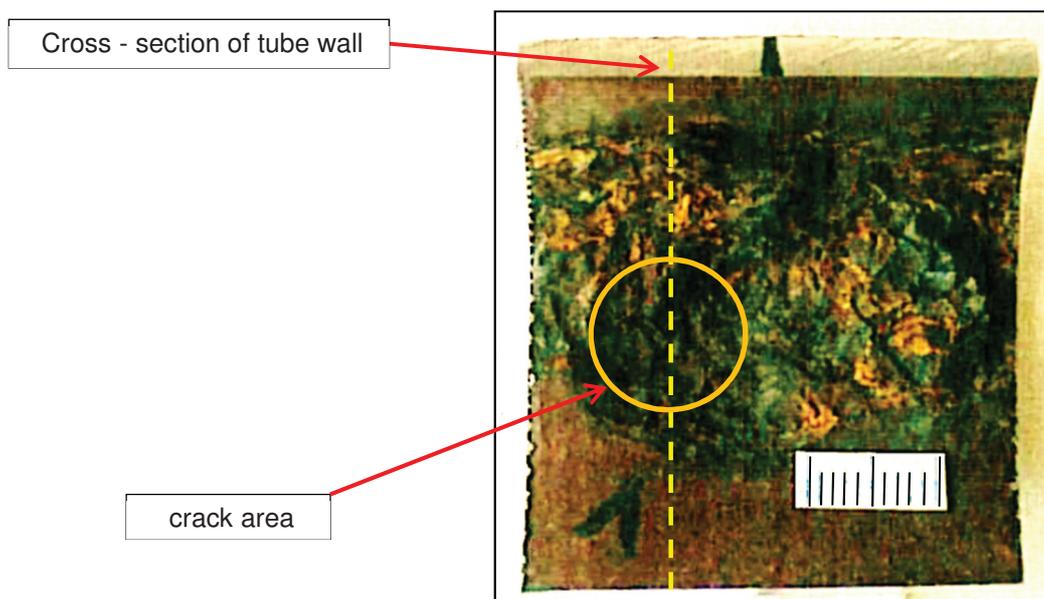
**Figure 2** Photo of corrosion of tube inner wall **incrustation**, enlarged 4x [4]

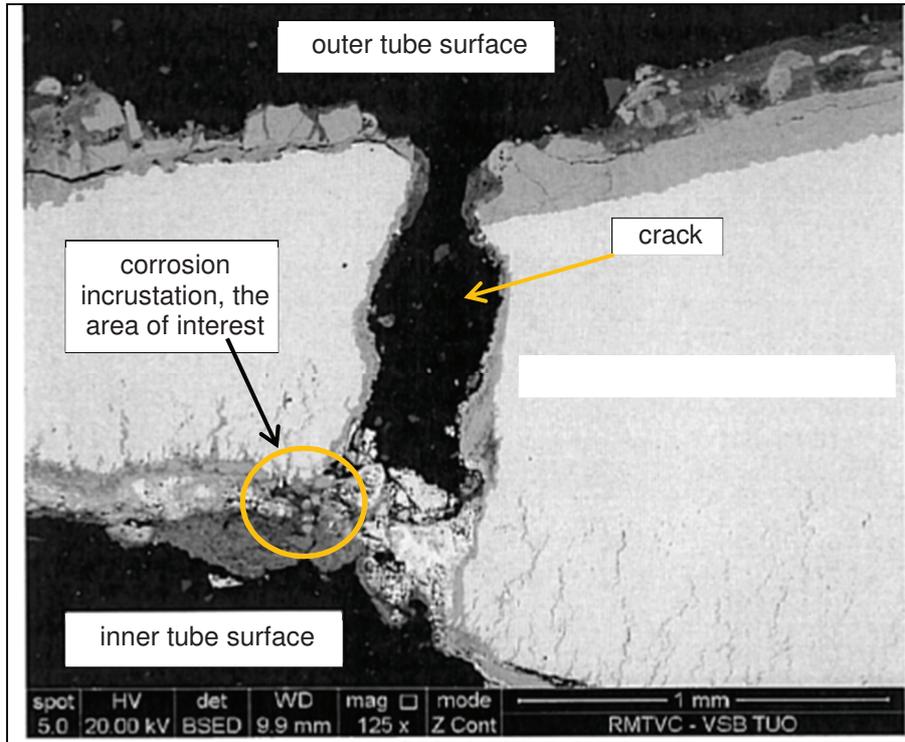
From the incrustation microanalysis shown in **Figures 3, 4, 5 and 6** results that in addition to high parameters of the common oxide phases of magnetite and hematite, the phases associated with aqueous phosphate mode or phase of Ca, Mg, Cl have also been found. Element highly present during collection at all positions, was copper, both in the metal and oxides forms.

**Figure 3** Crack - microanalysis of tube surface, enlarged 125x [4]

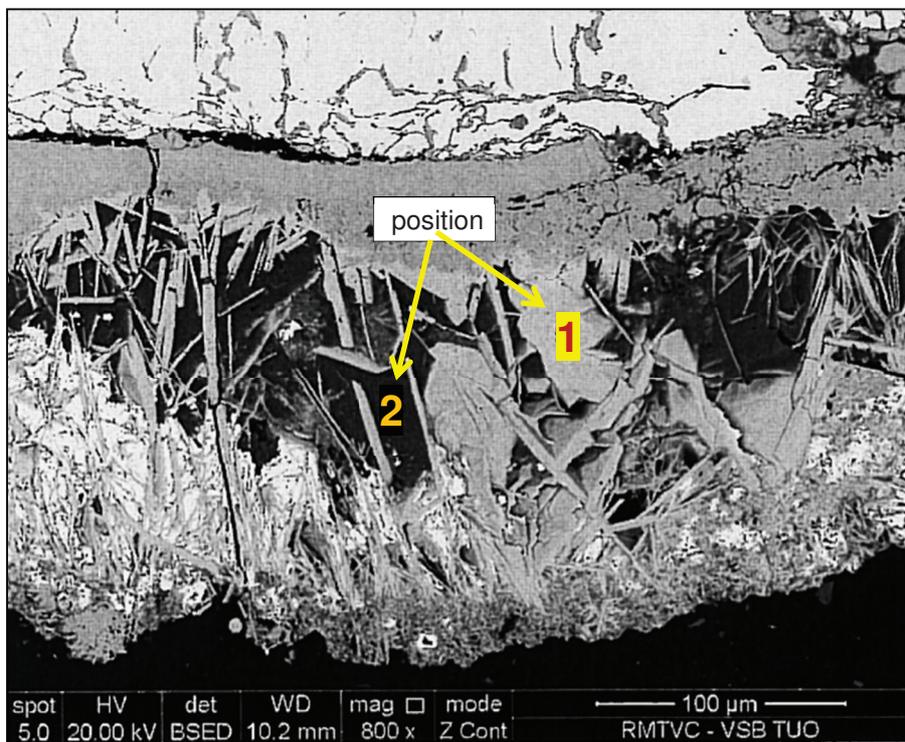
**Figure 4** Spectral microanalysis of tube surface - position 1 and 2, enlarged 800x [4]

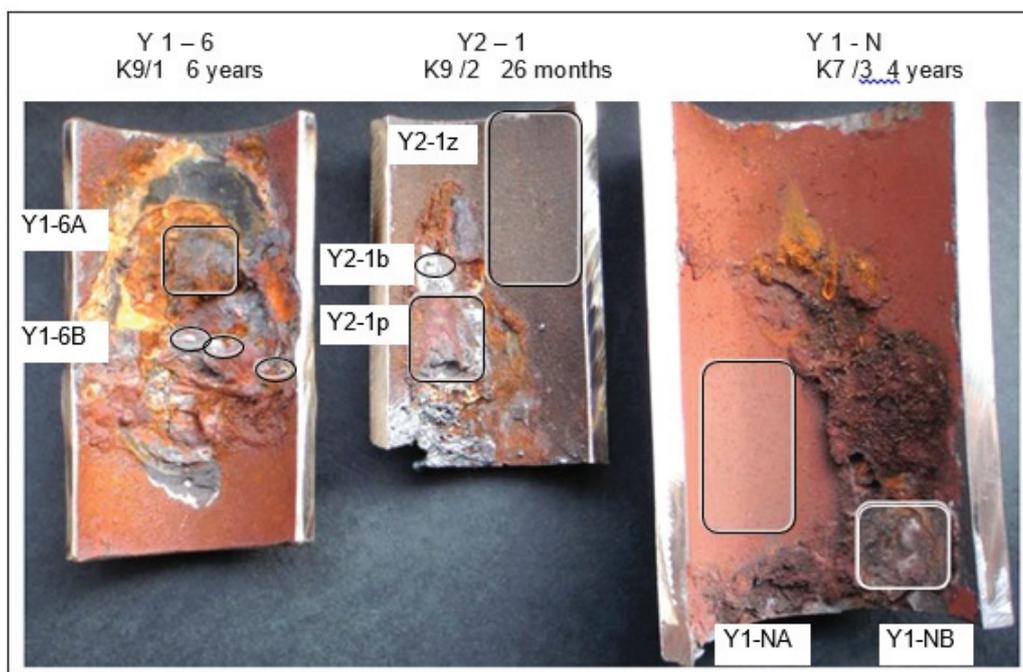
Mass analysis of corrosive incrustations from **Figure 7** is stated in **Table 2**.

**Figure 7** Corrosive incrustation of tube surface [2]

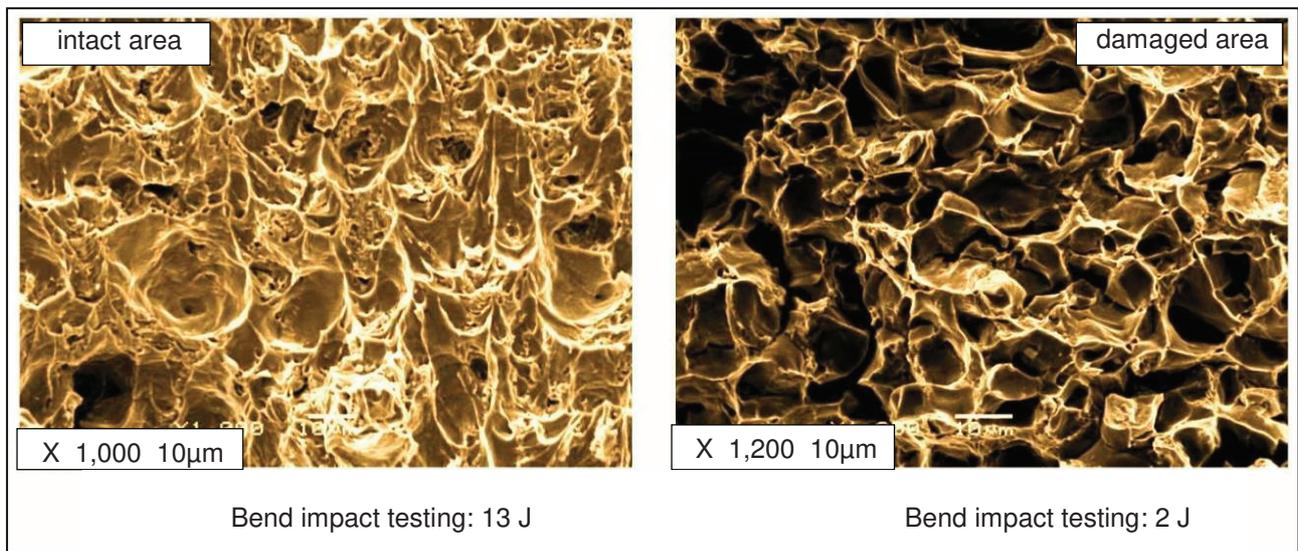
To check the changes of the mechanical properties of the tube material, the samples from various positions were taken for bend impact testing. The experiments carried out during dynamic load showed that the test pieces taken from the refraction area show significantly lower impact values (2-12 J) compared to intact areas of the tube material (12.5 - 13 J). The evaluation of fracture surfaces, see **Figure 8** confirmed the fracture surface material of the tube damaged area is fine-grained, without significant macroscopic deformation with high frequency of very small cracks. The fracture surface of the test piece from the undamaged section of the tube showed signs of persistent damage with moderate shear edges, see **Figure 8**.

**Figure 8** Photos of fracture surface of samples from damaged and intact area. [2]
