## THE CAUSES OF DAMAGE TO THE BRASS FITTINGS OF WATER SUPPLY SYSTEM

KRAUS Martin<sup>1</sup>, BYSTRIANSKÝ Jaroslav<sup>1</sup>, MAREŠ Vratislav<sup>2</sup>

### Abstract

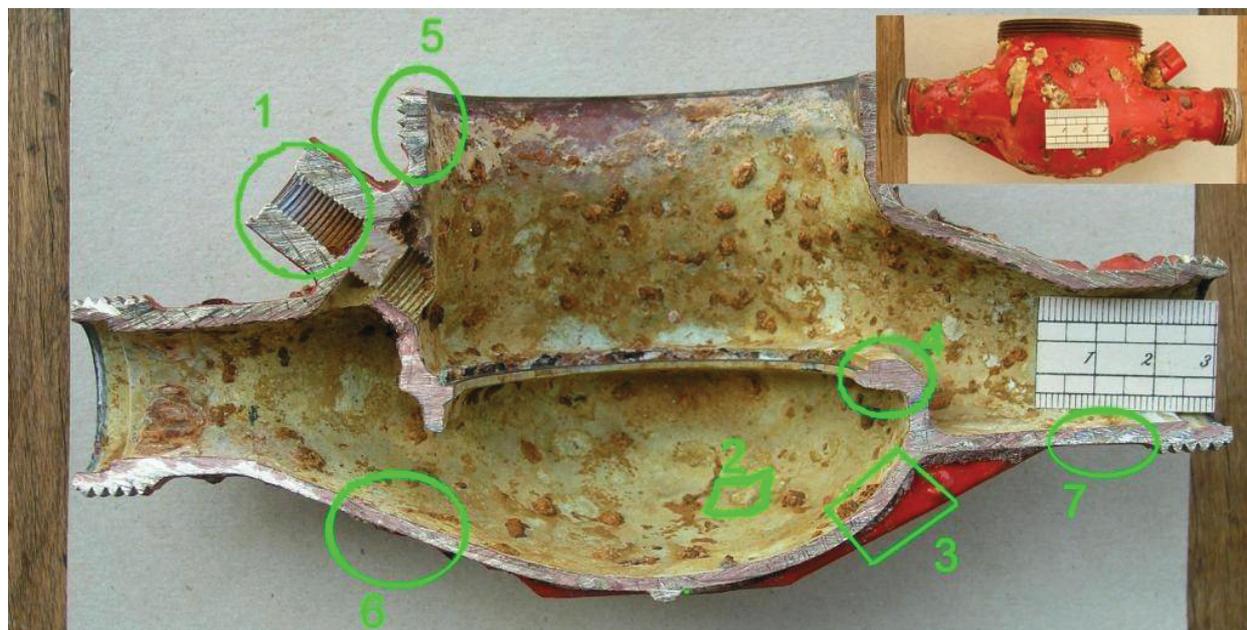
**Figure 1** Specimen extraction for metallographic and SEM analysis; **spec. 1** - basic material, unaffected, not in direct contact with the environment, the maximum wall thickness; **spec. 2** - the bottom wall under the outer blister with through pore; **spec. 3** - the bottom wall with technological connection to the rib stiffeners; **spec. 4** - internal desk (housing for indicator); effect of media on both sides; **spec. 5** - thread area of gauge lid; least affect intensity; **spec. 6** - „average“ wall; **spec. 7** - pipe part, following the thread for the connection of gauge

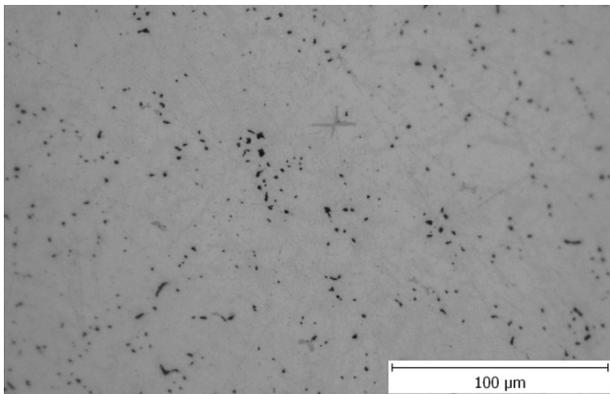
In **Figure 2** the cut surface of specimen 1 is in polished condition. In **Figure 3** then is the microstructure of base materials on the same specimen. Needle morphology is typical for two-phase brass, [1, 6]. **Figures 4** and **5** document the pore on scratch pattern of specimen 2 with visible crack spreading from the pore. This one is through, it is not clear, however, whether originated by the media or partially initiated already during the casting process. On both images is pronounced (dezincificated) area of the pink coloration with a typical round curving shape.

**Figure 2** Basic material, spec. 1, polished state

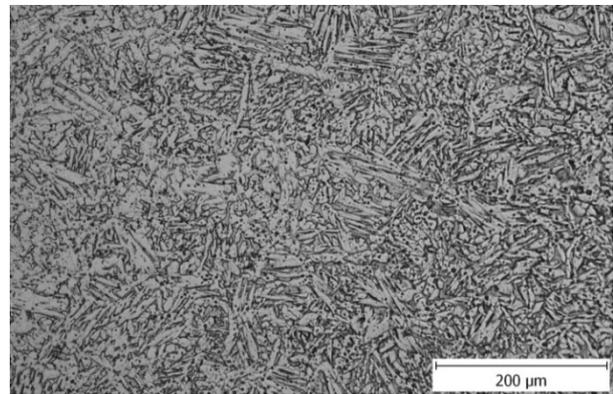
**Figure 3** Basic material, spec. 1, etched state

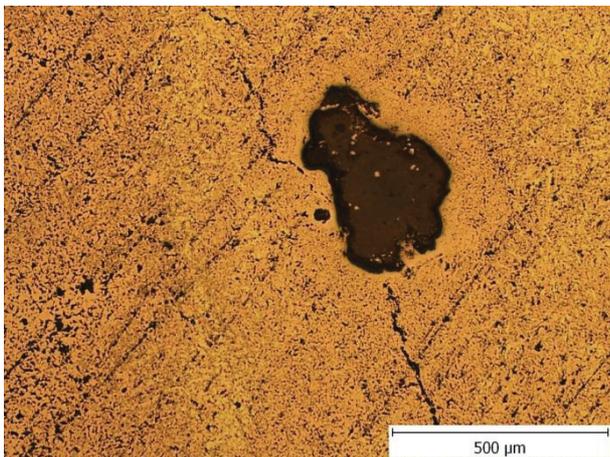
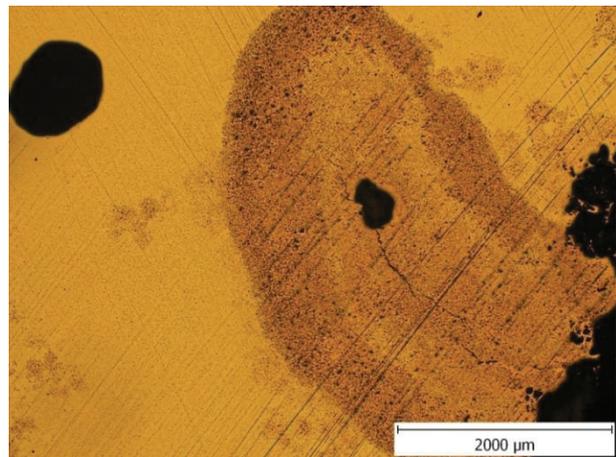
**Figure 4** Scratch pattern, spec. 2, polished state

**Figure 5** Scratch pattern, spec. 2, polished state

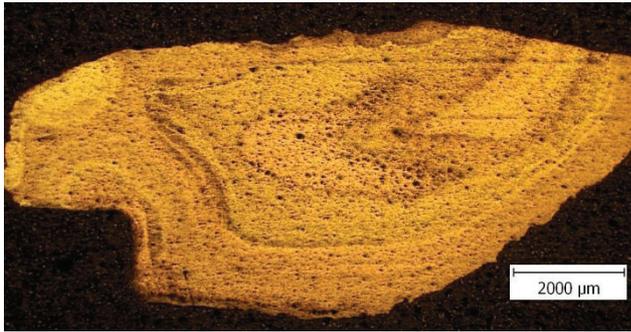
Specimen 4 evinces dezincification in full cross section, which is consistent with the fact that medium flows this part of water gauge from both sides (**Figure 6**).

**Figure 6** Dezincification- all cross section, spec. 4

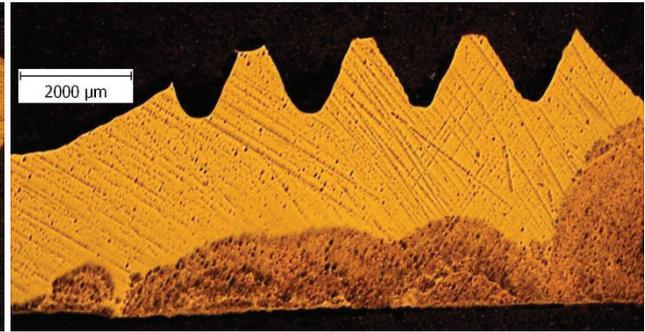
**Figure 7** shows the threaded part (spec. 5) of the gauge with attack, which is common throughout the full length of the gauge outer shell. Therefore, dezincificated spongy structure with significantly fluctuating attack depth of the wall thickness. Spec. 7 taken from the shell in place, which connects on the fittings, the considerable disintegration of structures evinces, with the visible crumble of the inner wall's particles (**Figures 8** and **9**).

**Figure 7** Thread part under gauge lid, spec. 5

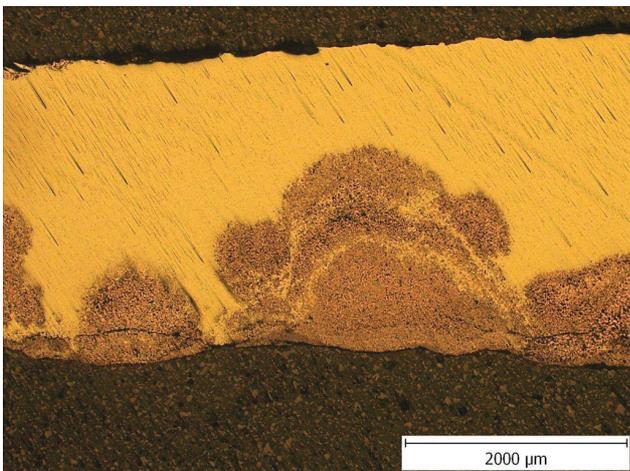
**Figure 8** The attack of spec. 7

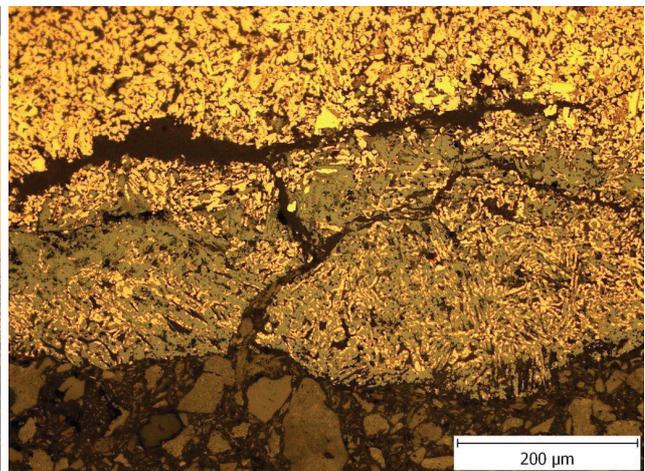
**Figure 9** Detail of microstructure disintegration

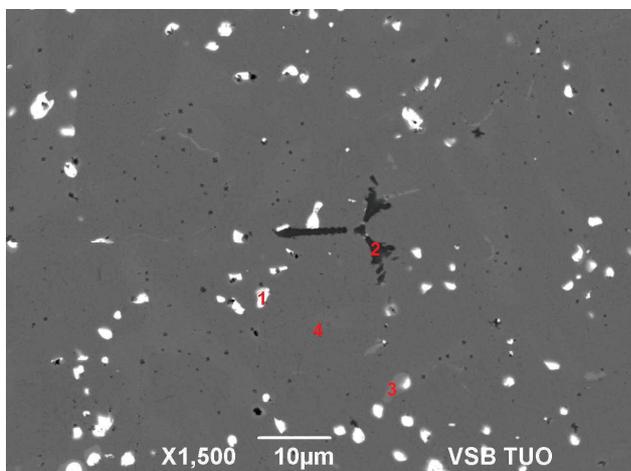
**Figure 10** and **Table 1** of are documenting the state of specimen 1, therefore the original material of water gauge. Surface analysis shows that this is a brass with an average content of approx. 61 wt.% copper and 34 wt.% of zinc. Microstructure is dual phase. Majority dark grey phase contains 65 wt.% Cu against 33.5 wt.% Zn. The minority phase (lighter) has about 53.5 wt.% Cu; 33 wt.% Zn and a relatively high content of Sn - over 11 wt.%. Further there are units (formations) on the basis of lead (Spectrum 1) and iron (Spectrum 2) occurring.

**Figure 10** SEM analysis of basic material, spec.1

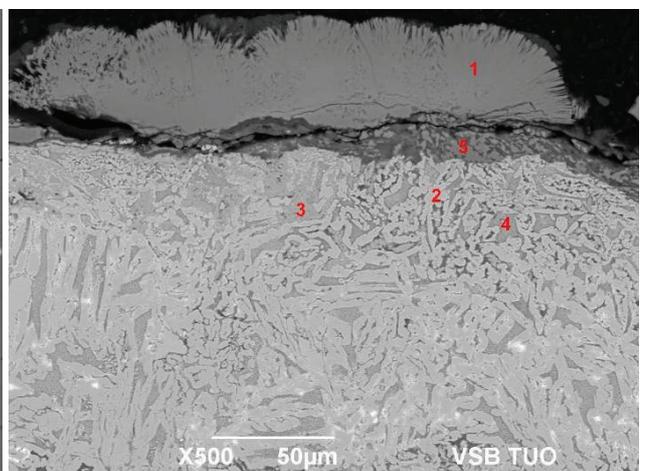
**Figure 11** SEM microstructure analysis of spec. 5

In **Figure 11** and in **Table 2** is described the situation at the inner surface of the specimen 5. Spectrum 1 and 5 corresponds to the zinc oxide deposits. Spectrum 2 to 4 shows on dezincificated area with almost absolute contents of copper, alternatively, copper and oxygen compounds. Area (surface) analysis in greater depth (or closer to the outer surface) has confirmed the composition of the base material, same as the sample 1. A similar situation also exists in the case of sample 7.

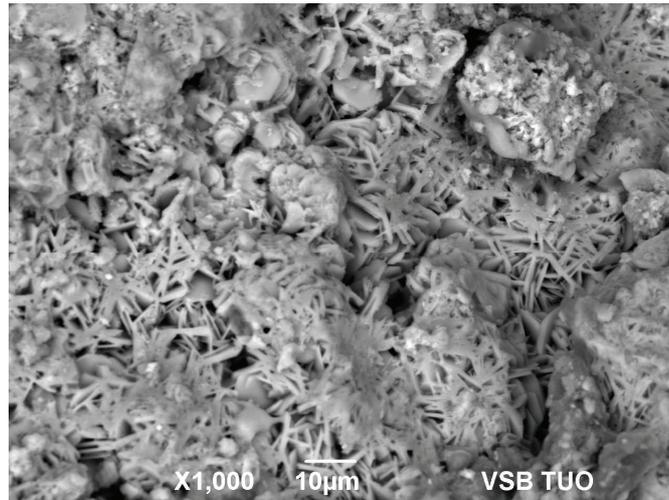
XRF and XFD analysis showed that samples A and B are related to its composition on the base with a high proportion of zinc, iron and copper, the content of which is substantially higher in the sample A (over 15 wt.%). Sample D from the water gauge lid is based on copper oxides with a significant proportion of Silicon. Sample (C) has a great difference from the others. Its composition with high levels of zinc and chlorine indicates the presence an upper email components (due to the nature of incrustation unfortunately inseparable) and the process of dezincification corrosion products. This fact confirmed also SEM or. EDS analysis of same product taken from a different location of the gauge - see **Figure 12 (Figure 1, cut)** and **Table 3**.

**Table 3** EDS analysis of composition of blister incrustation (rigid leakage) on outer gauge wall

element	O	Al	Si	S	Cl	Fe	Ni	Cu	Zn
wt.%	32.49	0.80	0.26	4.74	15.59	0.41	0.99	0.62	44.10

**Figure 12** SEM - microstructure of blister incrustation (rigid leakage) on outer gauge wall
