## EVALUATION OF THE FAILURE OF VIBRATION SCREENER SIEVE

This article discusses the causes of damage of the sieve of the vibratory separator of  $\text{MgCl}_2 \cdot 6\text{H}_2\text{O}$ . Sieve is made from Steel AISI 304. Damage manifested itself with the cracking of certain strand (wires), mostly in the area of the outer circular frame. The damage started to occur after change of the vibration (frequency) parameters. The possible influences of chemical damage by environment or corrosion attack were observed, mechanical stress, fatigue, etc.

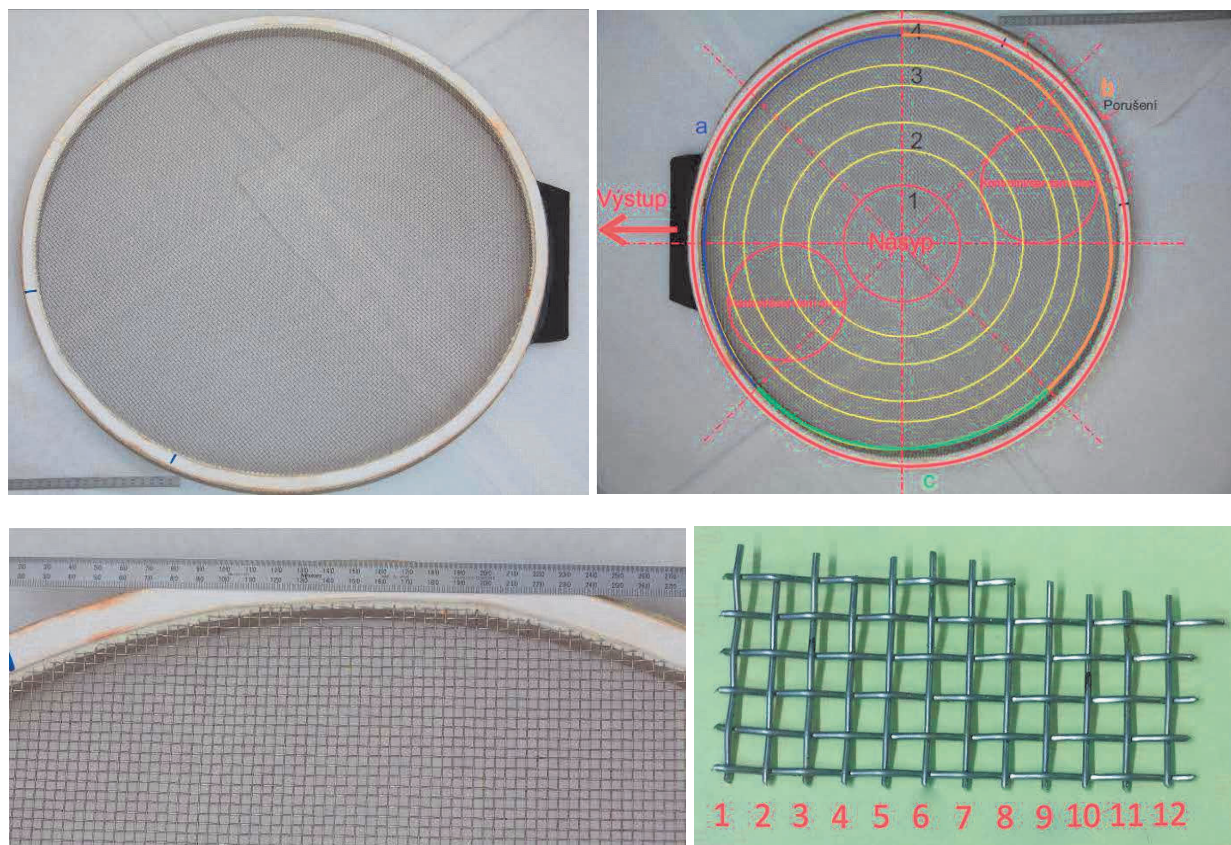
The supplied material is the sieve of the magnesium chloride vibration screener (**Figure 1**). In the mesh of sieve occurred break of many threads. The disorder appears to be random and occurred after three weeks of

**Figure 1** Sieve - the overall view; working scheme; detail of area A; wire numbering

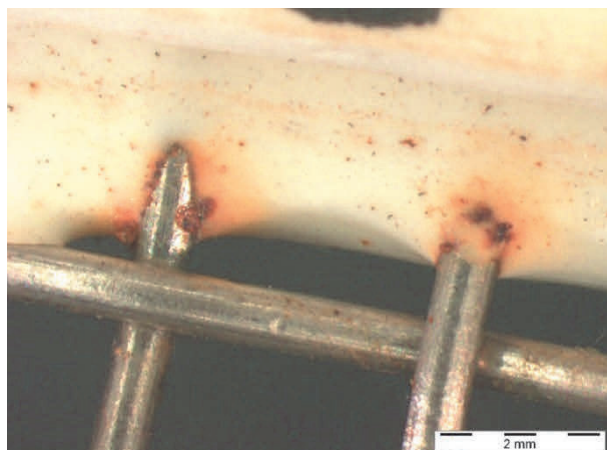
From the point of view of the surface, the wire mesh is not smooth, but in addition to the broken wires, no cracks have been found in other places. (**Figures 2 and 3**)

**Figure 2** State of wire in area A

In detail, small corrosion products were visible on the wire surface. It cannot be excluded, that this corrosion damage was partly caused by shutdown of the screen and next storing (**Figure 2**) due to residual contamination of the surface. An elevated temperature of the sift product would contribute to corrosion cracking, but only when critical relative humidity is exceeded. On some fracture areas origins of cracks with a plane perpendicular to the magistral plane were found (**Figure 8**). The influence of the environment could contribute to shortening the initiation and propagation rates, but the driving factor is the fatigue stress of the wire and the lower structural stability of the steel.

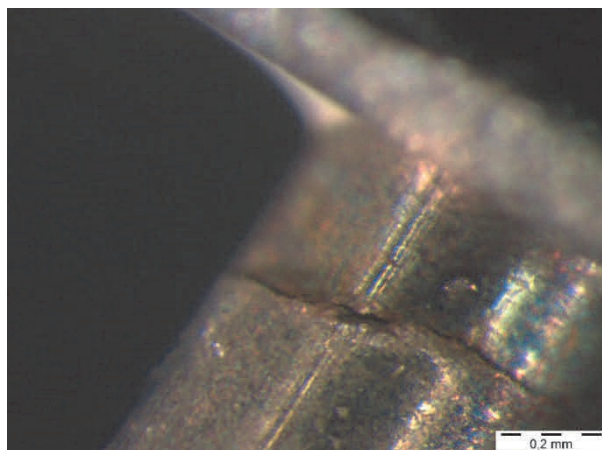
**Figure 3** Fracture in area A

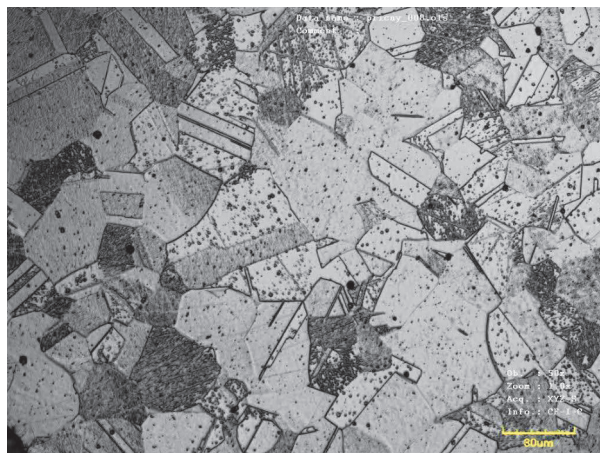
For the metallographic analysis of the wire material, which forms the mesh screen, several cuttings were prepared from the area of the input and from the region of the occurrence of fractures - A. The plane of the cuts was oriented in the transverse and longitudinal direction relative to the wire axis. Cracks on the wires No. 1, 4, 6 and 11 (**Figure 1**) were observed by metallography. No cracks on the metallographic cut of fracture surfaces were found (see **Figures 4 and 5**).

**Figure 4** Longitudinal wire cut - microstructure

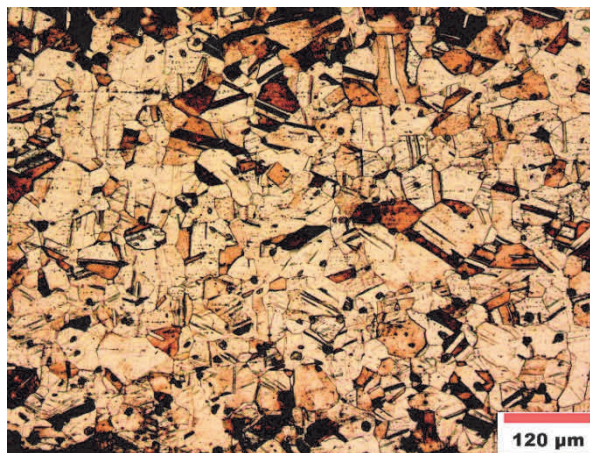
**Figure 5** Transversal wire cut - microstructure

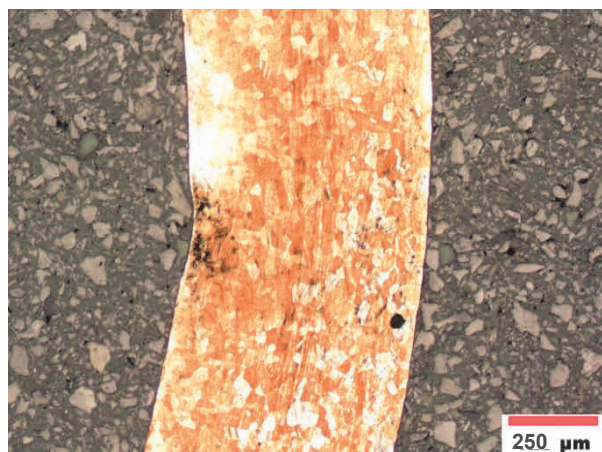
**Figure 6** Beraha solution etching - area of bending

Beraha II (HCl + water + NH<sub>4</sub>FHF) solution etching showed a microstructure in the wire bending and fracture area in the longitudinal cut [1]. In the bending region (**Figure 6**) of the screen wire, the sloping bands and the origin of the deformation-induced phase transformation were found from the upper and lower sides. This microstructural change was also found in the area of the fracture (see **Figure 7**).

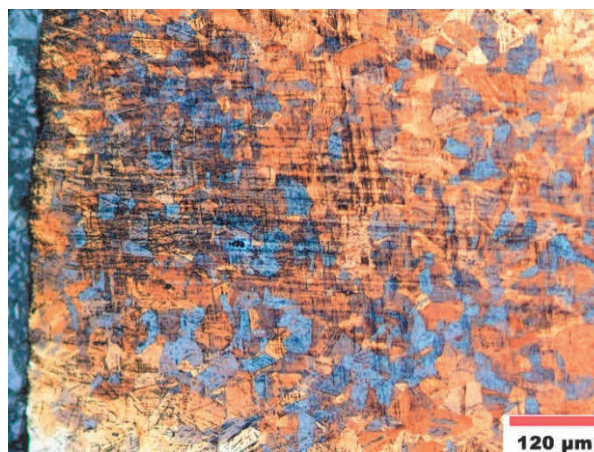
**Figure 7** Beraha solution etching - area of fracture

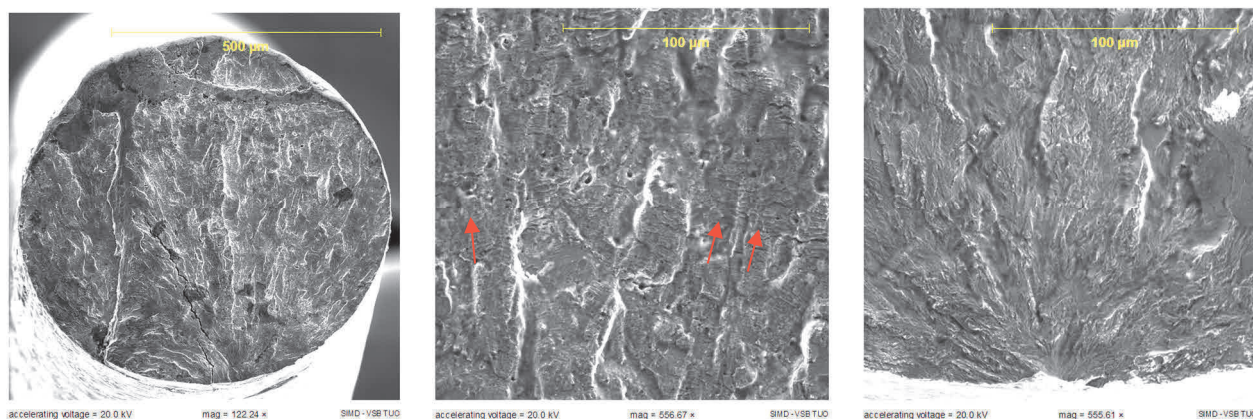
A portion of the sieve with the occurrence of fractures was separated from area A. Extremely worn fracture surfaces were excluded from further fractographic analysis and were used in metallographic analyses. Specifically, fractures No. 1, 4, 6 and 11 were numbered according to **Figure 1**. On the most preserved fracture areas - no. 5, 7, 10 and 12 have been found in the progress lines, the striations typical for fatigue failure (see **Figure 8**). The failure initiation is located on the top, hopper side of the screen. The exception is fracture No. 8, where a technological notch was found on the underside (wire perimeter of the sieved sieve outlet). At fracture 9, the fracture area is damaged by scratching, the determination of the initiation site is problematic, it is not possible to exclude the initiation and the procedure of the crack from the opposite surfaces (through the diameter of the wire) from the macroscopic view.

**Figure 8** Fracture surface No. 7: Global view; striations; initiation

The initiation of the fractures No. 2, 5, 7, 10, 12 occurred on the upper side of the screen; Fracture No. 8 on the underside of the screen - the opposite side. The unequivocal determination of initiation at fractures 3 and 9 is problematic.

Due to the occurrence of progressive lines (striations) on the fracture surfaces, it can be stated that in the initiation phase there was active fatigue damage.
