## EVALUATION OF THE MECHANISM OF DAMAGE TO THE FORGING DIE USED IN THE DIE FORMING HAMMER

### Abstract

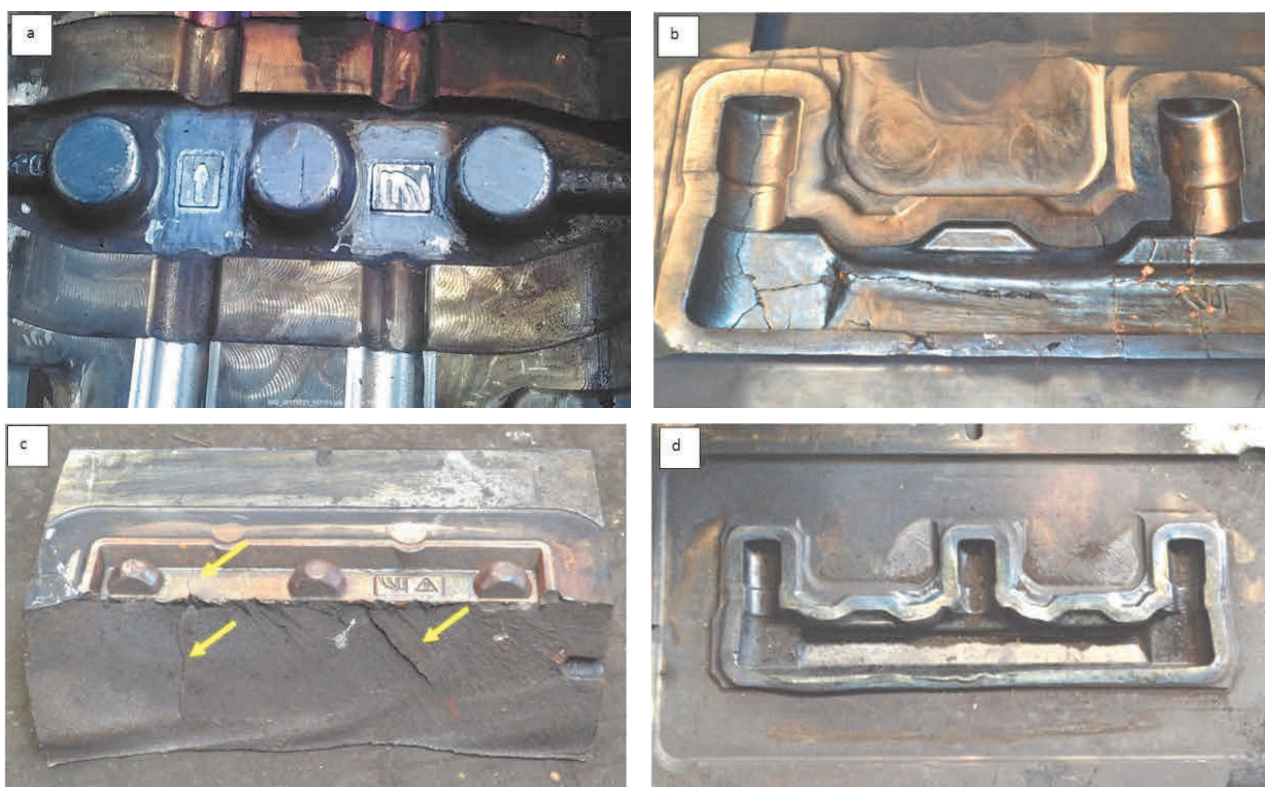
The matrices after exploitation were subjected to macroscopic observations, the results of which are shown in **Figure 1**. It has been found that there are different mechanisms for destroying tools in matrices, and in some cases these mechanisms occur together. The basic ones include abrasive wear, plastic deformation, thermal and mechanical fatigue. From the matrix which broke (**Figure 1c**), the material for the microstructure investigation was collected, the results of which are shown in **Figure 2**. The analysis of the structure of the matrix after exploitation made it possible to determine the presence of a martensitic structure with bright areas of the so-called white spots. This effect may be a consequence of segregation of the chemical composition or incorrectly conducted heat treatment (hardening).

**Figure 1** Examples of wear for hot forging dies: a - abrasive wear, b - thermal fatigue, c - mechanical damage, d - plastic deformation

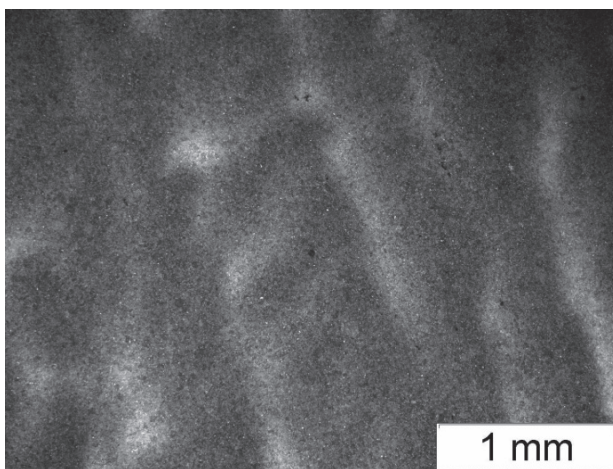
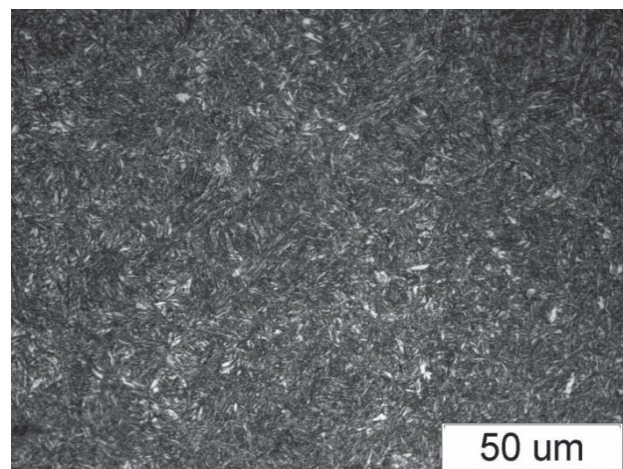
**Figure 2** The microstructure of the die for hot forging after operation. The structure of low-martensite, martensite and the presence of white patches

- 1) The material has a different martensitic structure, from correct (locally) to degraded to a degree that makes it impossible to continue using the matrix.

- 2) The material hardness of the die indicates improper heat treatment, consisting of tempering the die after hardening in too low a temperature or in too short a time (low-martensite).

- 3) The microstructure is differentiated by the presence of soft spots, the occurrence of which is the result of unheated or insufficiently intensive cooling, or due to the heterogeneity of the initial structure, e.g. ferrite clusters.

- 4) The correct structure enables the matrix to be repaired based on the use of the machining process or the repair by the method of welding. The change in the structure that prevents further use of the matrix results mainly from the fact that the structure, which has been degraded to a large extent, causes a drop in impact strength, and consequently an increase in susceptibility to cracking during the forging process.

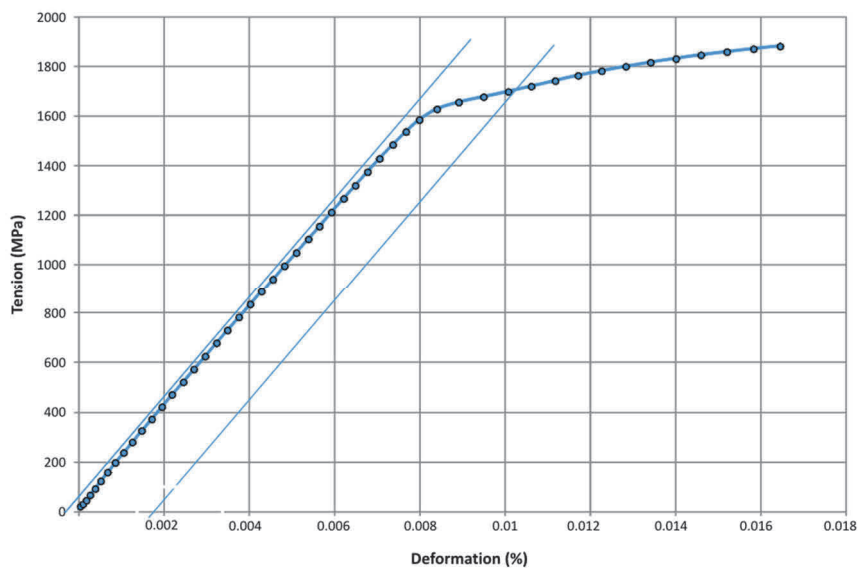
The results of mechanical properties are presented in **Table 2** and **Figure 3**. It was found that the material meets the requirements specified by the standard in terms of tensile strength and yield strength.

**Figure 3** Diagram of mechanical properties after a static tensile test for sample 1

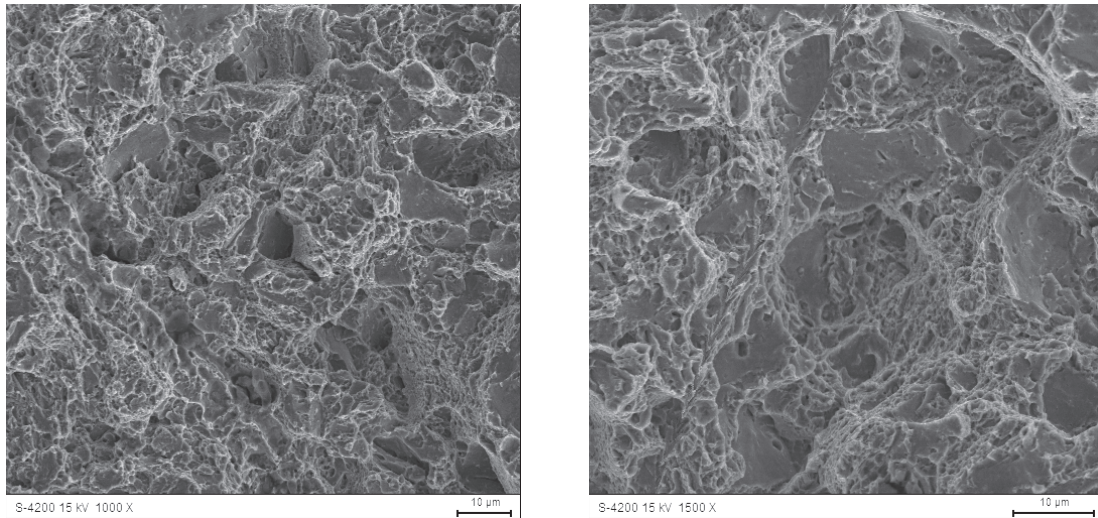
The obtained breakthroughs after a static tensile test were subjected to observations by means of a scanning electron microscope. The results are shown in **Figure 4**. It was found that the surface of the matrix fracture is mixed (ductile and brittle). Toughness of the matrix was determined using the Charpy test. Subsequently,

**Figure 4** Surface of the fracture of the sample after a static tensile test, mixed breakthrough

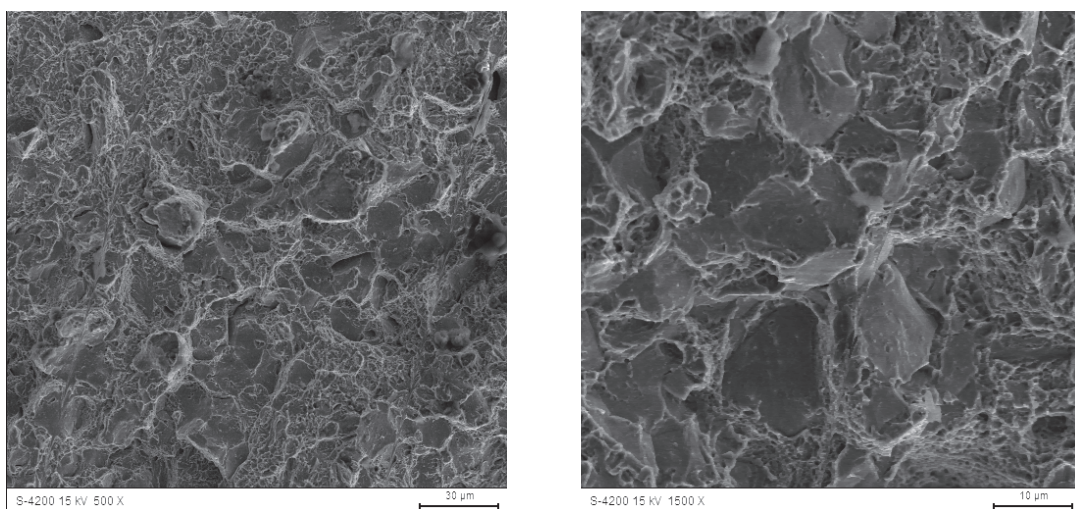
observations of the surface of obtained breakthroughs were performed using the Hitachi S-4200 scanning electron microscope. The results of breakthrough observations are presented in **Figure 5**. The impact strength results are summarized in **Table 3**. It has been found that the material has an impact resistance at a low level. The drop in impact strength may result from the presence of microcracks in the material, which are a consequence of the matrix operation.

**Figure 5** Surface of the fracture of the sample after a impact tests. Mixed breakthrough.

- 5) There was no loss of plasticity, as evidenced by the results of static tensile test and ductile fracture on the material after the impact test (observations by scanning electron microscopy).
