INVESTIGATION OF FAILURE CAUSES OF HELICAL COMPRESSION SPRINGS

Abstract

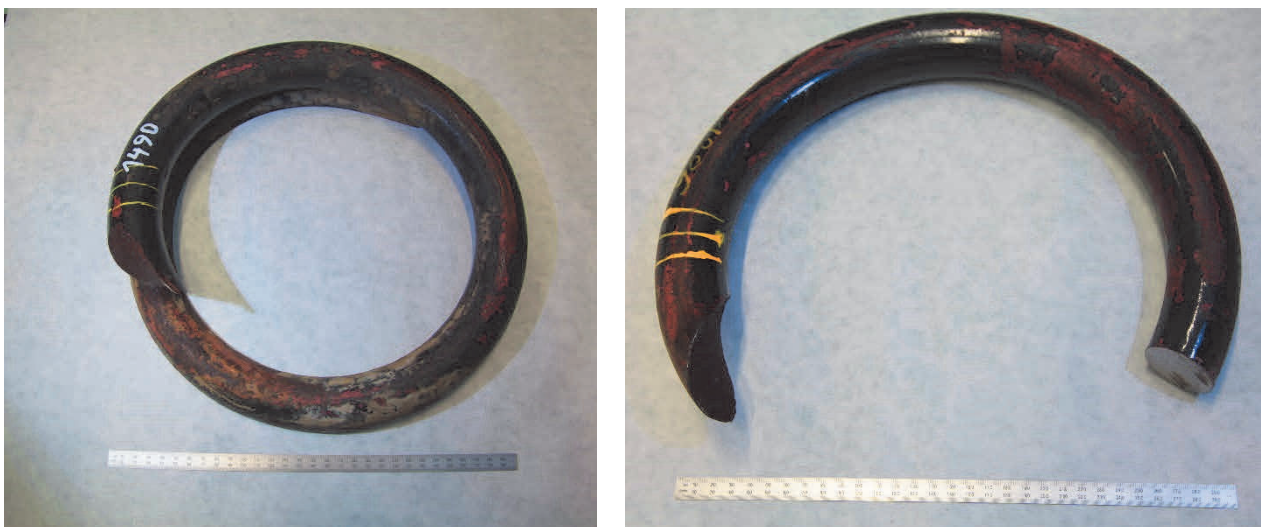
Two helical springs were provided for investigation, designated by their respective numbers - 1286 and 1490. Springs type were of open and ground type, which means the ends were grounded flat and last half-coil is inactive. Fracture surface was located on the first active coil in case of No. 1490 spring, while the rest of No. 1290 was sawed off - **Figure 1** and no information of fracture position in respect to spring was given. Polymer-based black coating which protects surface from corrosion was severely worn. Fracture surfaces were not protected from the environment, therefore were covered by uniform layer of rust. Surfaces were cleansed by Nital etchant for further inspection. Appearance of the fracture surface area pointed out area of origin which was later observed by scanning electron microscope - **Figure 2**. Edge of the fracture surface extended at angle 45° towards the spring axis, which is typical for torsional failure under cyclic torsion [1,2]. An artefact of bend edge is visible on spring No. 1286 but located aside from the area of possible crack origin and was not taken into consideration of fracture causes.

Figure 1 Fractured helical springs. (a) No. 1490 and (b) No. 1286

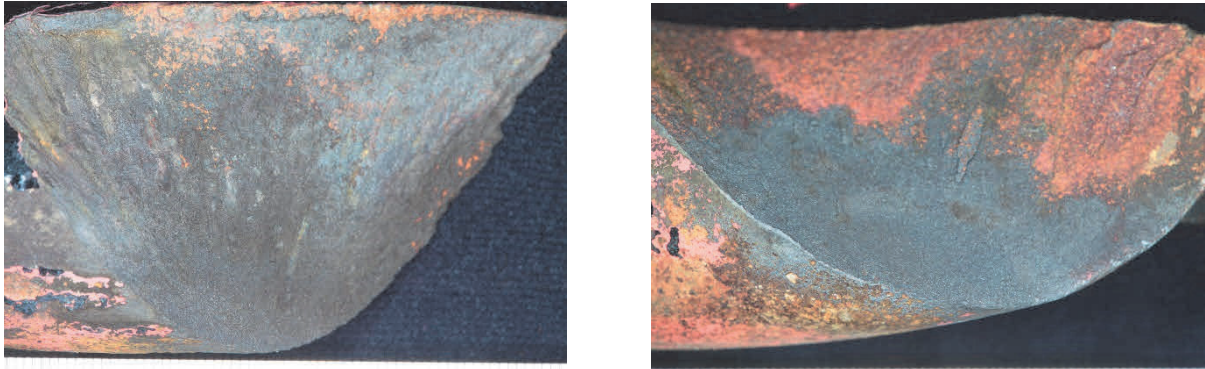
Figure 2 Close-up of the cleansed fracture surfaces (a) No. 1490 and (b) No. 1286

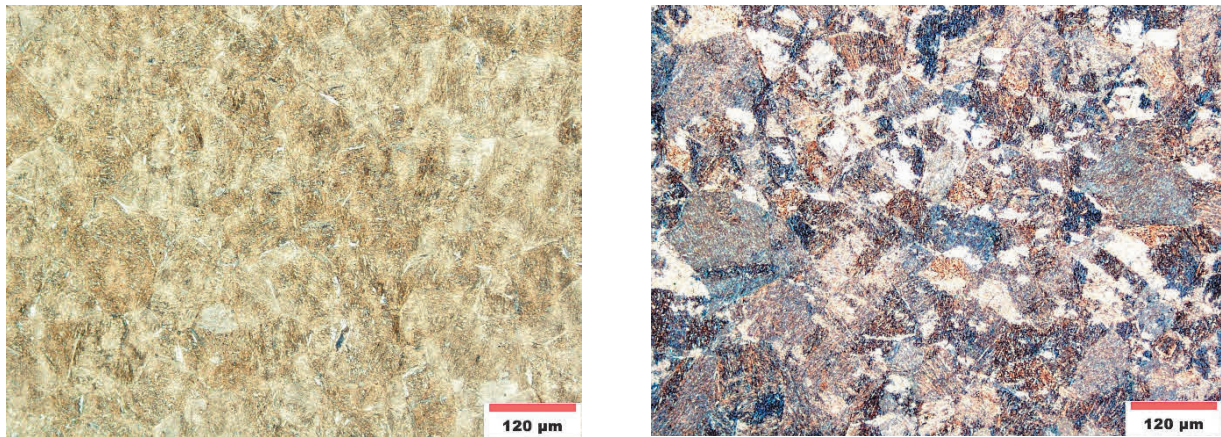
Figure 3 Microstructure of spring No. 1286 after etching in (a) Nital 4 % and (b) Vilella

Standard metallography specimens were prepared from the area close to fracture surface. Prevailing oxide type inclusions were observed in polished condition but not evaluated according to standard. Nital 4 % etchant was used to reveal microstructure which consisted of tempered martensite in the whole cross-section with minor decarburization on the surface. Depth of decarburization was later estimated by hardness testing. Furthermore, specimens were etched in Vilella's reagent to evaluate primary austenitic grain size. Lineal intercept procedure was used to determine the grain size number G which were found to be $G = 4$ for both

specimens. Grain size was consistent within whole diameter of the springs. This grain size was found to be inadequate as the grain size of manufactured springs must be at least $G = 8$. Observed microstructures of springs are shown on **Figure 3** and **Figure 4** in etched conditions.

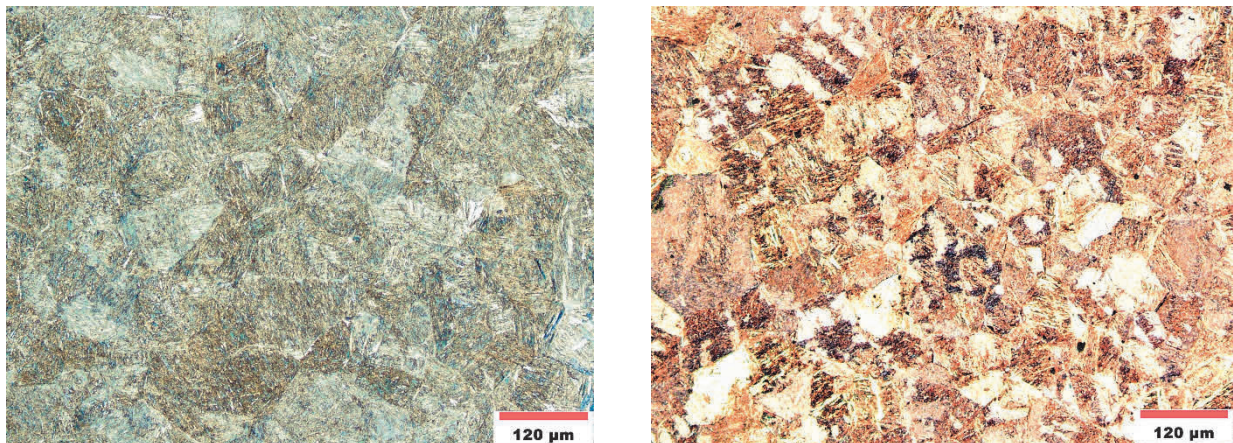
Figure 4 Microstructure of spring No. 1490 after etching in (a) Nital 4% and (b) Vilella

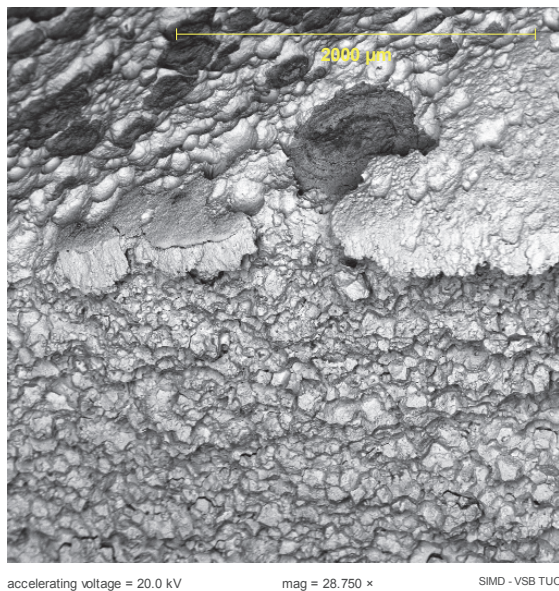
Fracture surfaces and the areas of probable fracture initiation based on the macro observation were studied in SEM. In addition, fracture surfaces of Charpy impact test specimens were also observed. Specific defect acting as a notch or stress raiser and precise origin of fracture was not observed on the surface of the springs, but such identification was found to be difficult due to state of the surface with multiple pits of uniform corrosion. Fracture surfaces of both springs consisted of brittle intergranular fracture. **Figure 5** shows edge of the fracture in the possible initiation area of the No. 1286 spring, where pitted surface with remnants of rust are visible in backscattered electrons. **Figure 6** shows higher detail of the fracture surface of specimen from impact test with distinctly visible grains which proves low energy fracture and low toughness of the springs.

Figure 5 Edge of the fracture - spring No. 1286

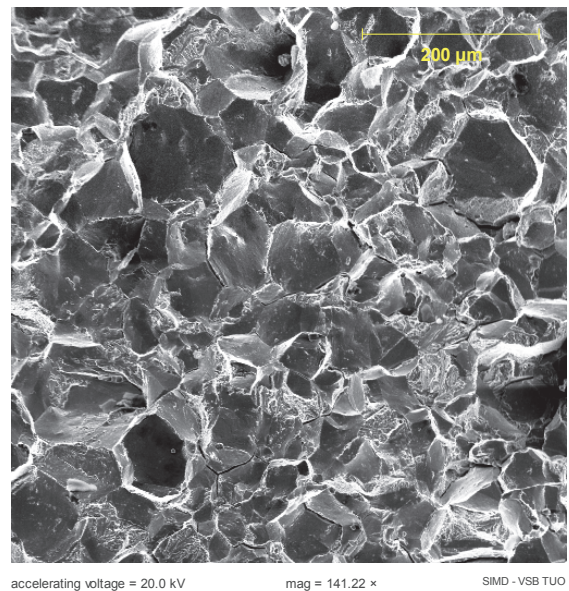
Figure 6 Fracture surface of impact specimen
