## THE STRUCTURAL CHANGES IN STEEL USING IN POWER INDUSTRY AFTER LONG-TERM OPERATED

Monika GWOŹDZIK

*Czestochowa University of Technology, Faculty of Production Engineering and Materials Technology,  
Institute of Materials Engineering, Czestochowa, Poland, EU, [gwozdzik.monika@wip.pcz.pl](mailto:gwozdzik.monika@wip.pcz.pl)*

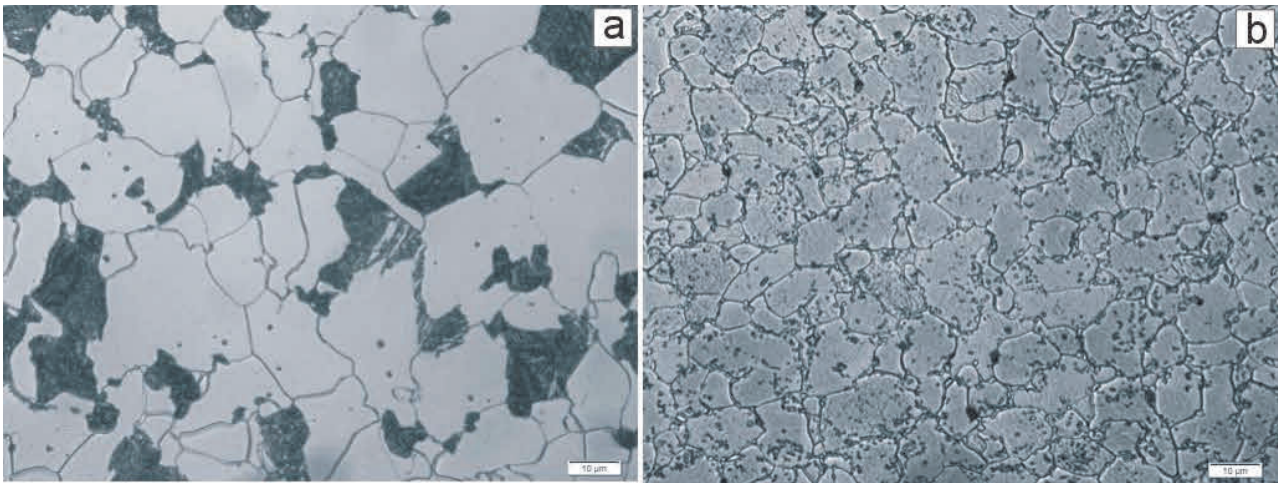
Microscopic observations of the structure of the steel tested showed (**Figure 1**) that 13CrMo4-5 steel operated at a lower temperature ( $T = 380^\circ\text{C}$ ) for a time of 130,000 hours was characterized by a ferritic-bainitic/pearlitic structure (**Figure 1a**). The longer operating time at a higher temperature caused that the structure of the tested steel was significantly degraded. **Figure 1b** shows the ferritic structure with degraded bainite/pearlite and very many carbide precipitates. In the case of steel 2, the pearlite/bainite has completely disintegrated. In addition, coagulated carbides in a very large form are formed both inside and after grain boundaries. The carbides occurring on the boundaries were combined, forming the so-called chains, and in places there is even the effect of double borders. In addition to carbide precipitations, creep pores are also visible in the structure of this steel.

**Figure 1** Structure of examined steels: (a) steel 1, (b) steel 2

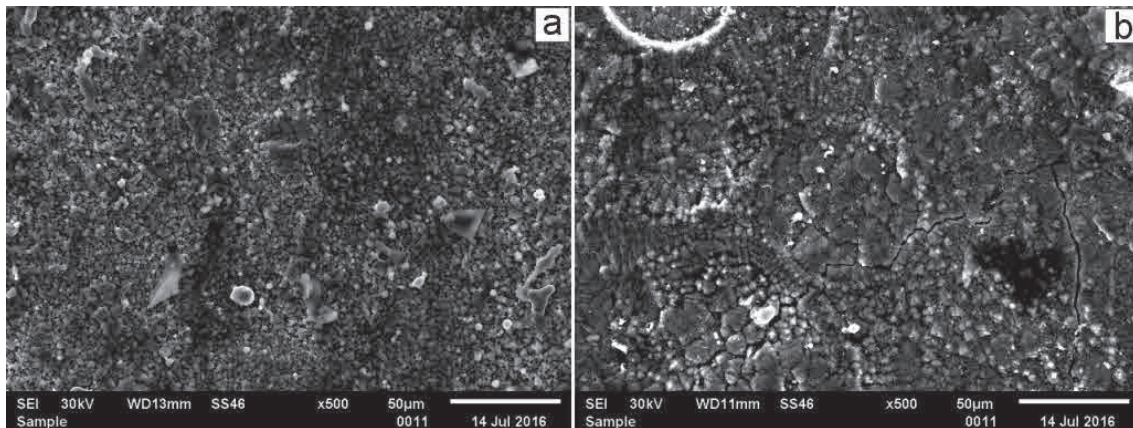
Microscopic observations (SEM) made on the surface of the oxide layer showed that this layer is more degraded in the case of steel subjected to a higher temperature and a longer time, as shown in **Figure 2**. The surface of the oxide layer created on steel operated at  $535^\circ\text{C}$  for a period of 230,000 hours is mostly cracked. The performed chemical analysis from the surface of the pipe walls showed presence oxides iron enriched in the chromium element for both steels (**Figure 3**). In the case of steel 2, additionally copper deposits appeared. Copper compounds on the inner surface of the power device element (steel 2) and thus in the entire water-steam system are the result of progressive erosion and corrosion processes in supply and condensation systems, where these waters are enriched in trace amounts of copper compounds. In the case of steel 1, the thickness of the oxide layer at the widest area was  $32.96\ \mu\text{m}$ , while for steel 2 the value of this parameter was four times higher and amounted to  $137.22\ \mu\text{m}$  (**Figure 4**). In both cases large discontinuities were observed in the oxide layer, however, the oxide layer on steel 2 is characterized by greater degradation. In this steel there are quite large cracks oriented perpendicular to the ground. In addition, this layer exhibits quite numerous slits of relatively large dimensions.

**Figure 2** SEM images of the inner site on the pipe: (a) steel 1, (b) steel 2

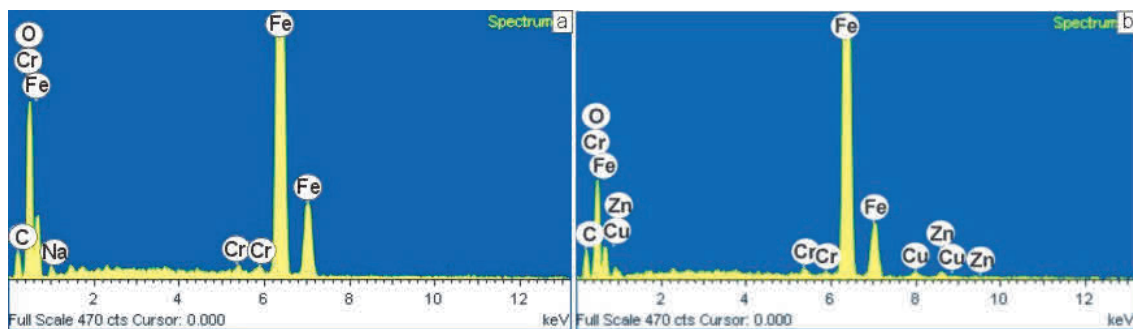
**Figure 3** EDS analysis of surface of oxide layer: (a) steel 1, (b) steel 2

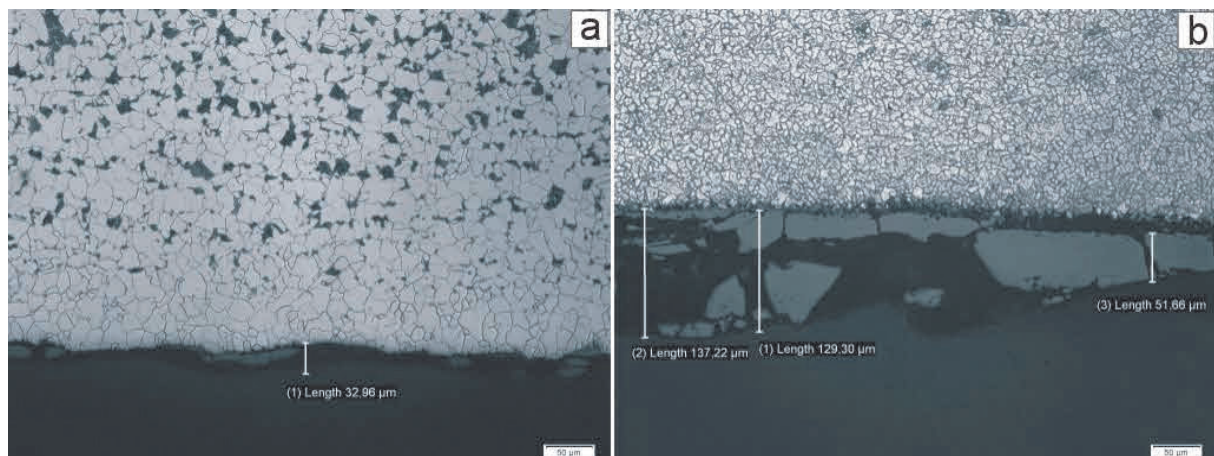
In steel 1 under the oxide layer there is decarburization reaching the depth of 120 µm, while steel 2 on the whole cross-section is characterized by a degraded structure. Surface topography studies showed significant differences in the roughness measurements of the steels tested, as shown in **Figure 5**. The average arithmetic deviation of the profile from the mean line ( $R_a$ ) was 9.82 µm and 23.54 µm, respectively for steel 1 and 2. X-ray measurements (XRD) showed a two-layered structure of the oxide layer consisting of hematite ( $Fe_2O_3$ ) and magnetite ( $Fe_3O_4$ ). The application of the method for determining crystallites based on the analysis of the diffraction line profile to the oxide layers formed on steels used in the power industry for a long time allows to determine the relationship between the size of  $D_{hkl}$  and the properties of structure on the cross section of the oxide layer.

**Figure 4** The oxide layers of examined steels: (a) steel 1, (b) steel 2

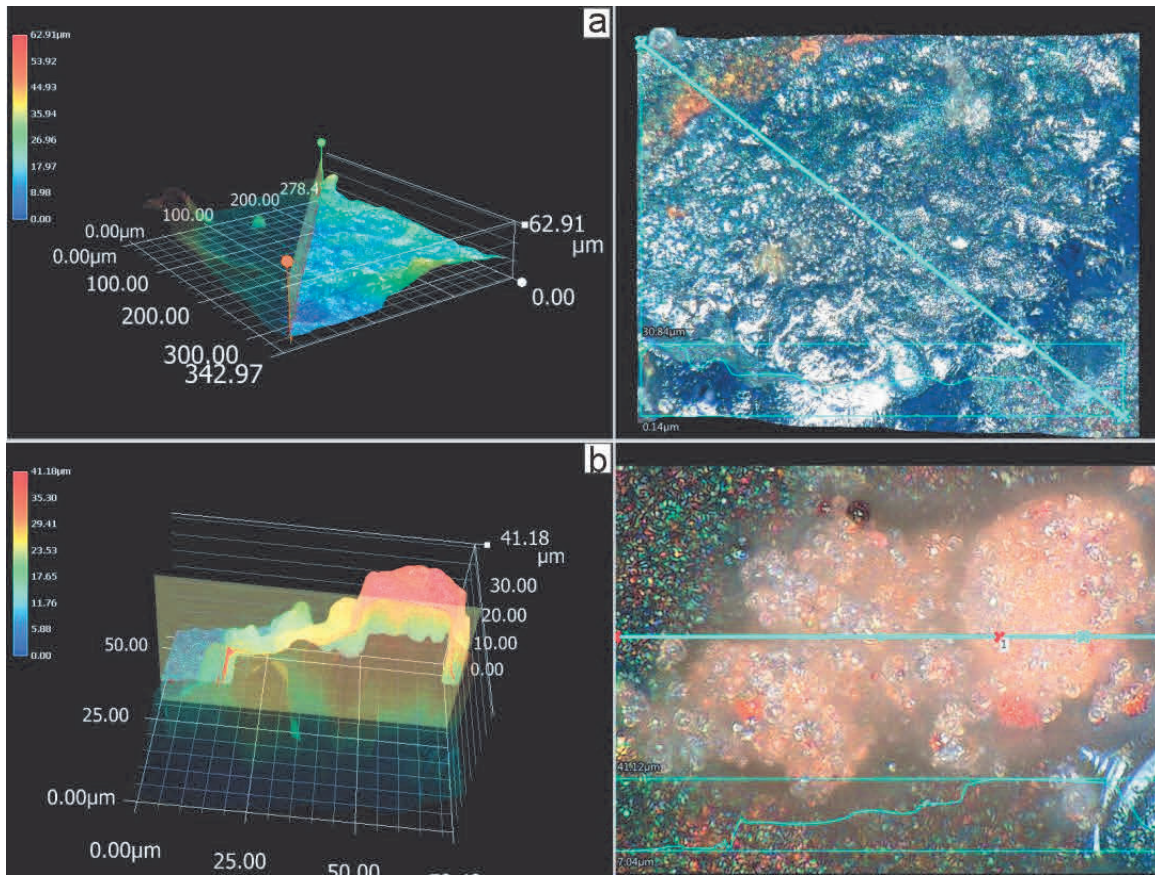
**Figure 5** Topography of the surface of the oxide layers studied: (a) steel 1, (b) steel 2

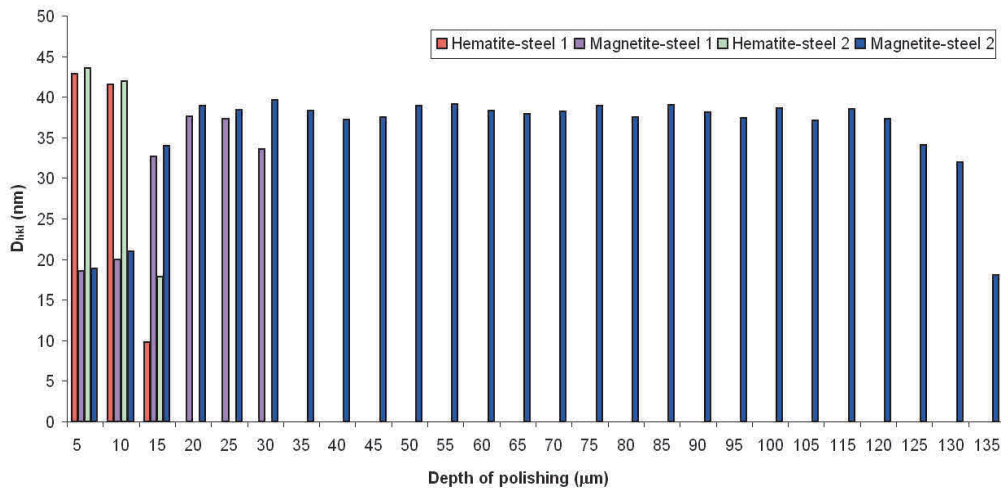
The obtained results showed (**Figure 6**) that steel 1 was characterized by smaller sizes of crystallites compared to steel 2. For steel 1, the highest value of  $D_{hkl}$  for hematite was 42.8 nm, while for magnetite 37.32 nm. In the case of steel 2,  $D_{hkl}$  was 43.5 nm and 38.6 nm respectively for hematite and magnetite. The results of XRD studies in connection with microscopic observations showed that the crystallite size changes as a function of the distance from the surface. In the case of larger crystallite sizes, the oxide layer is more brittle and prone to cracking. Then cracks form, oxide layers adhere poorly to the substrate, which in turn leads to failure of components operating in the power industry.

**Figure 6** Determination of crystallite size ( $D_{hkl}$ ) for main peaks  $Fe_3O_4$  and  $Fe_2O_3$
