METALLIC COATING DURABILITY IN SOIL

Zdenek BARTAK

SVUOM Ltd., Prague, Czech Republic, EU, bartak@svuom.cz

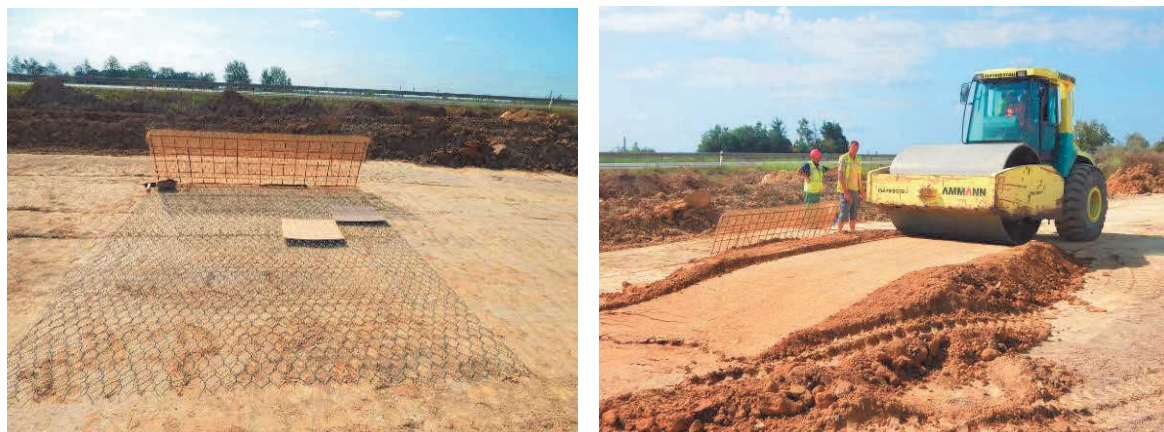
The sample of mesh was buried to simulate the procedure of installation of geosystem - the arches mesh panel should be unfolded; the shipping folds flattened out, and pulled tight to minimize future creepage. The granular backfill were installed in maximum lifts of approximately 300 mm. The valuation had been done on part of hexagonal woven wire mesh, ca 300 x 600 mm, made from galvanized and PVC coated wire mesh (8 x 10 mesh type), wire diameter 2.20 mm - **Figure 2**.

Figure 2 Sample of mesh for tests - simulation of installation

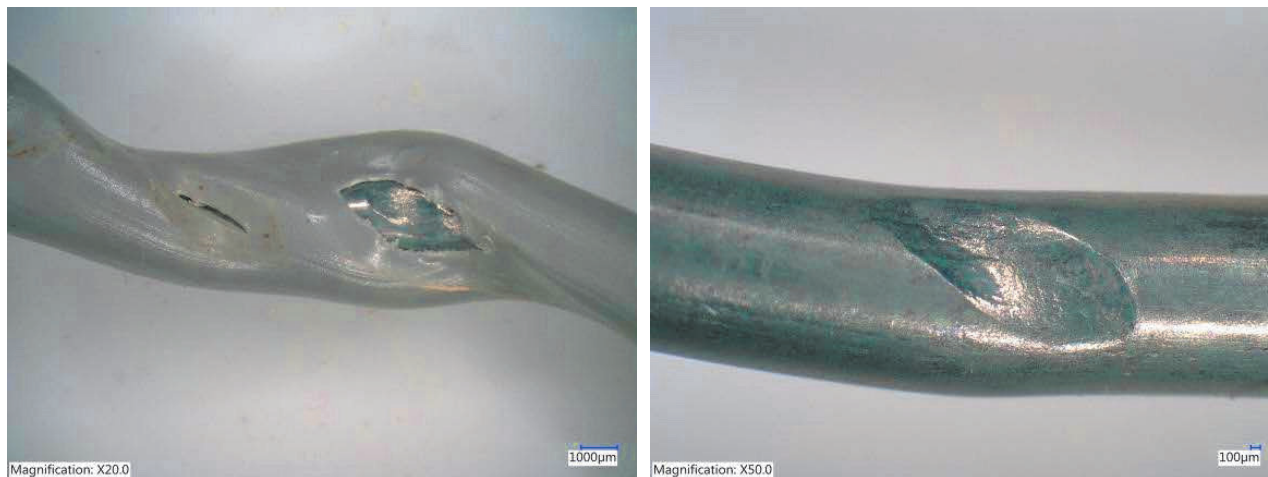
Polymer coating is cracked in twisted areas and zinc coating thickness distribution is not uniform around the wire diameter - **Figures 3 and 4**. The metallic coating also shows a lot of cracks in layer. Wire coatings and the underlying wire are abraded when soil particles impinge upon and grind them during installation. After this simulation the number of damages - cracks in polymer coating - was estimated as 12 % defects on twisted units of grid - **Figure 5**. Visual evaluation was done by 3D digital microscope Keyence VHX-5000, Japan.

Figure 3 Damage of polymer and metallic coatings due to production

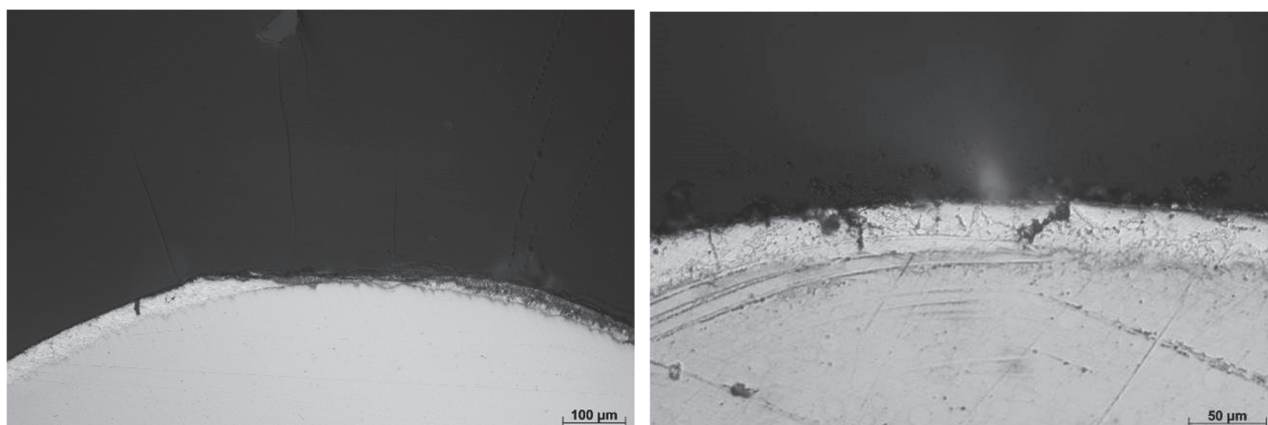
oxide coatings - Measurement of coating thickness - Microscopical method. The value was 243 g.m⁻², respectively 34 µm.

Figure 4 Cross section of non-exposed metallic coatings

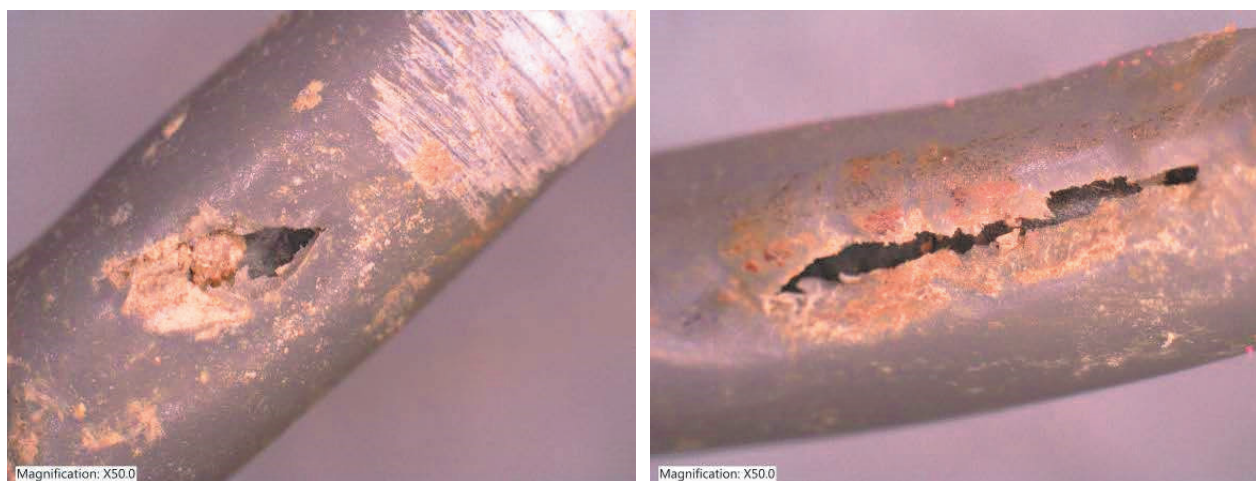
Figure 5 Example of damage of polymer coating due to installation of mesh in soil

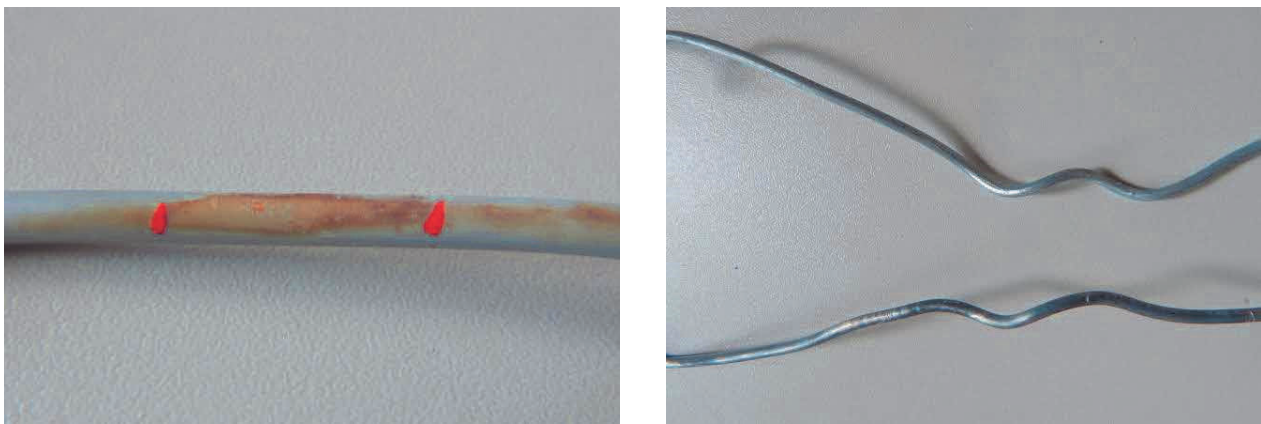
Mesh samples were exposed into QUV/spray cyclic test in chamber Q-Lab, USA, according to EN ISO 16474-3 *Paints and varnishes - Methods of exposure to laboratory light sources - Part 3: Fluorescent UV lamps*. The exposure period was 1400 hrs. The polymer coating was intensively degraded in areas of crack but the zinc coating only slightly darker - **Figure 6**.

Figure 6 Damage of polymer and metallic coatings after QUV/spray test

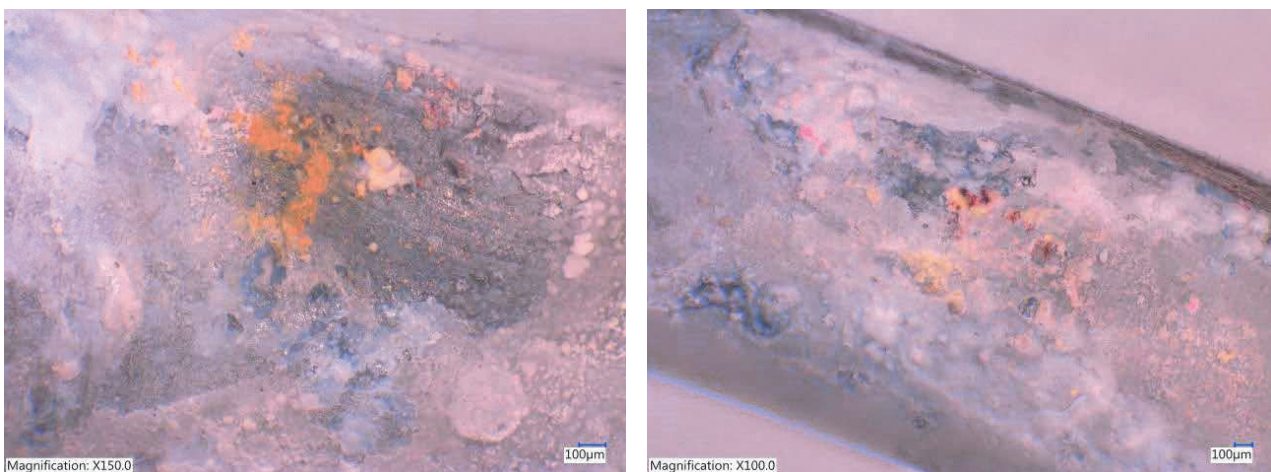
Mesh samples were exposed into condensation test according to EN ISO 6270-2 *Paints and varnishes - Determination of resistance to humidity - Part 2: Procedure for exposing test specimens in condensation-water atmospheres*. The exposure period was 3000 hrs. The zinc coating intensively corroded in areas of damaged polymer coating - **Figure 7**. Even the substrate steel corrosion spots occurred.

Figure 7 Damage of metallic coatings after condensation test

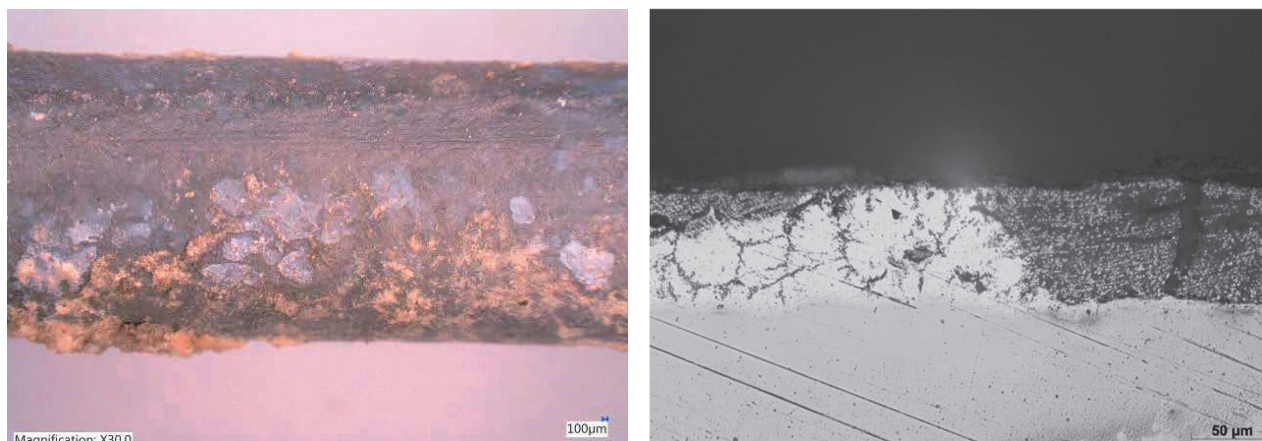
The wires with Zn15Al coating were exposed in soil (test site SVUOM in Horomerice) after 1 year. Corrosion loss of metallic coating was ca 35 μm according to gravimetric measurement but the corrosion attack of coating was very non uniform according to cross-section image - **Figure 8**. In pits the zinc alloyed coating is practically totally corroded.

Figure 8 Corrosion of zinc alloyed coating after 1 year exposure in soil

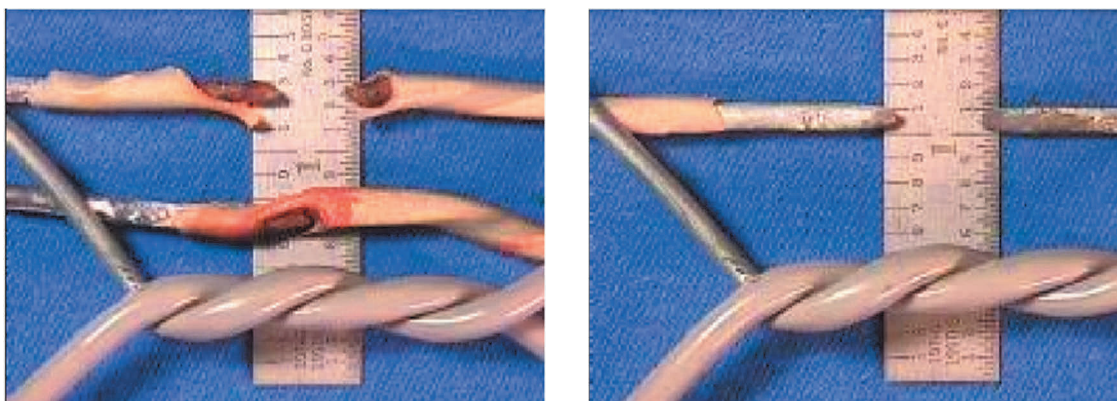
When investigating the performance and durability of engineering materials, some sort of failure criterion is needed. A long-term field study of corrosion and other damaging effects on wires of gabion mesh was performed at 14 sites in California [3]. Two styles of mesh were studied: twisted hexagonal and welded square-grid. The wires had corrosion protection coatings of either zinc, zinc-and-polyvinyl chloride (PVC-coated), or aluminum including the same type as tested in the CR. The galvanized wires with damaged PVC coated were totally broken after 13 wet seasons - **Figure 9**.

Figure 9 Broken coated wires after exposure in soil
