FEATURES OF THE RECOVERY OF HIGH CARBON STEEL PRODUCTS USING THE DIRECTED ENERGY DEPOSITION PROCESS

Sergei IGOSHIN, Dmitriy MASAYLO, Alexey ORLOV, Evgenii GYULIHANDANOV

Peter the Great St. Petersburg Polytechnic University, St. Petersburg, Russian Federation,
sergei.igoshin@gmail.com, dmasaylo@gmail.com, orlov_alexey88@mail.ru, bogomolova_ev@spbstu.ru

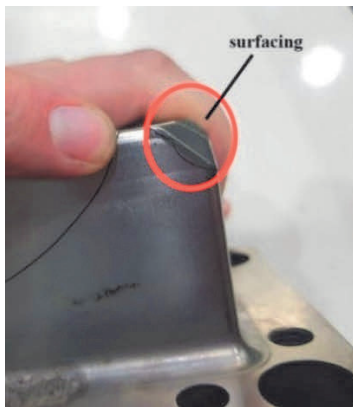
It was experimentally found that when surfacing new metal layers on the prepared die section in order to restore the original geometry, small cracks appeared on the die surface in the area close to the deposition point. The photograph of such cracks is shown in the **Figure 1**.

Figure 1 Cracks in the surfacing area

The reason for the formation of such cracks is presumably intergranular corrosion, which is a frequent problem in the processes of welding and surfacing [10, 11]. This defect appears due to the release of carbides along the grain boundaries as a result of overheating of the punch during the deposition process above 700 °C for a long time. There are several ways to solve this problem. The first is to use the low-energy flow mode, that is, use small surfacing speeds, use a thin laser beam and increase the airflow in the working area. This method is not suitable due to low productivity. The second method involves reducing the temperature gradient throughout the die volume, which can be achieved by preheating, for example, in a muffle furnace. From a technological point of view, the latter method is the simplest to implement, since the main task is reduced to the selection of the preheating temperature. This method was chosen. There is also a method of applying an intermediate buffer layer of ductile metal, which is deposited before the base metal is deposited. This method has its advantages, but it is difficult to say how its application will affect the performance properties, so this requires separate studies.

This article explores the possibility of repairing and restoring a die from Japanese steel SKD11 with a carbon content of C 1.65 %, and chromium Cr 11.5 % (in wt.%) using preheating in a muffle furnace. AISI H13 die tool steel was chosen as the material that replaces the worn parts of the die. This steel contains carbon C in the amount of 0.44 % and the main alloying element is chromium Cr 5.5 % (in wt.%).

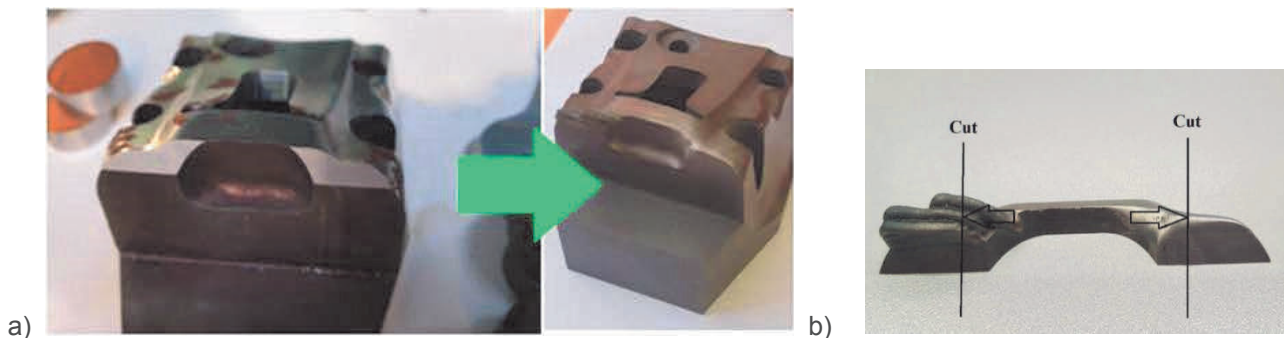
Figure 3 The die before repair and after repair by the DED method a), areas of a cut for research of material structure. The first area before milling, the second zone after milling b)

Since after the surfacing operation it is supposed to use the milling of excess material, then, as can be seen from **Figure 3a** and **Figure 3b**, the surfacing was carried out with a stock of material. Also, since on the die that we restored, there were 2 corners on which surfacing was performed, one of the corners was machined with a mill, and the other one was not. It was necessary to track the structure in the final finished material and in the material only after surfacing. The weld area together with part of the die presented is in **Figure 3b**.

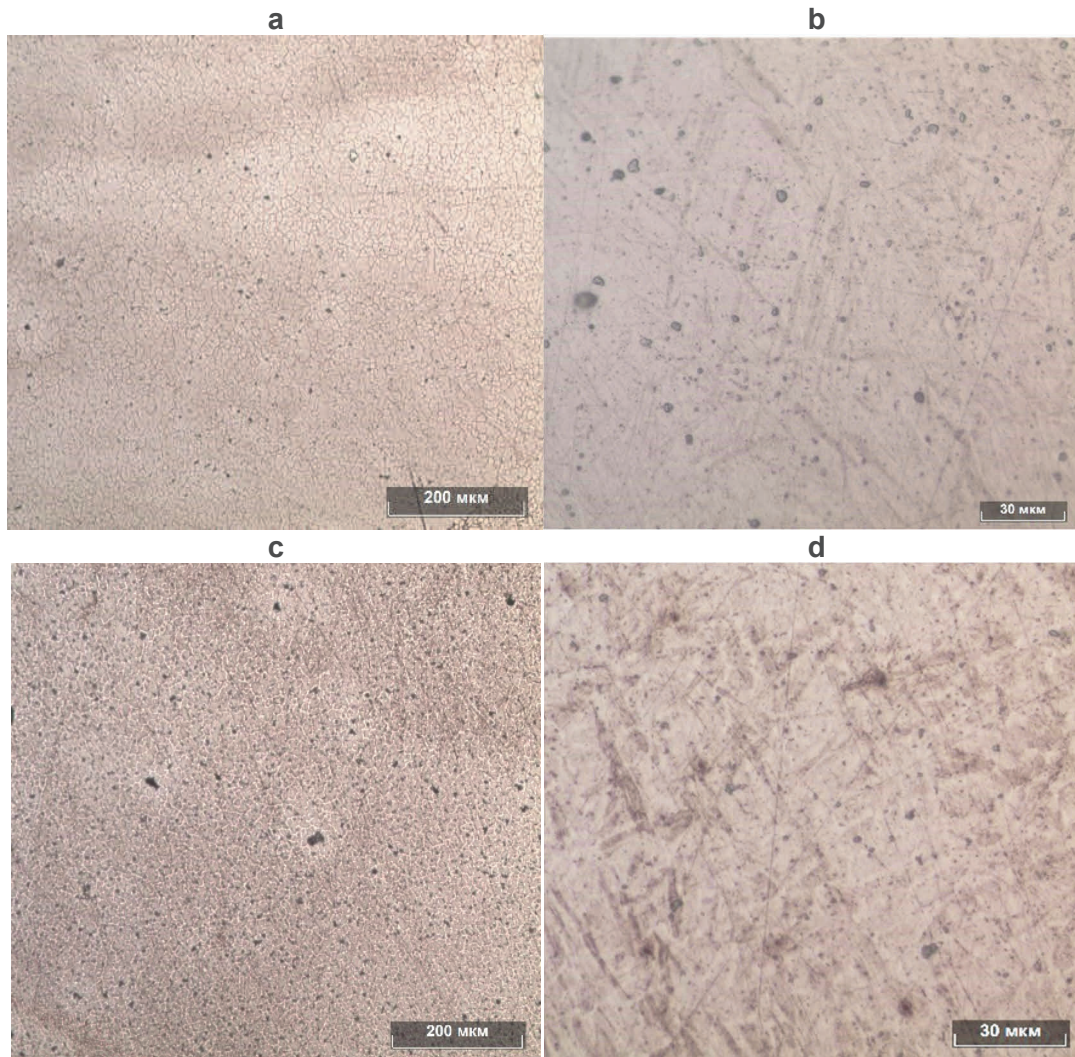
Figure 4 Structure of the built-up material ASIS H13, where a - sample after machining, b - sample after machining - fivefold magnification than in case a), c - sample before machining, d - sample before machining - fivefold magnification than in case c.

The main structure of the material after the restoration of the stamp is grain with a grain size of about 10 microns. Also in the cladding without machining (**Figure 4, d**) there are areas that consist of tempered martensite needles, which are a ferritic-carbide mixture. The needle structure in the sample with final processing is practically absent. Apparently, in the processed part, this structure was not found due to the fact that as a result of mechanical processing, additional heating occurred, contributing to the processes of decomposition. Further, the structure of the transitional heat-affected zone between the two materials was studied, where on top is AISI H13 steel, on the bottom is SKD11 steel, the results are presented in **Figure 5**. Since no differences were found in the structure for the two samples, photographs are presented only for the sample after machining. As can be seen from **Figure 5**, there is a region with a transitional structure between the two steels (heat affected area) and in this region the highest hardness is noted compared with the basic material of the punch and shell that will be shown later. Hardness was measured in four zones as shown in **Figure 6**.

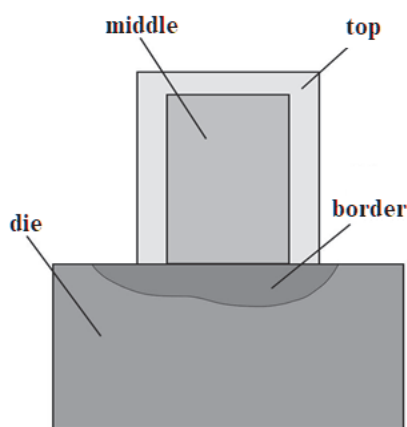
Figure 6 Hardness measurement areas

According to the results of measuring the hardness, it is clear that the total hardness of the two materials is approximately the same, but it was also noted that the hardness at the boundary in the heat-affected zone reaches the highest values of 57 HRC, and the average hardness of the weld material is 53 HRC. This

hardness is satisfactory for this product, but still this value is rather low. As a recommendation, it is possible to suggest surface hardening, or, in the process of surfacing, to use increased cooling conditions to obtain a large proportion of martensitic structure in the AISI H13 surfacing steel.
