## THE INFLUENCE OF TECHNOLOGICAL PARAMETERS AS THE HANDLING AND SINTERING PROCESS ON THE STRUCTURE OF IRON BASED POWDERS

The subject of this article is the failed bushing used in the car suspension. The claim of the broken bushing came from the car producer. The main aim of this paper was to know if the failure was a green crack as evidenced by steam treatment oxide on the crack interfaces. To check, these items a Scanning Electron Microscope (SEM), hardness testers, and optical microscope were used. The density of the upper edge where the crack occurred was checked. Based on this investigation it was found that the crack was not caused by the rollover application.

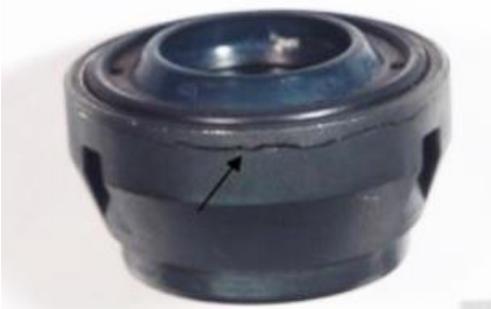
The part was photographed as received to document its condition and the photographs are found below in (Figure 1) and in (Figure 2). Initial observations of the bushing/rollover assembly found a crack around the circumference of the upper edge approximately 50 mm long (Figure 1).

**Figure 1** Bushing assembly as received. Crack is visible just below upper edge of the bushing

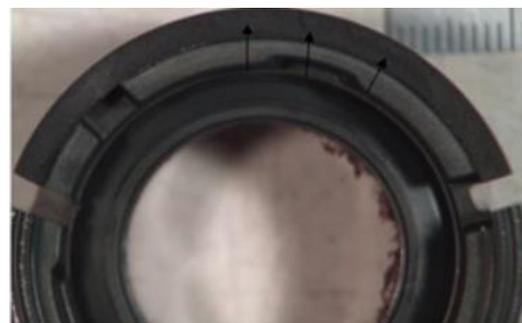
**Figure 2** Overview of fracture face after removal of the upper edge. The fracture was found to change appearance toward the outside edge. The image above shows this change at the arrows

After the initial observations were made, the upper edge was removed from the part for examination in the Scanning Electron Microscope (SEM). Once removed, the area underneath the broken portion exhibited steam treatment across the fracture face, with a change in appearance toward the outer edges (**Figure 2**).

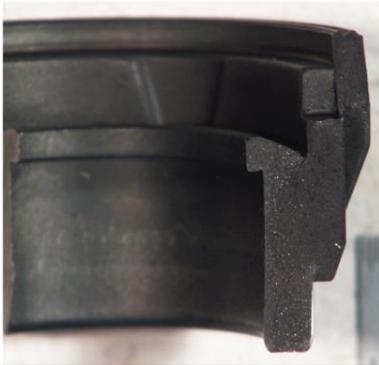
Of note, the presence of steam treatment on the fracture face does not automatically indicate a green crack, as the steam treatment penetrates through the entire part via interconnected porosity. (**Figure 3a**) below, illustrates this as the bushing was split in half to show the darkened appearance to the fracture face vs. the appearance of the part due to abrasive saw cutting (silver) (**Figure 3b**).

**Figure 3a** Laboratory created fracture

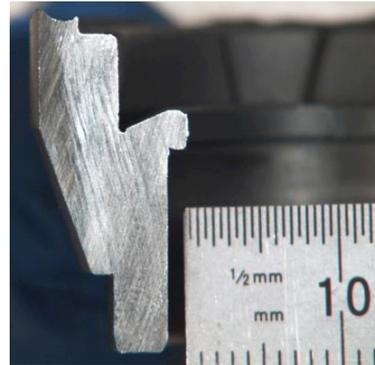
**Figure 3b** Abrasive saw cut surface

Notice the change in appearance based on the method of separation.

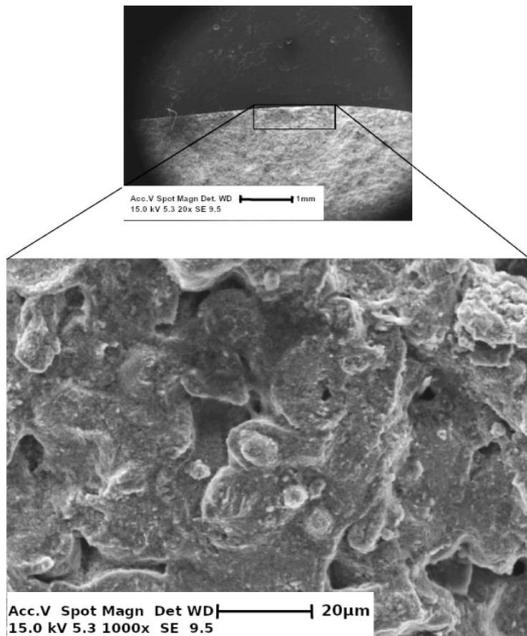
**Figure 4** SEM image of the surface at the outer diameter of the fracture. Notice the lack of a fracture mode with an uninterrupted steam treat layer

The surface appears to be an uninterrupted steam treatment layer, with individual powder particles visible (**Figure 4**).

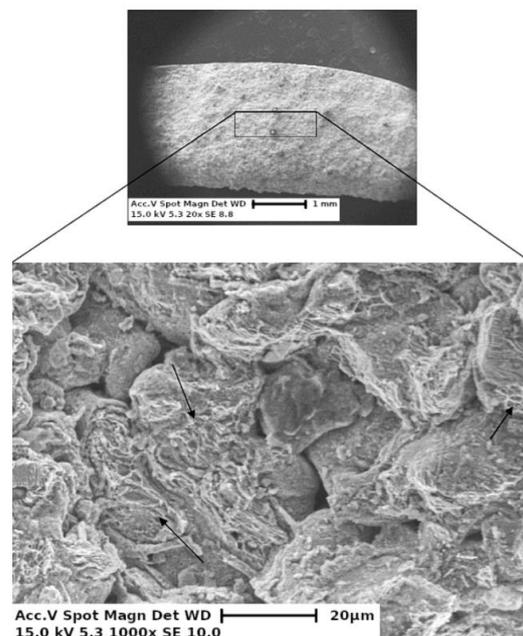
**Figure 5** SEM image of the fracture face near the center of the fracture. Individual particles were found with dimple ruptures on the fracture faces (arrows). This indicates these particles and this area were fused together during sintering

For comparison, the fracture face immediately inboard was found to exhibit a completely different appearance (**Figure 5**). The presence of the material fracture was found on the powder metal particles in the form of a dimple rupture, indicating this area was fused during sintering.

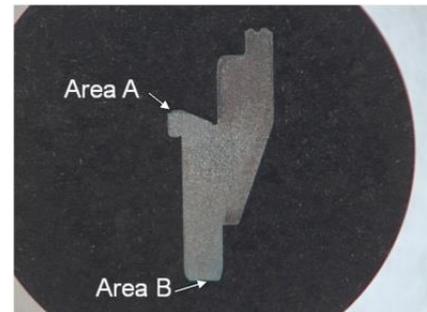
In order to obtain hardness values on this sample, requirement #2 had to be violated. As such, the numbers below should be viewed for informational purposes only. Material yielding was also noticed on the check valve portion of the bushing (Area A). This is presented in **Figure 6** The hardness results are given in **Table 1**.

**Figure 6** Areas of hardness readings

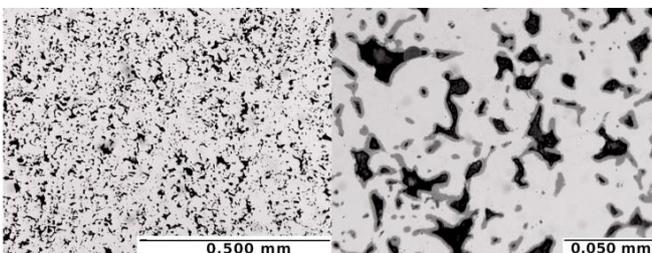
**Figure 7** Unetched microstructure of the body of the bushing. Powder particles appear to have a satisfactory compaction and distribution

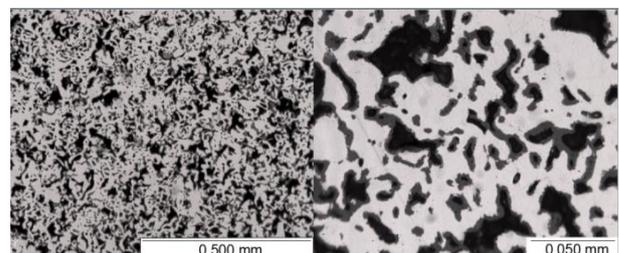
**Figure 8** Unetched microstructure of the upper edge of the bushing. Powder particles appear to be loosely packed, with small sinter necks between the particles. This area would most likely have a lower density than the full panel, which would make this a lower strength area

A section from the part was removed directly behind the fractured area and prepared as per ASTM E3 for microstructural evaluation. A marked difference in density was found between the body, and the upper edge of the part (**Figure 7**). It appears that the fractured area may not have had a proper fill or compaction (**Figure 8**).

A density requirement was not on the finished part blueprint, so it is not known if the overall part density was satisfactory. However, it may be advisable to place a sectional density requirement on the upper edge to prevent this type of failure in the future.

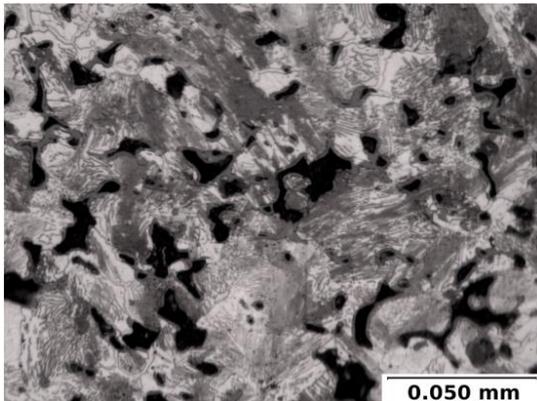
**Figure 9** Etched microstructure in the body of the bushing. Combined carbon by way of visual estimate was 0.6%. The part was specified to be FC0208-40 material and this level of carbon retention would be satisfactory

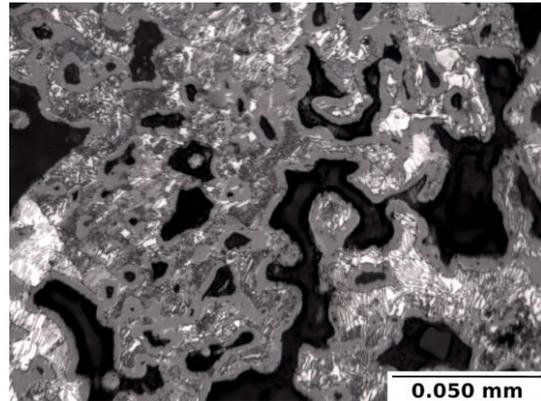
For comparison, the etched structure of the upper edge reveals a much less dense particle network (**Figure 9**) and (**Figure 10**).

**Figure 10** Etched microstructure of the upper edge of the bushing showing a low-density particle network
