**MATERIAL ANALYSIS OF OUTER DOOR HANDLES OF THE HISTORICAL CAR TATRA 87**<sup>1</sup>Lukáš KUDRNA, <sup>2</sup>Petra VÁŇOVÁ, <sup>3</sup>Jitka MALCHARCZIKOVÁ, <sup>4</sup>Tomáš KUBÍN<sup>1</sup>VSB - Technical University of Ostrava, Department of Production Machines and Design, Ostrava, Czech Republic, EU, [lukas.kudrna@vsb.cz](mailto:lukas.kudrna@vsb.cz)<sup>2</sup>VSB - Technical University of Ostrava, Department of Material Engineering, Ostrava, Czech Republic, EU, [petra.vanova@vsb.cz](mailto:petra.vanova@vsb.cz)<sup>3</sup>VSB - Technical University of Ostrava, Department of Material Engineering, Ostrava, Czech Republic, EU, [jitka.malcharczikova@vsb.cz](mailto:jitka.malcharczikova@vsb.cz)<sup>4</sup>VSB - Technical University of Ostrava, Department of Production Machines and Design, Ostrava, Czech Republic, EU, [tomas.kubin@vsb.cz](mailto:tomas.kubin@vsb.cz)<https://doi.org/10.37904/metal.2020.3503>**Abstract**

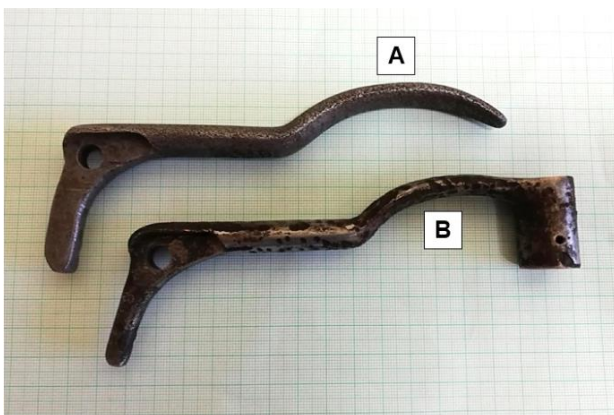
At first glance, the door handles A and B differed in appearance. The handle A had a matte, rough surface (**Figure 1**). The B handle showed that the surface was coated with a metallic glossy layer but damaged by uneven corrosion (**Figure 1**). For handles A and B (**Figure 1**), only the chemical composition using an X-ray spectrometer has been evaluated, using Delta Professional by ED-XRF method due to cause the least damage to historical handles. The disadvantage of this method is that it does not allow for steels to reliably determine the carbon content and therefore the given quality of the steel. First, measurements were made on the degreased surface, than the handles have been ground at the point of attachment to the bodywork to remove the surface layer and provide a place to measure the chemical composition of the base material (**Figure 2**). It was found that the handle A did not contain a surface layer and was made of non-alloy, carbon steel (**Table 1**). A high nickel and copper content were detected on the surface of handle B implying that this one was surface-treated using nickel, with copper being used as the underlying layer (**Table 1**). After the surface was ground, in the analysis of the chemical composition of the base material, there is an increased percentage of Ni and Cu, but this analysis is affected by the surrounding surface, which has not been ground (**Table 2**). The base material is expected to be carbon steel again.

**Figure 1** Door handles A and B

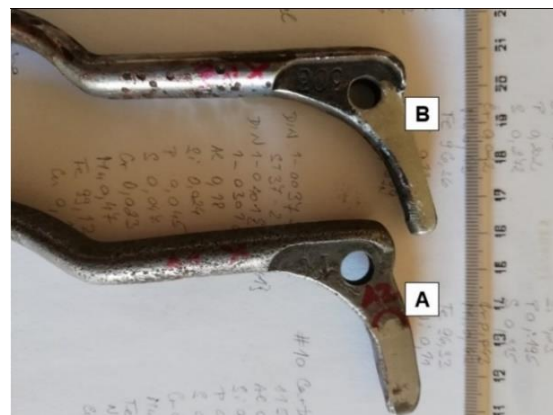
**Figure 2** Detail of the surface and place of measurement of chemical composition using the ED-XRF method

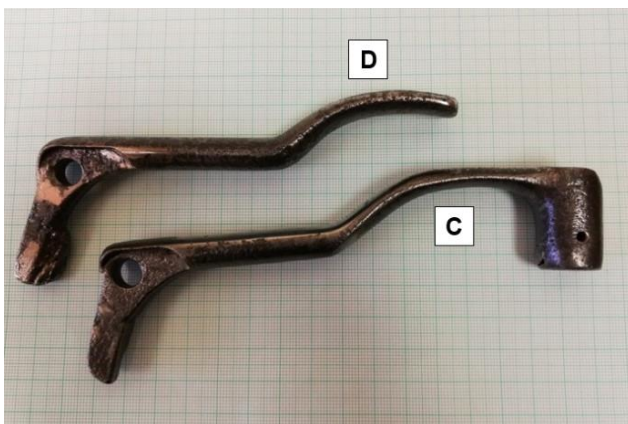
**Figure 3** Door handles C and D

It was possible to cut the C and D handles (**Figures 3** and **4**) and perform a metallographic analysis on them and measurement of chemical composition using a more precise method of optical emission spectrometry with smouldering discharge (GDOES) on GDA 750 produced by Spektruma company, which also allows the carbon content to be measured [6, 7]. For comparison with previous handles, a chemical composition measurement was also made using the Delta Professional X-ray spectrometer using the ED-XRF method. Both C and D handles were coated (**Figures 3** and **4**), which shows the presence of a glossy surface. For handle D, a layer of copper was visible under a glossy surface layer. Both handles were attacked by uneven corrosion, although more pronounced corrosion was observed with handle D (**Figure 3**). The handle C was coated with chrome layer as opposed to the handle D, coated with a nickel layer beneath which was a layer of copper (**Table 2**). The basic material consisted of non-alloy, carbon steel (**Table 2** and **Table 3**). GDOES analysis found that the handle C was made of carbon-containing steel 0.30 wt% and the D handle of carbon-containing steel of 0.17 wt% (**Table 3**).

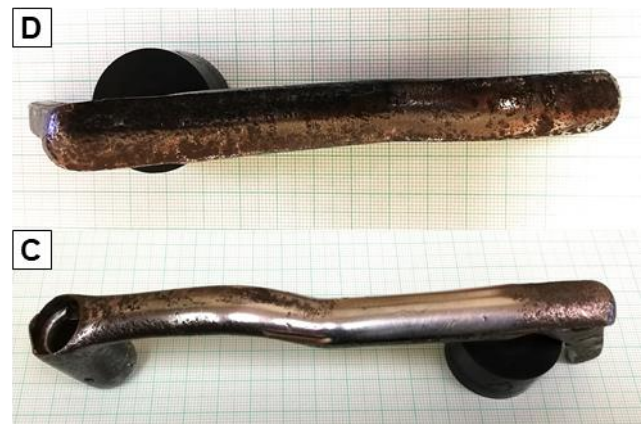
**Figure 4** Handles C and D surfaces

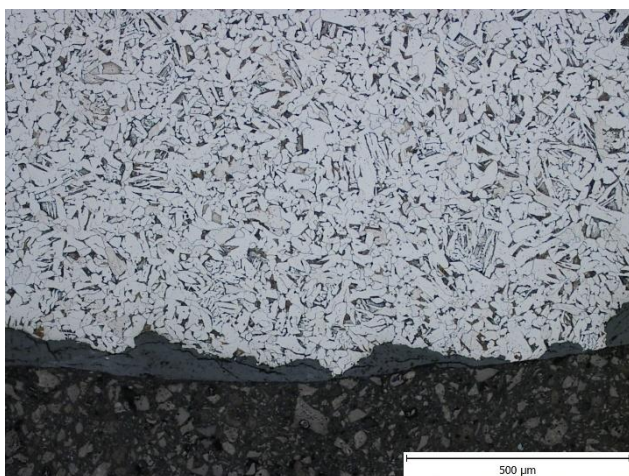
The microstructure of the handles was analyzed on x-section metallographic cut-outs using the Olympus GX51 light microscope (abbreviated LM) in a polished and etched state in 4 % HNO<sub>3</sub> solution in alcohol (Nital). On the lower and lateral parts of the handles, you can see uneven corrosion on the surface, reaching a depth of 50-100 µm (**Figure 5**), in an etched state it is a very thin (units of micrometres) surface layer (**Figure 6**). In the

**Figure 5** Microstructure of door handle D, surface with corrosion, etched in Nital (LM)

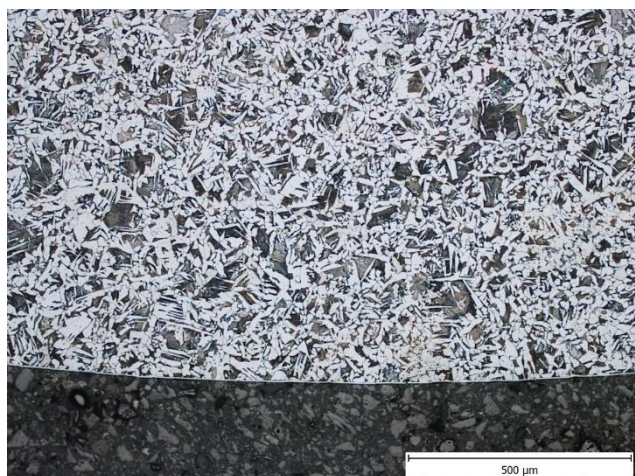
**Figure 6** Microstructure of door handle C, surface with a thin layer, etched in Nital (LM)

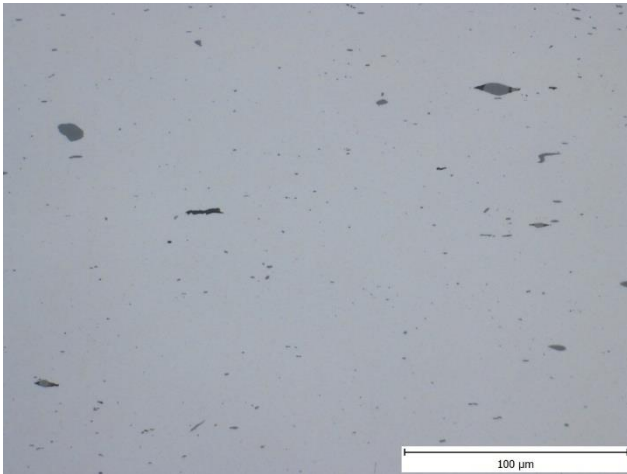
microstructure in the polished state, non-metallic inclusions based on MnS are visible (**Figure 7** and **Figure 9**), to a greater extent for handle C (**Figure 7**), corresponding to the increased sulphur content (**Table 3**). Also, some coarser inclusions of the alumina type were found. After etching in the Nital solution, the ferritic-perlitic microstructure occurred (**Figures 8** and **10**). For the top surface of handle C, the microstructure contains slightly coarser grains of pearlite than there is on the side and bottom. The pearlite proportion was lower for handle D, corresponding to the lower carbon content of the matrix (**Figures 8** and **10**).

**Figure 7** Door handle C, polished state, inclusions

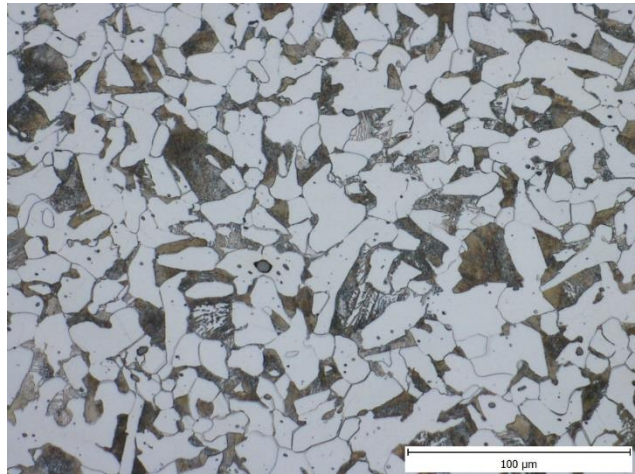
**Figure 8** Microstructure of door handle C, etched in Nital (LM)

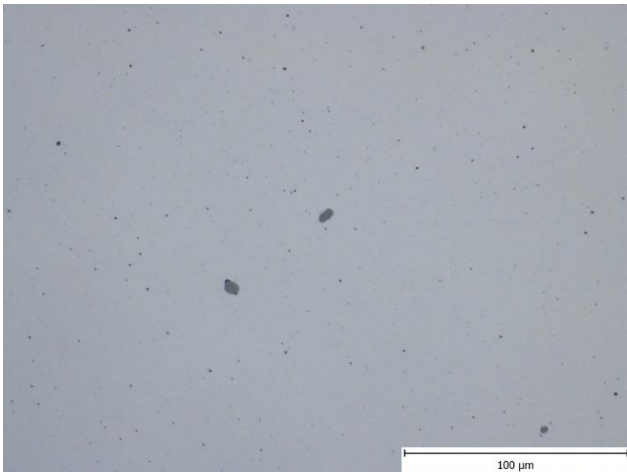
**Figure 9** Door handles D, polished state, inclusions

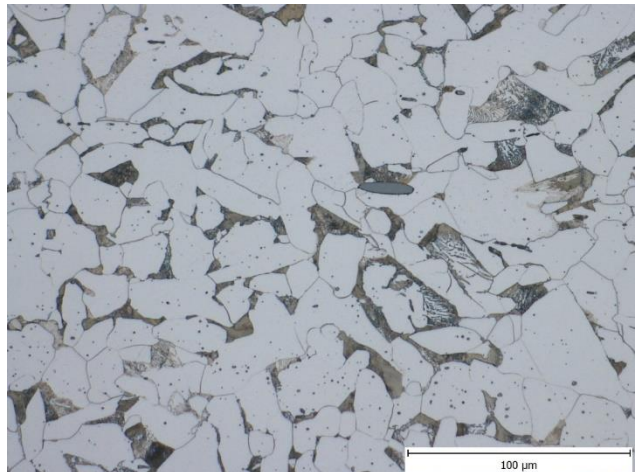
**Figure 10** Microstructure of door handles D, etched in Nital (LM)
