## THE EFFECT OF HYDROGEN CHARGING ON THE QUALITY OF ZINC AND POWDER PAINT COATINGS

### Abstract

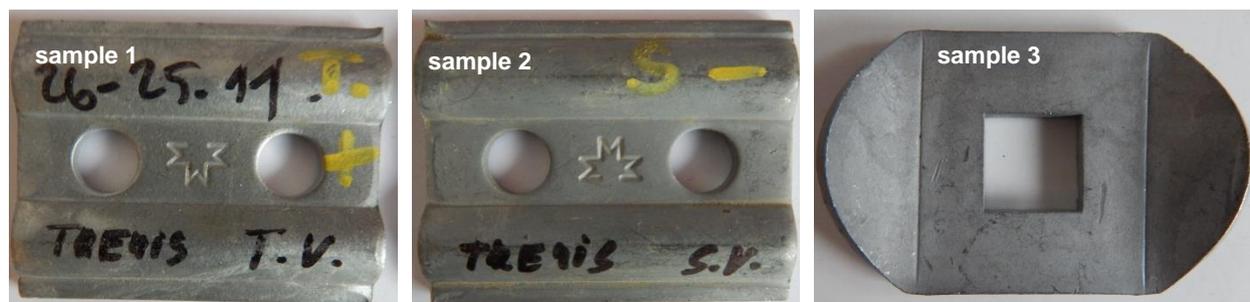
The low zinc coating adhesion was the problem with tested articles – sample 1. As the hot-rolled steel strips had been covered by thick layer of mild scale the strips had been pickled in hydrochloric acid before articles' forming and once again before galvanizing. The same articles had been made from cold-rolled steel without layer of mild scale – sample 2. On these articles the zinc layer shows low adhesion, too. Adhesion was tested by device for adhesive strength tests compliant with ASTM A123 (removed in 1989 edition). As reference sample was used very similar articles galvanized in the same conditions – sample 3, which zinc layer was adherent.

**Figure 2** The galvanized articles - samples

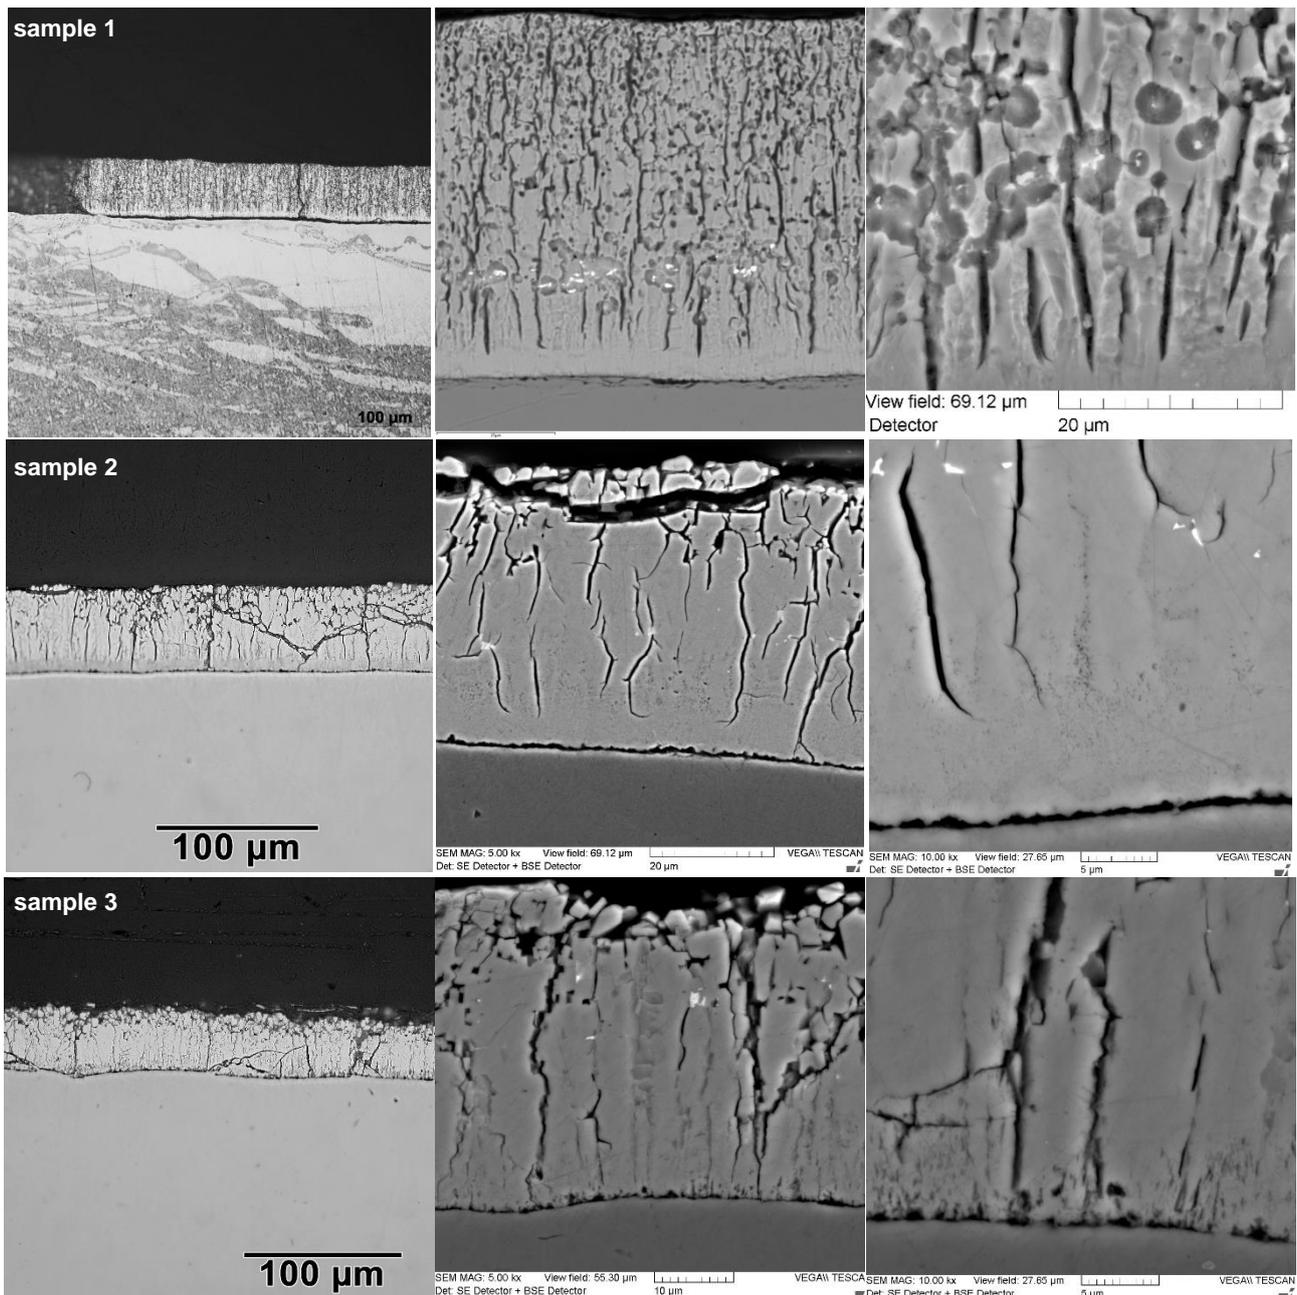
The electron scanning microscope was used for SEM image of structure of zinc coating. On **Figure 3** there are cross-sections from all tested samples in various magnifications. There is seen the gaps between steel surface and the first zinc phase layer. The differences between morphology of zinc coating especially close to interface zinc/steel are evident. On sample 1 the coating is characterized by many cracks and small pores (bubbles) with very typical round shape. The diameter of these “bubbles” decreases with increased distance from steel surface. On other samples 2 and 3 the zinc coating layers have also cracks, but in small numbers, and no pores.

**Figure 3** The structure of zinc coating on different samples

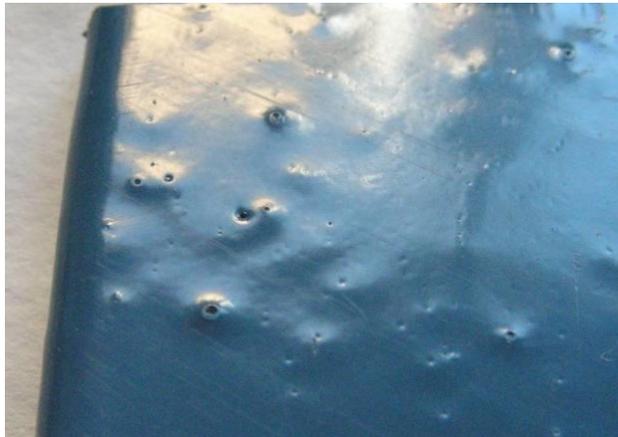
Steel panels with dimension 950 x 1770 x 4.5 mm, ca 230 pcs, were galvanized and then the powder coating was applied. Immediately a lot of defects as pinholes with various diameter (ca 5 mm) occurred; some of them

were up the coating surface and some in the coating (**Figure 4**). These bubbles form tiny craters on the surface of the coating. According to EN ISO 4628-2 the defects occurrence can be evaluated as 2-2(S2) to 2-2(S3), i.e. ca 0.05 to 0.5 % from total surface of panel. Thickness of zinc coating was ca 75  $\mu\text{m}$  and powder coating ca 230  $\mu\text{m}$ .

**Figure 4** Example of defects on panels - pinholes

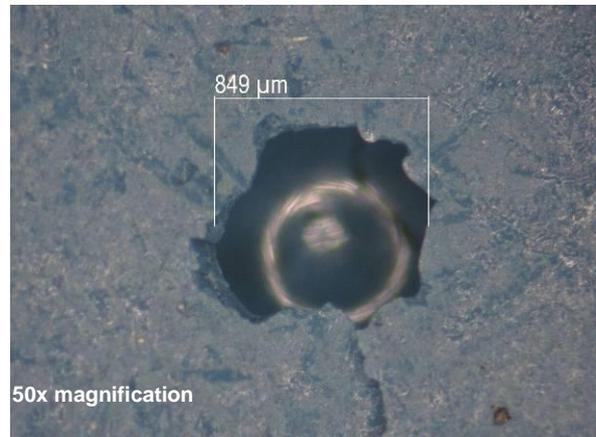
**Figure 5** Defect on interface between zinc and organic coating

The microscopic evaluation shows large defects in the shape of bubbles on the interface between organic and zinc layers (**Figure 5**). The cross-sections of zinc coating illustrate the pores and cracks in the layer and especially on the interface of zinc coating and substrate steel (**Figure 6**).

The powder coating layer is cured by heating till ca 230 °C. In this temperature the recombination of diffused hydrogen in steel occurred and created such defects in zinc and subsequently in organic coating layers.

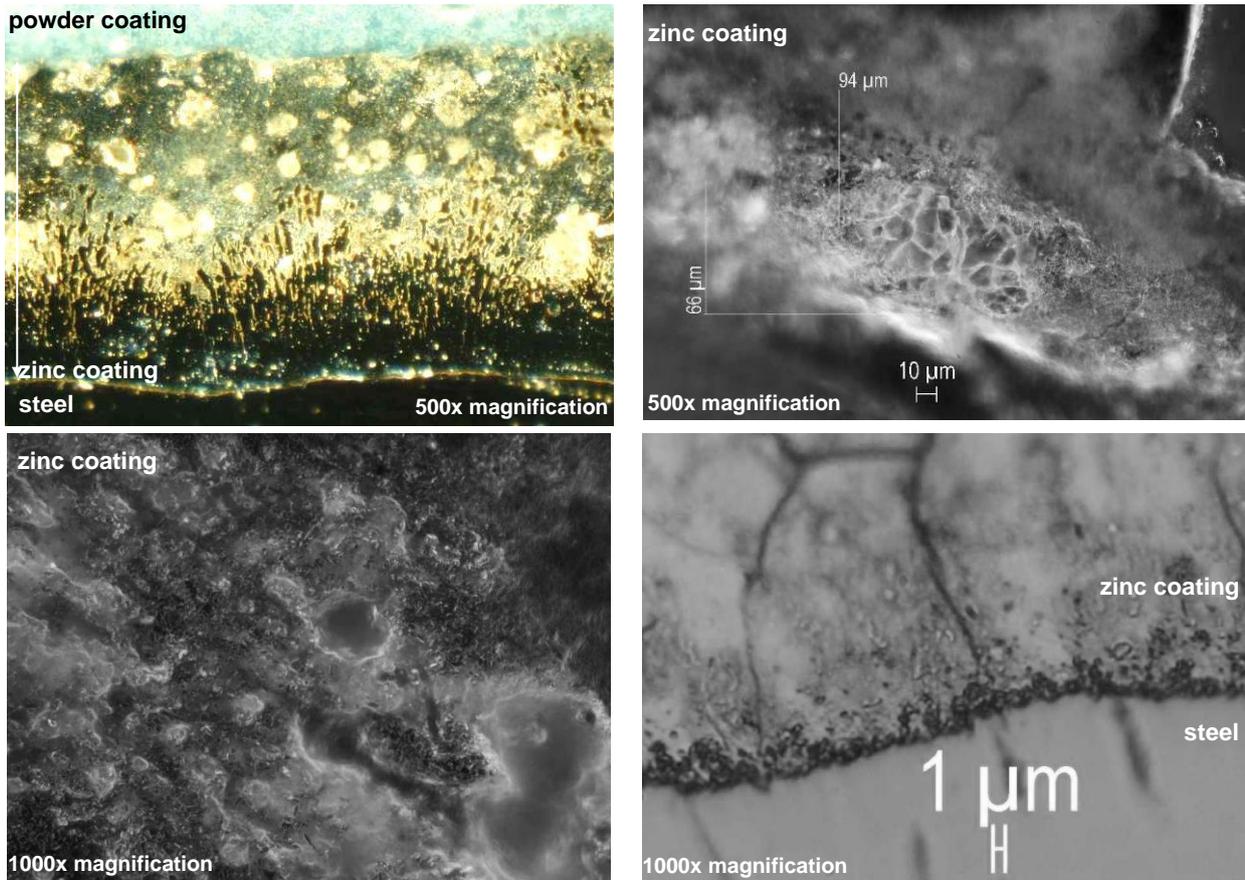
**Figure 6** The cross-section of zinc coating with powder coating
