## **CORROSIVE - MECHANICAL DAMAGE OF THE PRESSURE PARTS OF HEAT ENERGY EQUIPMENT**

### **Abstract**

The paper presents an analysis of corrosion - mechanical damage to the heat exchanger (economizer) of the biomass boiler.

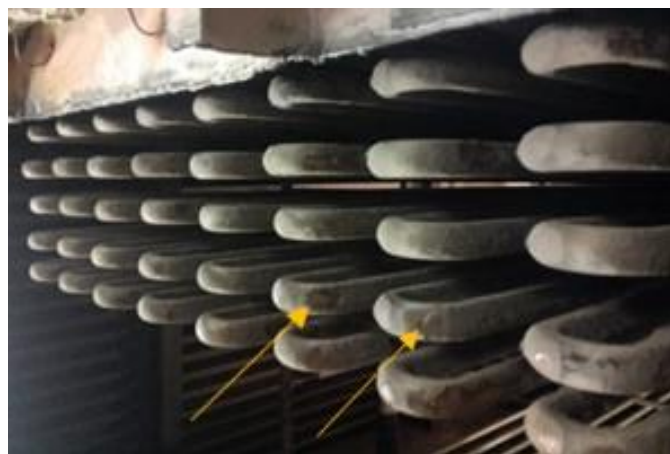
A view of the location of the economizer tubes in the boiler device is shown in (**Figure 2**). At the location indicated by the arrow, external wear of the wall surface is visible on the lower pipe bend. Wear, which led to the thinning of the wall of the tube under investigation, was found in several tubes in the economizer. The flue gas stream with high ash content (up to 30%) degraded the surface and damaged not only the protective oxide coating but also the steel material itself.

**Figure 2** Shot on the bottom of the economizer tubes with visible external wear (indicated by an arrow)

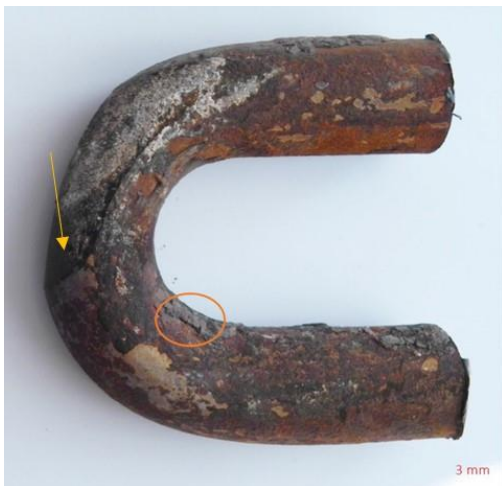
The results of the macroscopic analysis are documented in **(Figure 3)** and **(Figure 4)**. More detailed view of the damaged location of the lower arc of the tube is in **(Figure 3)**. In **(Figure 4)** the perforation region of the pipe with cracks on both sides thereof is visible. A cut-out was made at the point of the crack to prepare a sample for microscopic analysis (in **Figure 4** this is the location indicated in the formation).

**Figure 3** Lower tube bend with a strong abrasive effect of the flue gas

Macroscopic analysis of economizer tubes (EKO) showed significant corrosion - erosive damage on the steel surface at the bottom of the arc. This damage was caused by a flue gas stream containing a high to 30% solids content of fly ash. This damage process resulted in a significant loss of pipe wall thickness by the flow of solid ash components in the flue gas. At the thinnest point of the wall of the tube, the thickness was reduced from 4 mm to 0.7 mm, which represented an 80% reduction in material. At the point where the pipe wall thickness reached a critical value, the pipe wall was perforated and heated water leaked out. When the water flows from the inside of the pipe towards its outer surface, the corrosion layer moisture has been increased and released from the pipe surface. The result of this process can be seen in (**Figure 3**) and (**Figure 4**) in places where it is very thin, resp. totally missing corrosion layer on the surface (areas are indicated by an arrow).

- 6) the solution is to keep the specified technological parameters: temperature of the combustion process and pressure of the flowing medium in the heat-exchange tubes,

- 7) another effective solution is to reduce the content of aggressive flue gas components to the recommended limit value, especially the HCl content. It is recommended to keep the chlorine content of the fuel below 0.06% [12];

- 8) it is also recommended to reduce the ash content to a maximum of 7.1%, which is a requirement for quality fuel [13]. At the same time, the ash particles are hygroscopic and help to maintain moisture on the steel surface and thus prolong the corrosion process time.

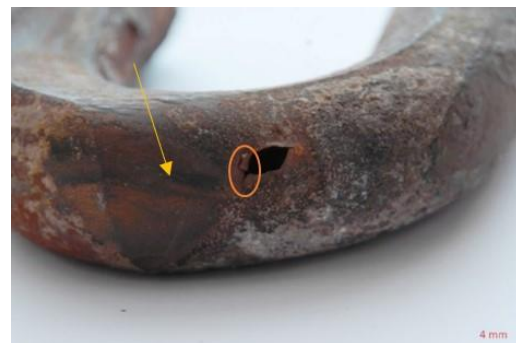
**Figure 4** Lower tube bend with wall perforation

On the steel surface on the outside of the pipe wall at the arc point as well as on the crack surface at the edge of the perforation point (the place marked in **Figure 4**) there was only a thin corrosion layer that locally reached a depth of max. The thickness of the corrosion layer was reduced by a stream of solid ash components in the flue gas. As mentioned, the perforation resulted in a considerable separation of the corrosion layer by escaping hot water from the economizer tube.

- 4) the degradation process was also aided by a flue gas stream with a high, up to 30% solids ash content,
- 5) the abrasive process by the action of particulate matter in the flue gas reduced the wall thickness of the economizer pipe by up to more than 80% at the bottom of the bend, resulting in perforation of the pipe wall;

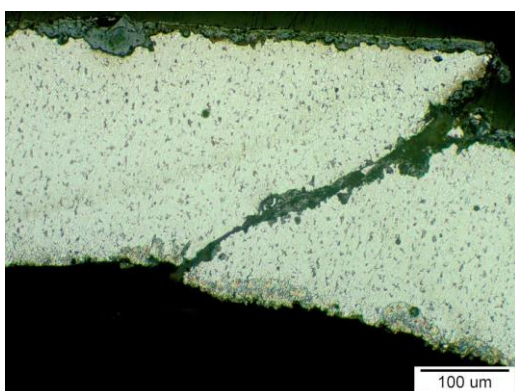
Light microscope observation revealed that the steel structure of the economizer tube was ferritic-pearlitic and is documented in **(Figure 5)**. The steel hardness was 63.8 HV10. On the steel surface on the outside of the pipe wall at the arc location as well as on the crack surface at the edge of the perforation point (the location indicated in **Figure 4**), there was only a thin corrosion layer that locally reached a depth of max 100  $\mu\text{m}$ . Samples were taken for the EDX analysis on a scanning electron microscope from the locations (indicated in **Figure 3**) where a corrosion layer of greater thickness was observed, **(Figure 6)**.

**Figure 5** The location of the crack edge documented in **(Figure 4)**

Analysis of the chemical composition of the economizer tube material and microscopic analysis showed that P235GH steel was used. The ferritic-pearlitic structure had a perlite content corresponding to approximately 0.2% of the carbon content of the steel; (**Figure 5**). The grain distribution and shape of the structural

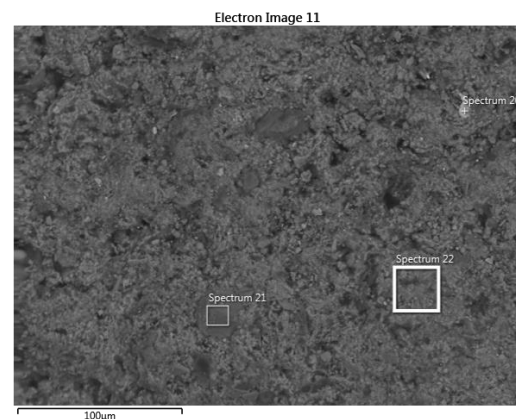
**Figure 6** EDX analysis of the corrosion layer on the tube surface from the sampling site of **(Figure 3)**

Based on EDX analysis from a site of greater corrosion layer thickness (site in the formation shown in **Figure 3**), in detail in (**Figure 6**), it was found that the corrosion layer contained elements that were part of the chemical composition of the steel, such as Si, Cr, Ni, Cu, Fe. Furthermore, there were elements such as S, Cl, Mg, Ca, Al, Zn, K, which were components of the flue gas and, when reacted with the metal surface, passed into the corrosion layer. In particular, elements such as: Cl, S, Na, K, Zn were involved in the destruction of the protective layer of iron oxides.

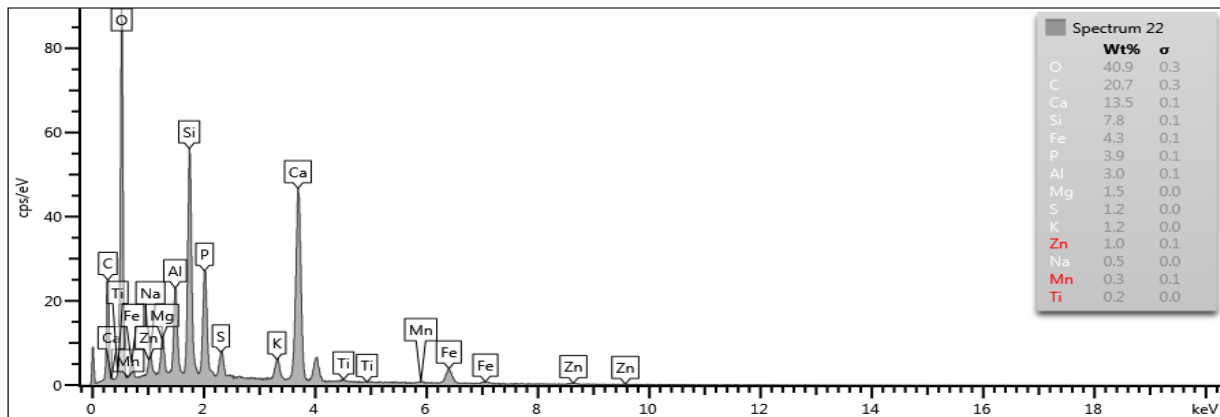
**Figure 7** The EDX analysis of the corrosion layer of (**Figure 6**) - Spectrum 22

The results of the analysis from a documented location on the tube surface are shown as an example of the selected spectrum in (**Figure 7**) and summarized in **Table 2**.
