MATERIAL ANALYSES OF PRESTRESSED CONCRETE BRIDGE FAILURE

Petr ČÍŽEK, Zdeněk KUBOŇ, Ladislav KANDER

MATERIAL AND METALLURGICAL RESEARCH, Ostrava, Czech Republic, EU,
petr.cizek@mmvyzkum.cz

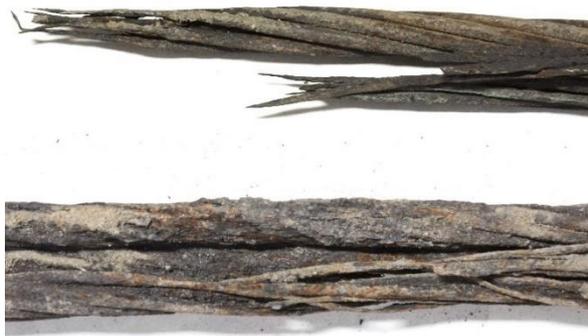
Visual inspection revealed heavily corroded strands of bearing cables especially located just to the segment ends where even the protection sealing tubes were destroyed by corrosion, **Figure 1** and **Figure 2**. Detailed view of the corroded and deformed ends of broken cables is stated in **Figure 3** and the same view of not damaged wires in bearing cables fully covered by injection grout is stated in **Figure 4**.

Figure 1 Broken and corroded strands of bearing cables

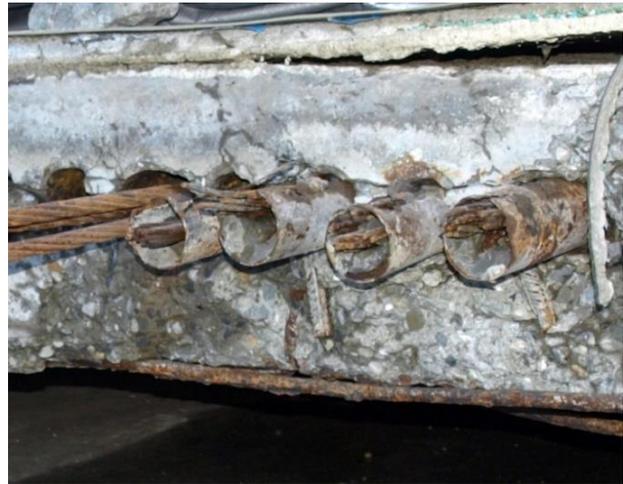
Figure 2 Corroded sealing steel tubes at the end of a segment

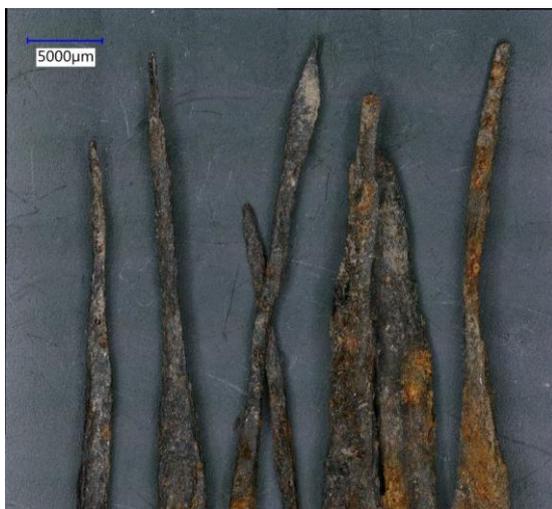
Figure 3 Detail of broken and corroded wire ends of bearing cable

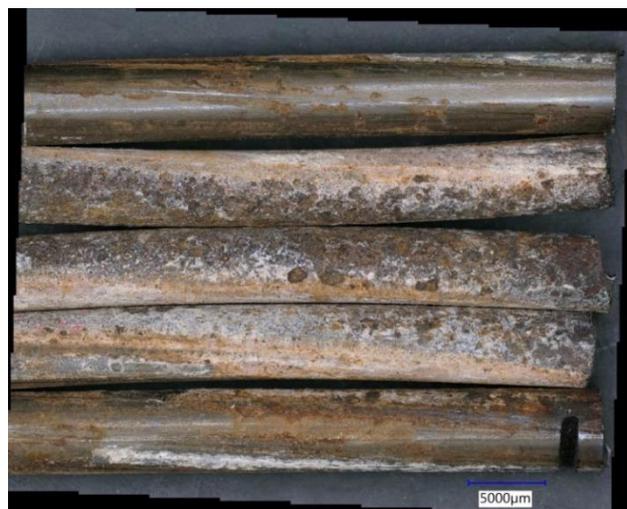
Figure 4 Detail of wires in bearing cables fully covered by injection grout

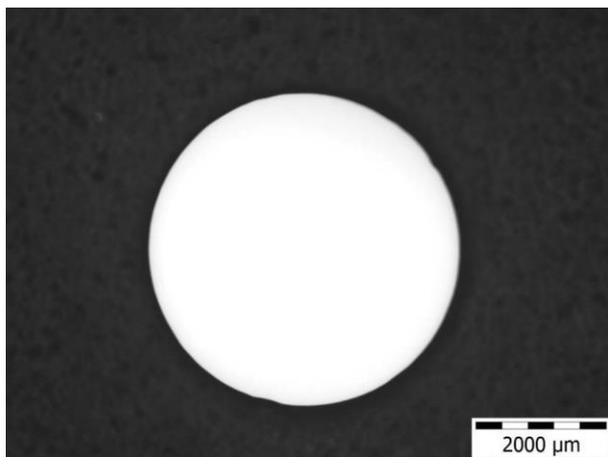
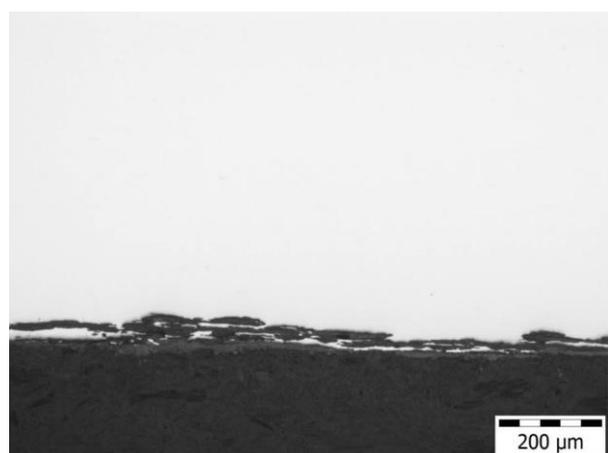
Visual examination revealed that the most heavily corroded cables were located approximately in the central third of the total footbridge length where was also the highest point of the footbridge and where the central channels with the prestressed bearing cables were not completely filled with concrete or grout. Metallographic analysis then revealed that cables sampled from undamaged location, where the cable was completely poured in injection mixture were in a very good condition with no significant signs of corrosion, **Figure 5**. In corroded wire strands taken from the central part of a footbridge where they were not been grouted completely, metallography analysis proved considerable reduction of the load-bearing profile of the wire, thick corrosion layer along the whole wire, heavy internal corrosion and corrosion blunted ends of a wire, **Figure 6**.

Figure 5 Cross section and very mild corrosion attack of a wire strand in completely injected cable

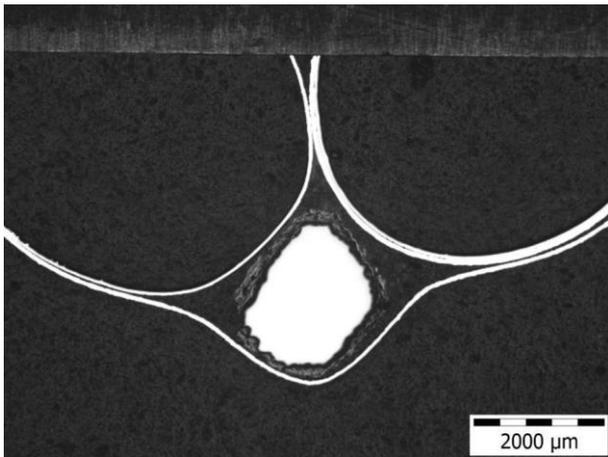
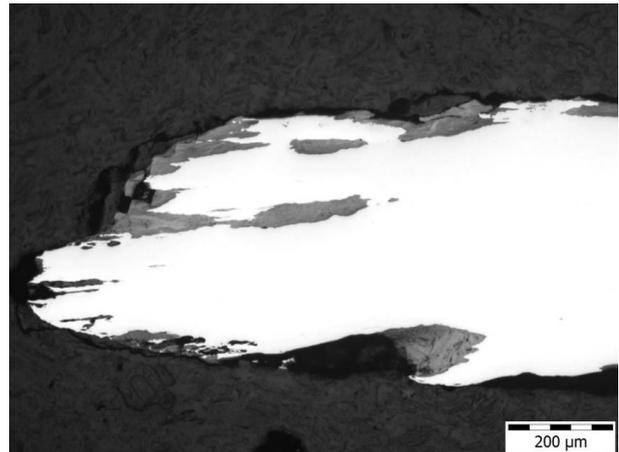
Figure 6 Cross section and heavy corrosion attack of a wire strand in a damaged cable

Microstructure of the wire was pearlitic, but locally there were observed thin films of different contrast (probably ferrite or cementite) elongated in direction of wire drawing.

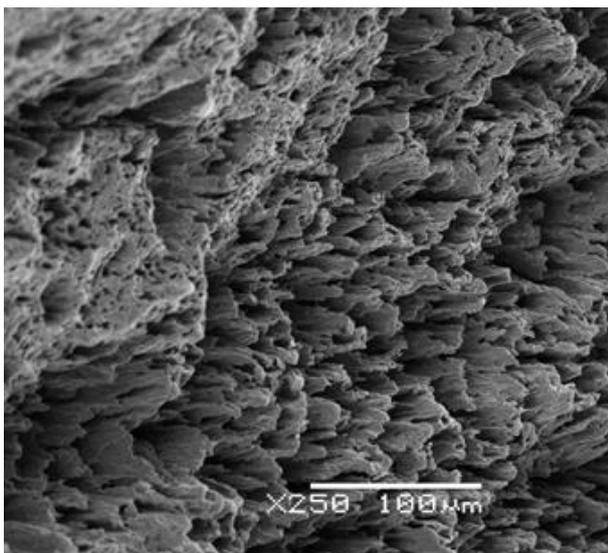
Fractographical analysis was performed on two samples that visually represented two different types of fracture. Fracture surface of the first specimen had a shape of letter V and was covered by heavy corrosion layer. After cleaning the fracture surface was formed by ductile dimple fracture with elongated dimples, **Figure 7**. The second analyzed wire was corroded so heavily that its diameter was considerably narrowed and the end of the wire had many longitudinal and transverse cracks, **Figure 8**. Supposed fracture mechanism was primarily corrosion damage with subsequent break of remaining cross section by fracture from overload.

Figure 7 Ductile fracture with elongated dimples

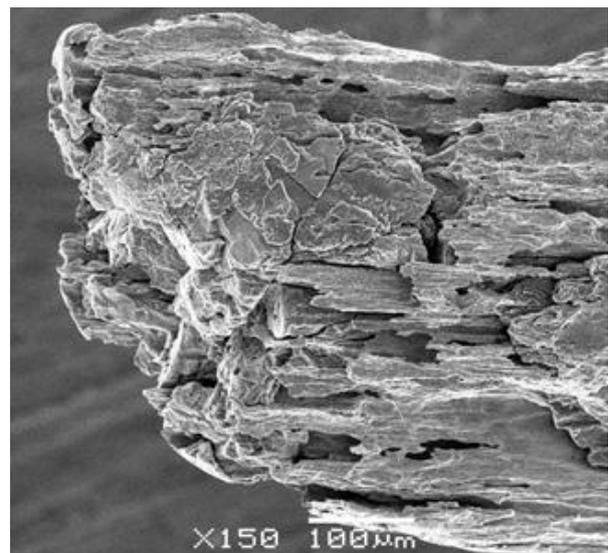
Figure 8 Fracture surface of corrosion damaged wire
