## METHODS FOR EVALUATION OF PAINT COATINGS COMPOSITION

Hana GEIPOVÁ<sup>1</sup>, Lubomir MINDOŠ<sup>1</sup>, Pavlína FIALOVÁ<sup>1</sup>, Libor TUREK<sup>1</sup>

<sup>1</sup>SVÚOM Ltd., Prague, Czech Republic, EU, [geiplova@svuom.cz](mailto:geiplova@svuom.cz)

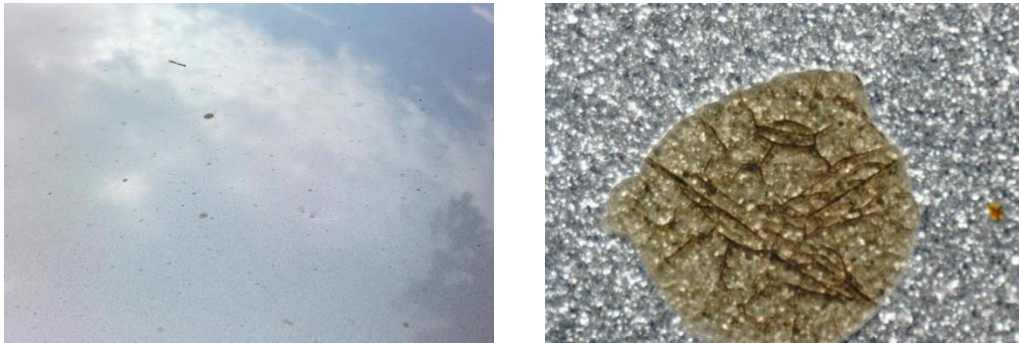
Optical microscopy evaluation was used to evaluate car body paint defects. Two types of car paint system were evaluated: white colored coating (sample 1) and anthracite metallic pigmented coating (sample 2). Both paint systems showed defects in the form of cracks, coloured spots or peeling in the clear coat (**Figure 1**). In the field the defects of coating were documented by portable microscope with 50x magnification.

**Figure 1** Defects in the car coating (left sample 1, right sample 2)

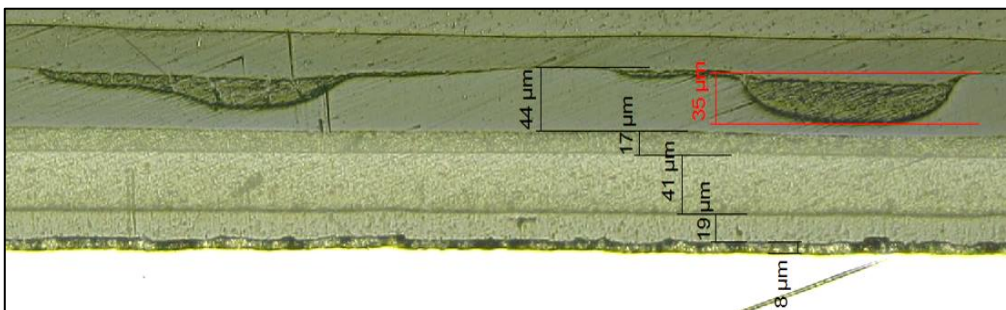
**Figure 2** Microscopic evaluation – sample 1 cross section – holes in clear lacquer layer

Detailed evaluation was done. **Figure 2** and **Figure 3** show cross section of car body coatings, in which a significant thinning of the top clear coat is visible. Depth of the defect was different, from 10  $\mu\text{m}$  to 40  $\mu\text{m}$ , practically peeling clear coat. This evaluation was done in laboratory by light microscope Zeiss NEOPHAN 32. Light microscope cross section allows to identify the number of coating layers, the thickness of each one, and possible the structure of layer, especially the metallic pigment particles are evident – shape, size, amount, distribution, etc. In case of sample 2 the deterioration of top layer and corrosion of aluminium pigment particles is evident.

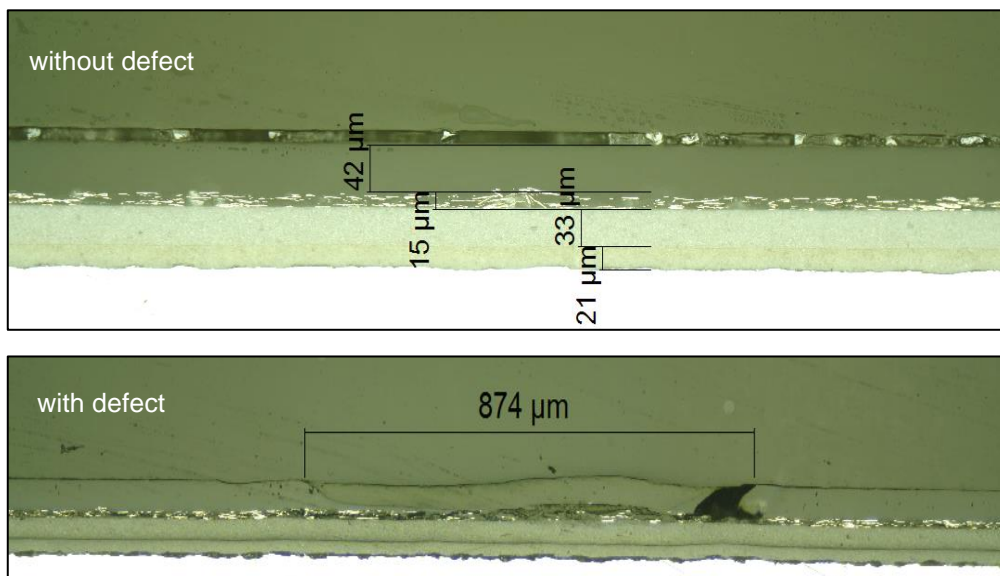
**Figure 3** Microscopic evaluation – sample 2 cross section – holes in clear lacquer layer, clear coat degraded – corrosion of Al pigment

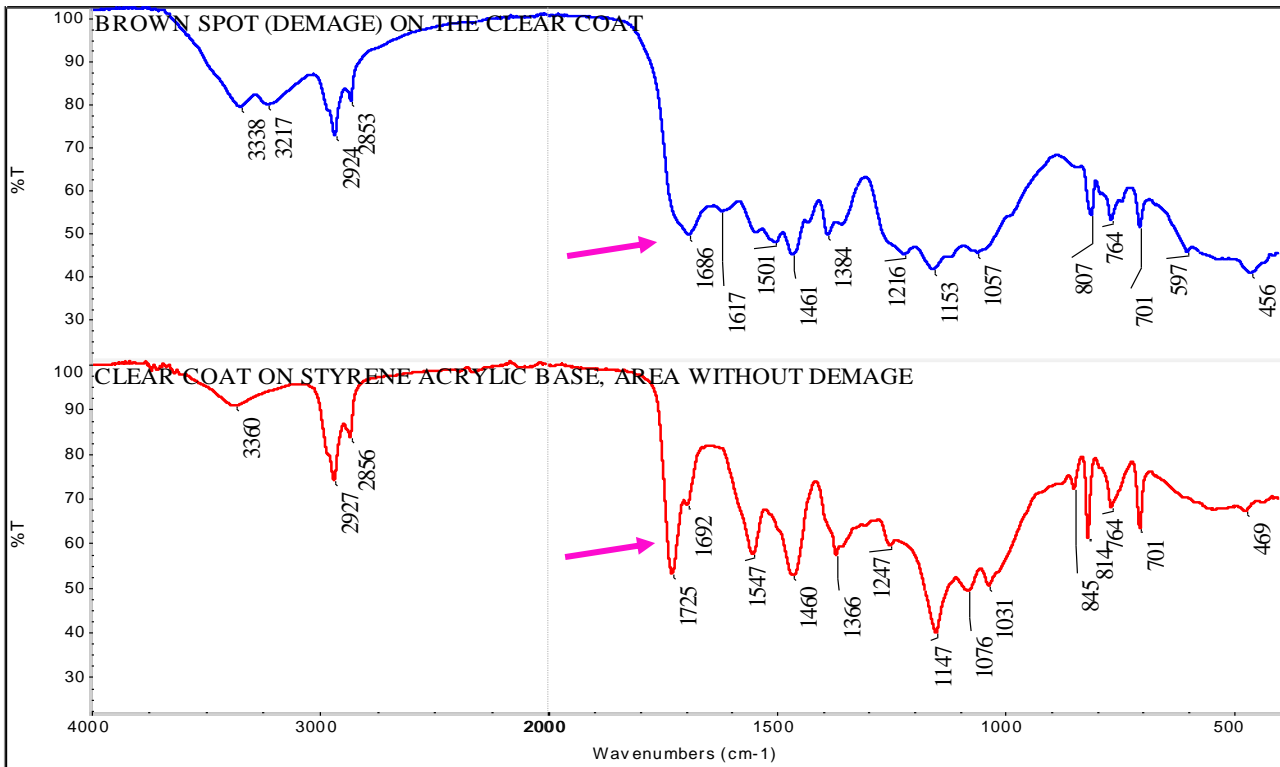
FTIR analysis of sample 1 top coat determinates styrene-acrylate copolymer like binder. In stain area the peak characteristic for C=O bond is missing. From the spectra it was found that hydrolysis of top layer had to take place (**Figure 5**).

Description: blue line – brown spot (damage) on the clear coat  
red line – clear coat on styrene acrylic base, area without damage

**Figure 5** FTIR spectra - difference of peaks in the area of hydrolysis (arrows)

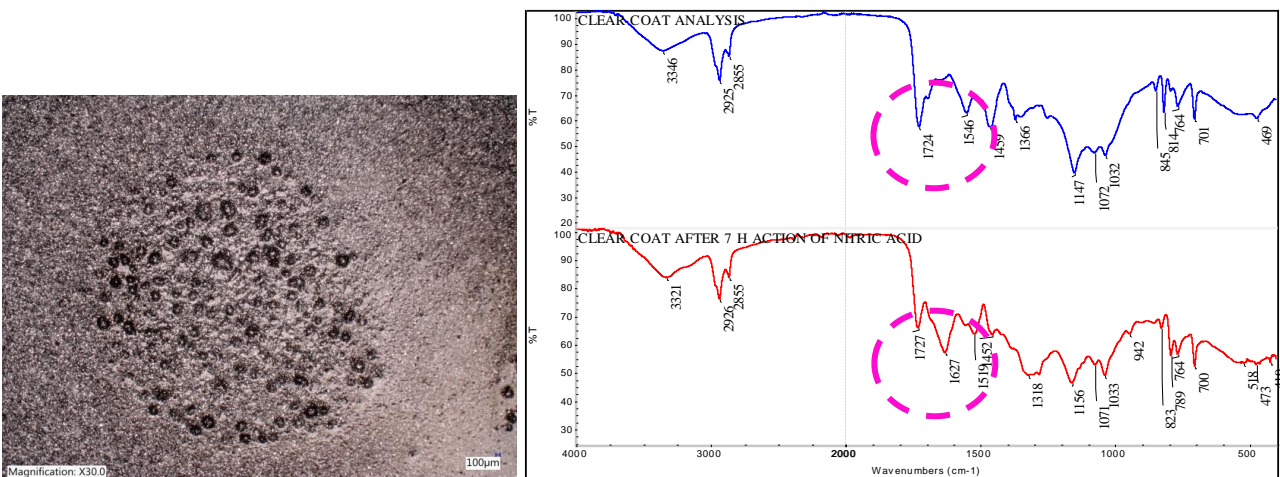
The acidic contamination of paint surface by sulfuric and nitric acid into consideration as main air pollution sources. During laboratory simulation the mechanisms of degradation of the top paint layer caused by both acids was different. While sulfuric acid promoted by UV radiation caused hydrolyses, nitric acid caused swelling of the top coat without hydrolysis (**Figure 6**).

Description: blue line - clear coat analysis  
red line - clear coat after 7 h action of nitric acid and UV

**Figure 6** FTIR spectra of top layer after nitric acid effect and its swelling
