THE FAILURE ANALYSIS OF A PIPELINE BEND MADE OF 16Mo3 STEEL

¹MATERIALS AND METALLURGICAL RESEARCH s.r.o., Ostrava, Czech Republic, EU,
zdenek.kubon@mmvyzkum.cz

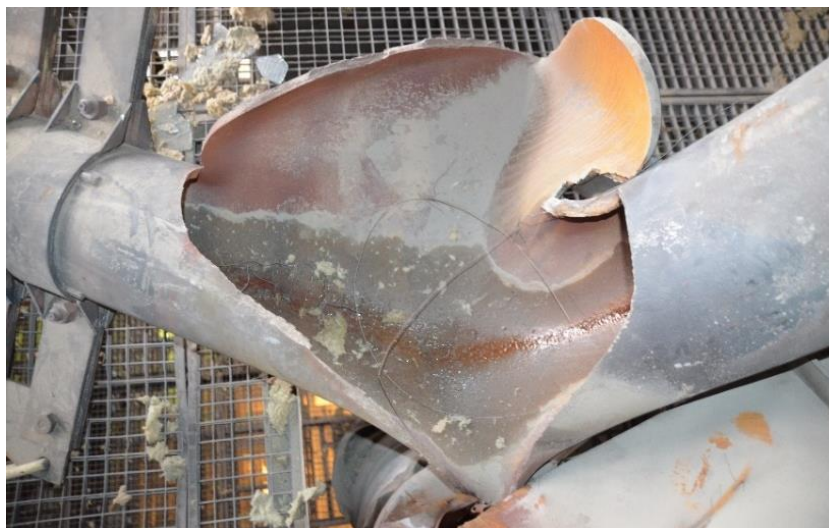
The aim of this paper is to present the results of complex material analysis carried out on a broken bend of a pipeline \varnothing 273 x 20 mm made of 16Mo3 steel after nearly 180,000 hours of exposure at nominal temperature 468 °C. The pipeline connected the outlet header of superheater I and the inlet header of superheater II and the pressure of the steam released during the burst caused the entire steam pipe to bend to the opposite side, broke the hangers and supports and damaged the wall of the boiler room even in the surrounding floors, **Figure 2.**

Figure 2 Damaged part of the pipeline bend

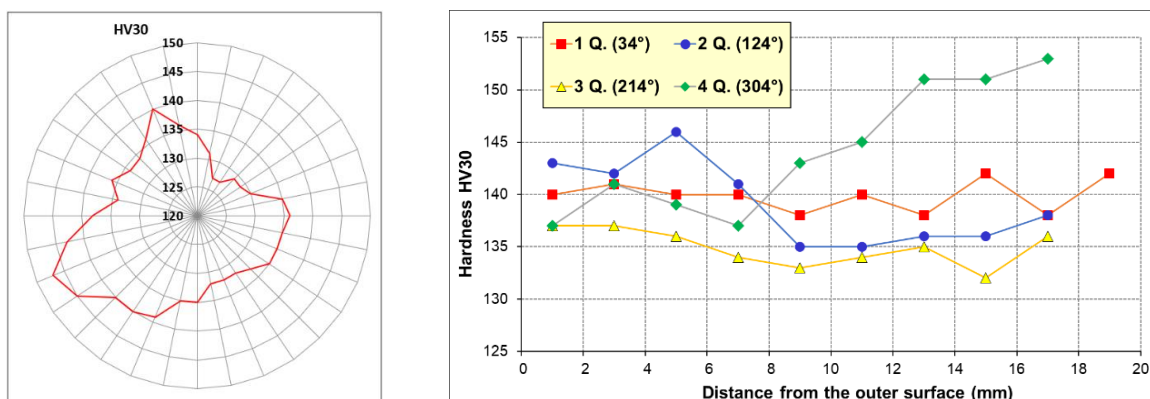
Figure 3 Hardness along the circumference of the steam pipe (left) and across the wall thickness (right)

close to the burst line (about 34° clockwise from the extrados with minimum hardness as shown in **Figure 3** left) and then measured in four quadrants clockwise in the direction of water/steam flow. The results of these measurements are shown in **Figure 3**.

The required hardness ranges from 140 to 190 HV and the material is considered satisfactory if the extended limit is 125 to 205 HV. From the results shown in **Figure 3** is clear that hardness lies close to the lower limit due to softening after long-term exposure and the low hardness corresponds well also to the tensile strength.

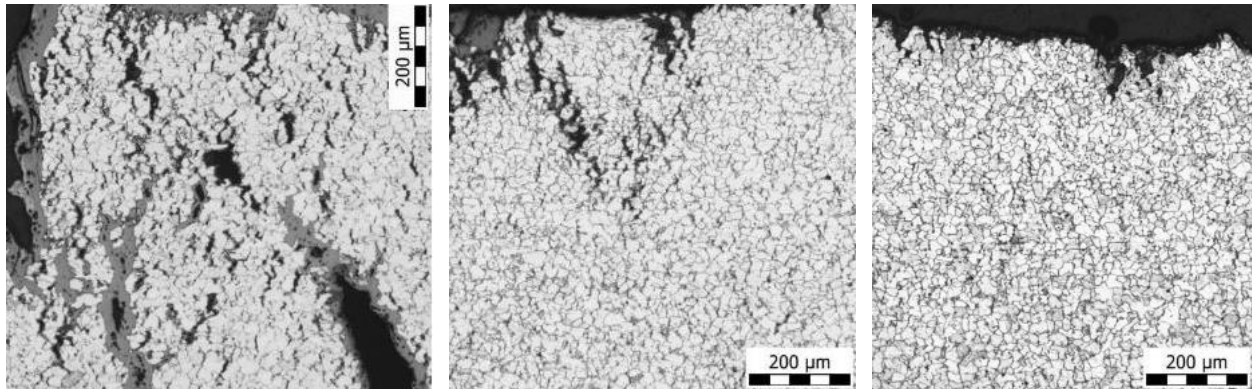
Figure 4 Sample A: Creep cavitation damage at the burst opening (left) 25 (middle) and 50 mm away (right)

namely in the vicinity of the burst opening, with macrocracks and microcracks observed, **Figure 4**, while the damage decreased at greater distance from the fracture. **Figure 5** shows heavily decomposed pearlite and carbides and cavities appearing on grain boundaries. Large particles of graphite, at least an order or magnitude larger than cavities, were observed not only close to the fracture but in all analyzed parts, **Figure 6**.

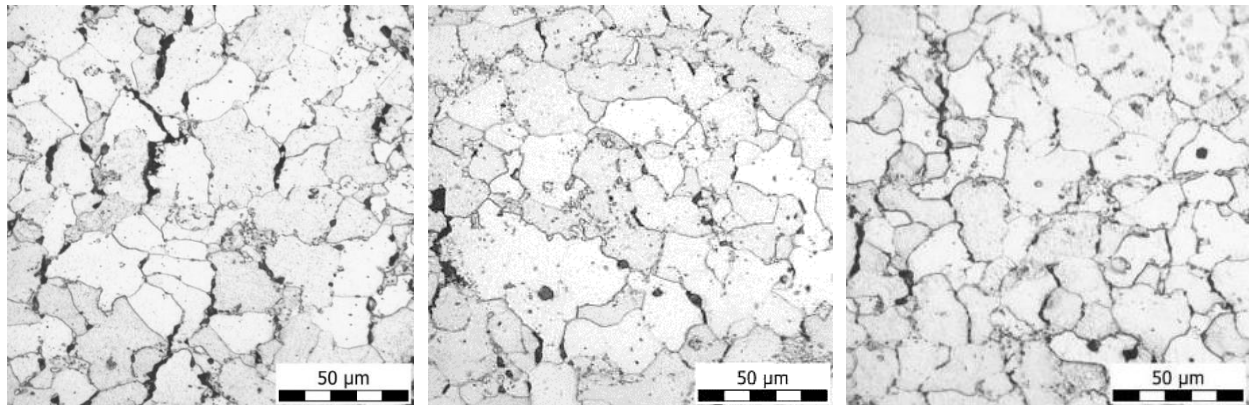
Figure 5 Sample A: Detail of microstructure at the burst opening (left) 25 (middle) and 50 mm away (right)

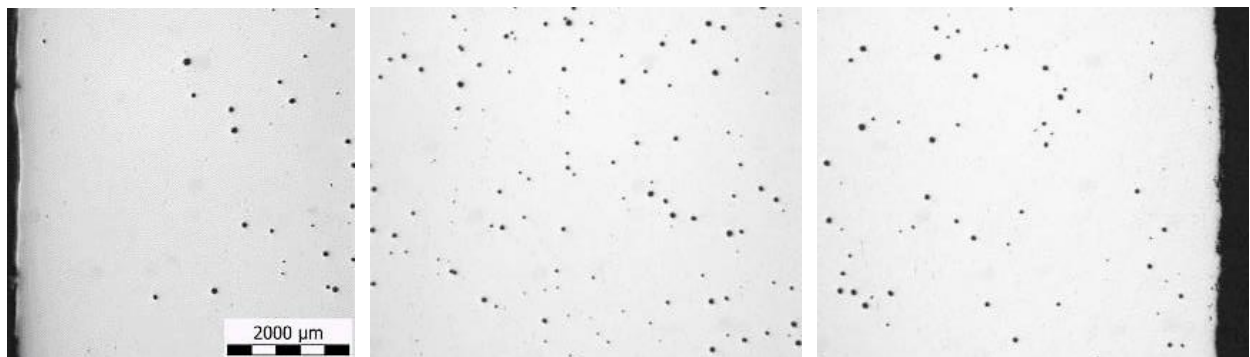
Figure 6 Sample B: Graphite particles in the pipe wall on the extrados of the pipe bend away from fracture

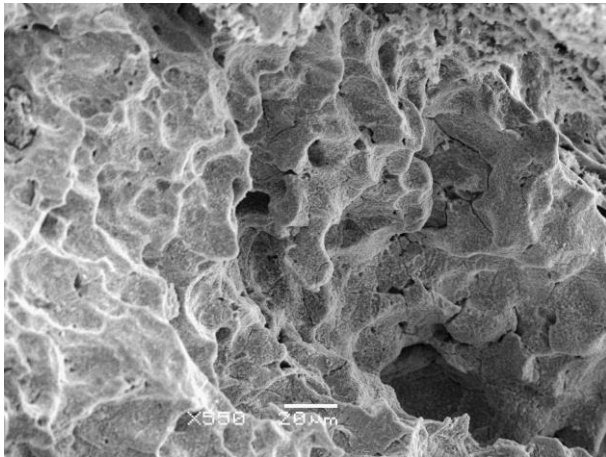
After cleaning the sample taken for the fractographic analysis just from the expected initiation area of burst by ultrasonic cleaning in the water solution of hexamethytetramine+HCl, the different types of fracture were detected on the outer and the inner side of the pipe wall. Close to the outer surface the fracture mode was mainly intergranular with the appearance of a large number of small voids - cavities, **Figure 7**. On the other hand, close to the inner pipe surface, the combined fracture mode consisting principally of the transgranular ductile fracture with dimples of various size and partly also of the intergranular fracture, **Figure 8**. It is clear that the damage started at the outer surface of the pipe wall and then spread through the pipe wall.

Figure 7 Fracture mode, the outer surface of the pipe

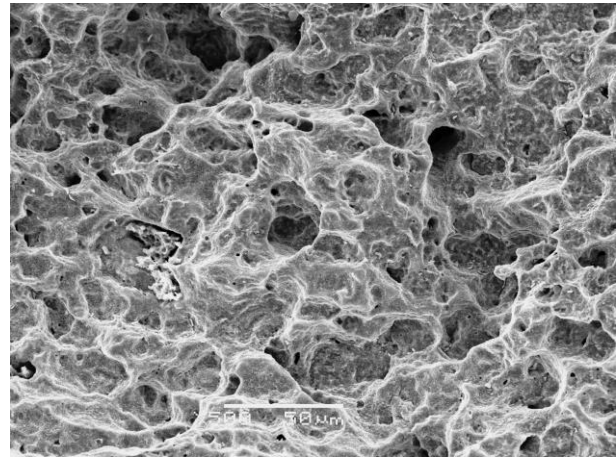
Figure 8 Fracture mode, the inner surface of the pipe

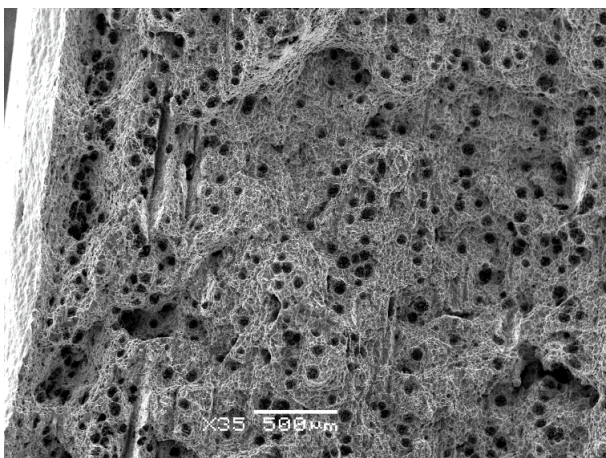
Detailed EDX microanalysis was performed on the Charpy-V notch sample, where numerous graphitic particles were found even at low magnification, **Figure 9**, and the chemical composition of these particles having without exceptions 100 % of carbon content is confirmed in **Figure 10**.

Figure 9 Graphite on the fracture surface of Charpy V-notch sample

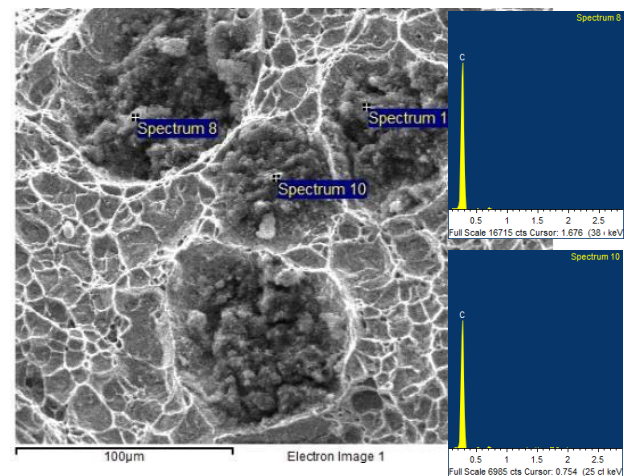
Figure 10 EDX microanalysis of graphitic particles

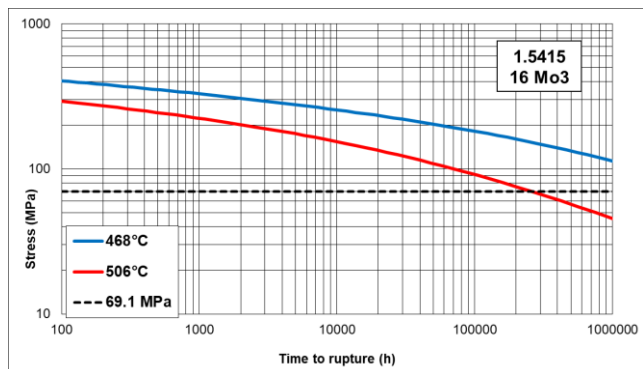
The standardized safety coefficient 1.25 for the service life 200,000 hours is used when calculating the maximum permissible stress in the pipe wall, i.e., the stress in this simplified calculation is 69.1 MPa. Times to rupture for both the design and the effective temperatures can be seen in **Figure 11** for the mean creep rupture strength of steel 16Mo3 stated in the material standard. While the predicted time to rupture for the design temperature significantly exceeds a million hours, at 506 °C it is only slightly over 200,000 hours. Despite the considerable simplifications used in this calculation, it is clear that the shift of the operating temperature could significantly reduce the service life of the steam pipe itself.

Figure 11 Stress-time to rupture dependence of 16Mo3 steel at various operating temperatures
