THE ANALYSIS OF SUSPENSION SPRING DURABILITY IN PASSENGER CARS AFTER LONG-TERM OPERATION

¹Zbigniew BAŁAGA, ¹Michał OPYDO, ¹Agata DUDEK

¹Czestochowa University of Technology, Czestochowa, Poland, EU, <u>zbigniew.balaga@pcz.pl</u>

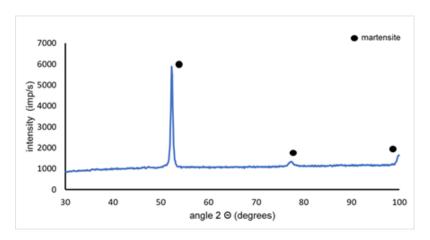
To determine the structure of the tested steel, X-ray diffraction (XRD) analysis was performed using a SEIFERT diffractometer equipped with a cobalt anode tube. The resulting diffractogram revealed three diffraction peaks corresponding to martensite (**Figure 1**).

Figure 1 X-ray diffraction pattern obtained from the steel sample taken from the tested spring
