CORROSION DAMAGE ANALYSIS OF DRINKING WATER PIPING

¹Zdeněk KUBOŇ, ¹Helena JANČÍKOVÁ, ¹Gabriela ROŽNOVSKÁ

¹1MATERIALS AND METALLURGICAL RESEARCH s.r.o., Ostrava, Czech Republic, EU, creep.lab@mmvyzkum.cz

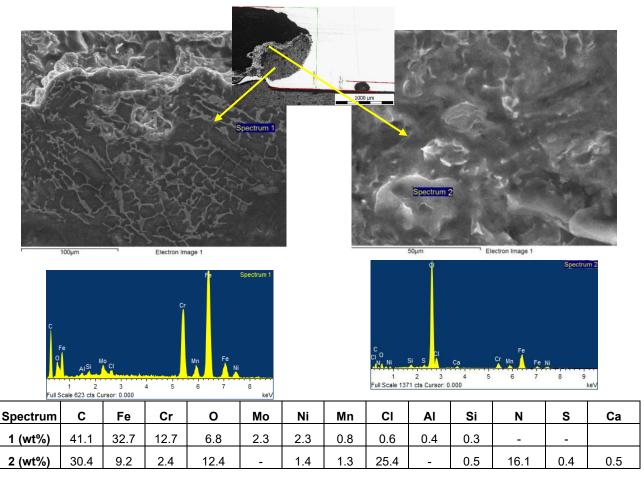
On the edge and inside the large corrosion pit shown in **Figure 10** there was an area with corrosion products that were analyzed by EDX microanalysis. The results of this analysis are shown in **Figure 13**. Apart from the absolute dominance of the carbon content, the analysis on the left side of the figure is one that was apparently carried out on the residues of the corroded matrix from which the corrosion products were washed away (high concentrations of Fe, Cr, presence of both Ni and Mo), the results on the right side of the figure represent most probably corrosion products with high concentrations of chlorine, oxygen, but also nitrogen and a complex of other elements including sulfur and calcium.

Figure 13 Analyzed areas and results of EDX microanalysis inside the corrosion pit, pipe in branch B
