CORROSION DAMAGE ANALYSIS OF DRINKING WATER PIPING

¹Zdeněk KUBOŇ, ¹Helena JANČÍKOVÁ, ¹Gabriela ROŽNOVSKÁ

¹MATERIALS AND METALLURGICAL RESEARCH s.r.o., Ostrava, Czech Republic, EU,
creep.lab@mmvyzkum.cz

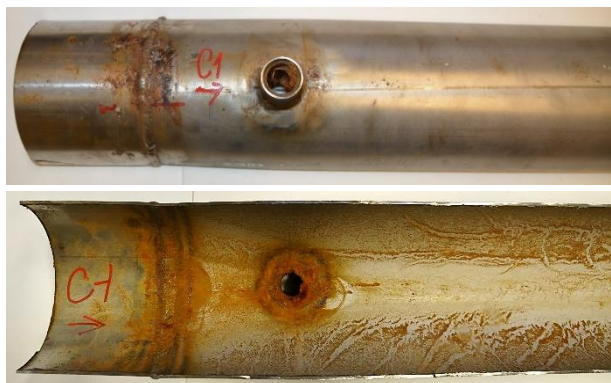
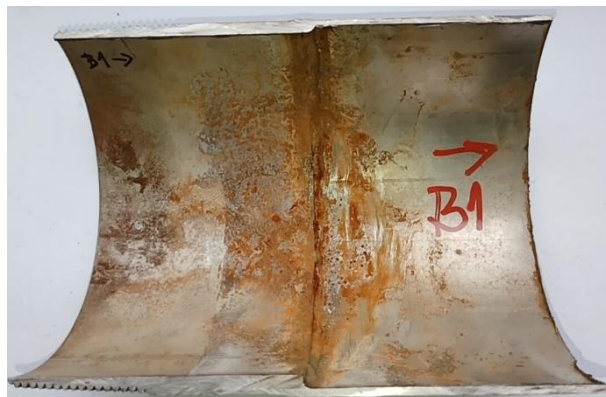
Samples delivered for analysis were cut around the damaged welds in both branches of the piping. At first glance, the appearance and surface finish of pipes from branch A differ from those in branch B. Samples forming branch A had a matte finish on both surfaces and were probably originally supplied in a pickled or sandblasted state, while pipes in branch B were shiny and polished. Besides the corroded ring around cross welds inside and outside there was also heavy attack of welds around nozzles and even numerous small corrosion spots were found around the whole inner pipe circumference in branch A, see **Figure 3**. The extent of corrosion of pipes in branch B was much less than in branch A, corrosion products were only found locally around the cross welds on the inner surface of the pipe, see **Figure 4**. Absolutely no corrosion attack was

Figure 3 Corrosion attack of cross welds, fillet weld of nozzles and inner surface of a pipe in branch A

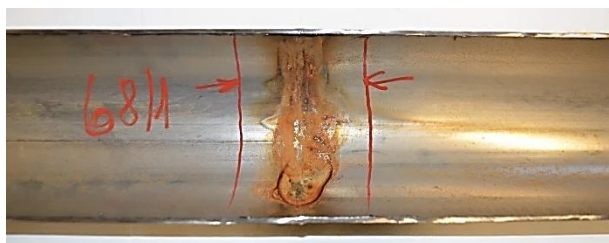
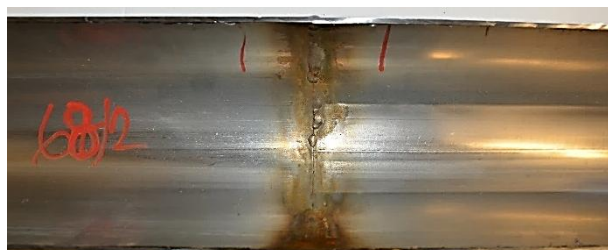
Figure 4 Corrosion of cross welds in a pipe in branch B

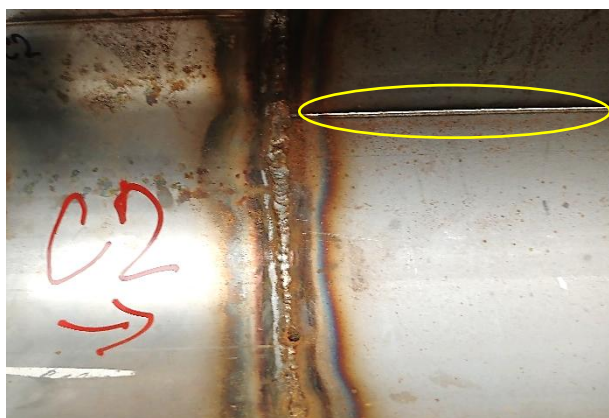
detected around the longitudinal laser in-shop welds, **Figure 5**, on the other hand, relatively large internal defects (corrosion pits) were found even under the apparently flawless weld surface, see **Figure 6**.

Figure 5 Clean surface around longitudinal in-shop laser weld, pipe in branch A

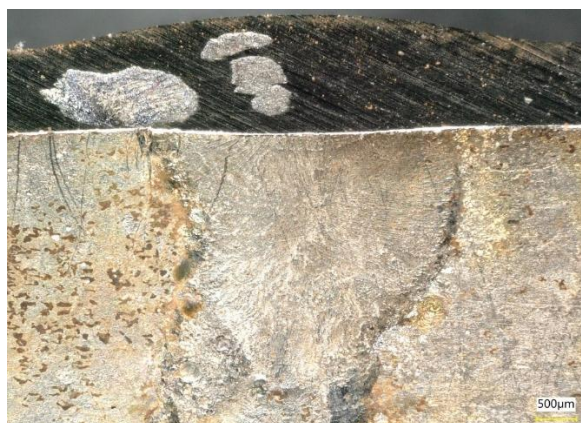
Figure 6 Corrosion pits inside the weld metal, pipe in branch B

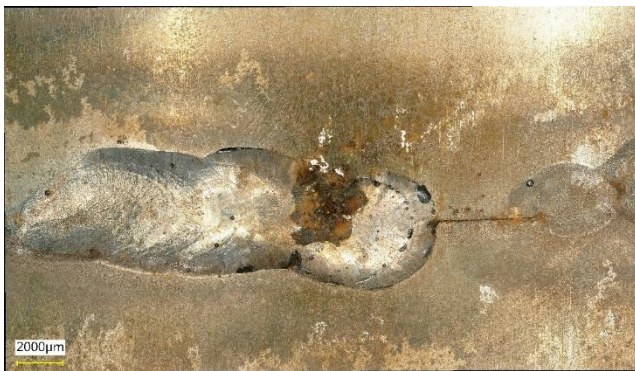
The detailed visual analysis performed on optical-digital microscope Keyence VHX 5000 revealed the details of damage concentrated mainly in the root of the welds. Besides lack of fusion in the root there were detected other welding defects like linear misalignment, shrinkage grooves, spatter on the inner surface and temper colour (oxide bands around welds indicating insufficient weld root protection by inert gas), see **Figures 7, 8**.

Figure 7 Lack of fusion in the weld root and corrosion spot indicating attack of weld metal, pipe in branch B

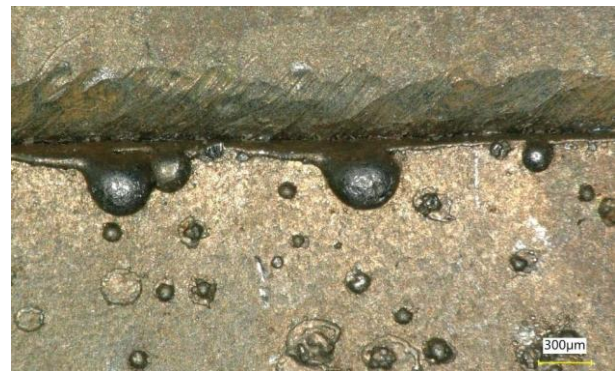
Figure 8 Linear misalignment forming a crevice and spatter on inner surface of pipe in branch A

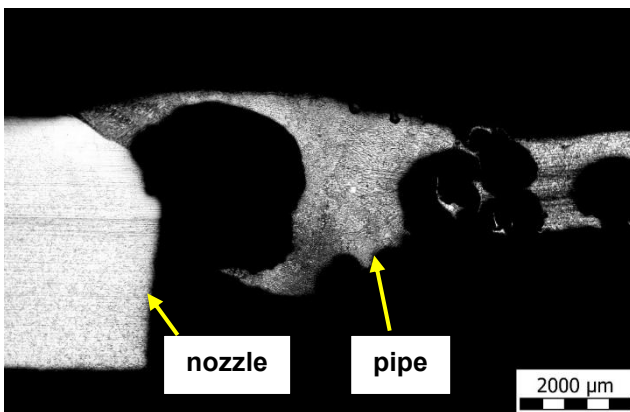
Samples for the analysis of microstructure were prepared using a standard grinding, polishing and final etching in V2A etchant for stainless steels. The first sample was prepared from the heavily corroded area close to the nozzle in the branch A, **Figure 9** and **10**, and shows in detail the difference between extensive attack of the pipe (including weld metal) and very limited corrosion damage of the nozzle that was made of AISI 316L. Regardless of whether it is base material or weld metal, corrosion pits penetrated through the entire thickness of the pipe wall in branch A. While in branch A practically all the pipe circumference was corroded, the completely different was the situation in branch B, where corrosion was restricted just around the weld joints, pitting started either just in the fusion line or at the end of heat affected zone (HAZ), see **Figures 11** and **12**.

Figure 9 Different intensity of corrosion attack on the pipe and the nozzle, pipe in branch A

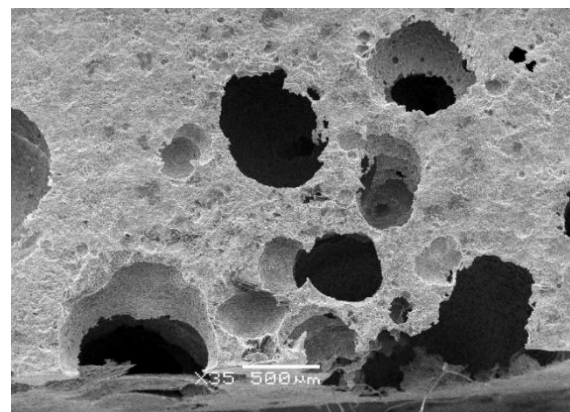
Figure 10 Corrosion pits penetrating through the whole pipe wall in branch A (SE, SEM)

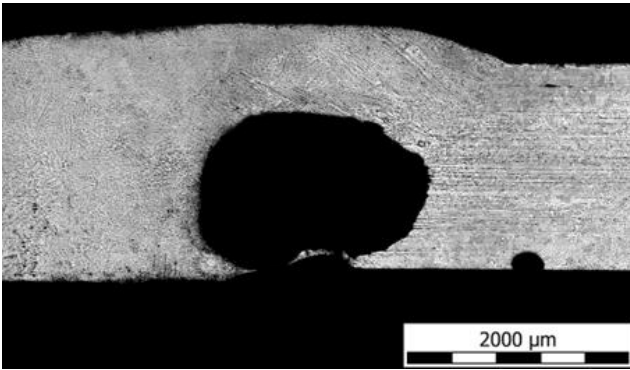
Figure 11 Pitting corrosion starting in the fusion line and small pit at the end of HAZ, pipe in branch B

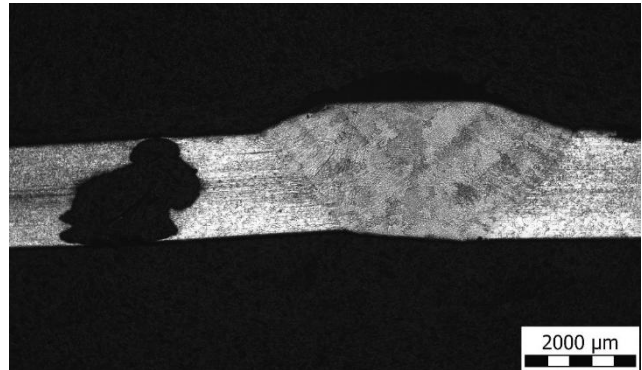
Figure 12 Pitting corrosion attack starting at the end of HAZ, pipe in branch B

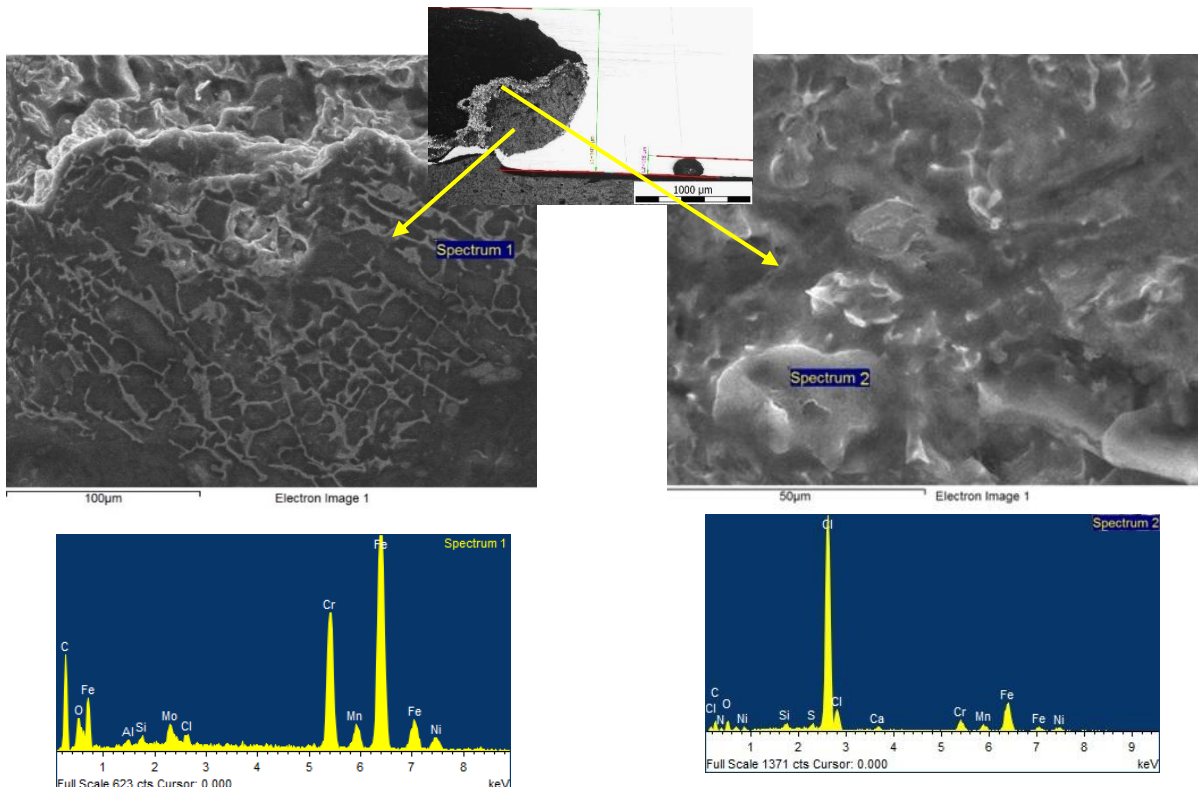
On the edge and inside the large corrosion pit shown in **Figure 10** there was an area with corrosion products that were analyzed by EDX microanalysis. The results of this analysis are shown in **Figure 13**. Apart from the absolute dominance of the carbon content, the analysis on the left side of the figure is one that was apparently carried out on the residues of the corroded matrix from which the corrosion products were washed away (high concentrations of Fe, Cr, presence of both Ni and Mo), the results on the right side of the figure represent most probably corrosion products with high concentrations of chlorine, oxygen, but also nitrogen and a complex of other elements including sulfur and calcium.

Figure 13 Analyzed areas and results of EDX microanalysis inside the corrosion pit, pipe in branch B
