NONDESTRUCTIVE AND DESTRUCTIVE TESTING OF WELDED JOINS

Iva DUFKOVÁ, Eva MACAJOVÁ, Pavel KEJZLAR

Technical University of Liberec, Liberec, Czech Republic, EU

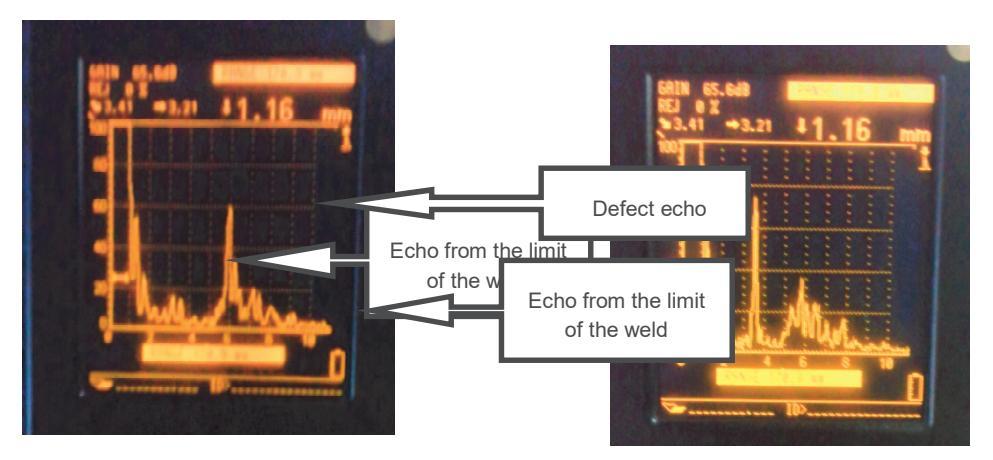
During the measurement undesirable damping was observed due to the considerable amount of austenite. The noise signal on the display must be below 12 dB (into 25 % increments) and for detection of defects it is necessary at least 6 dB, that's why for this measurement 8 dB was elected (**Figs. 1-3**).

Fig. 1 Defectoscope display - echoes coming from defects

Fig. 2 Without defect

Fig. 3 Defect was found

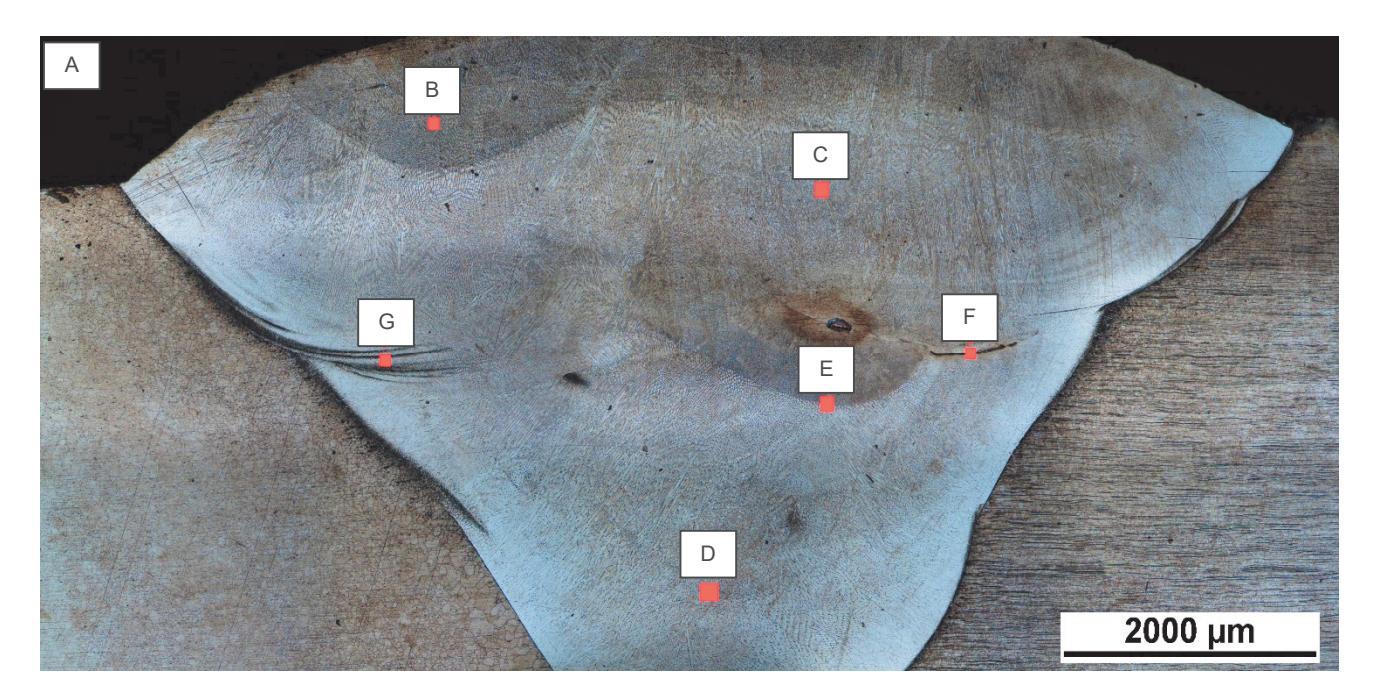
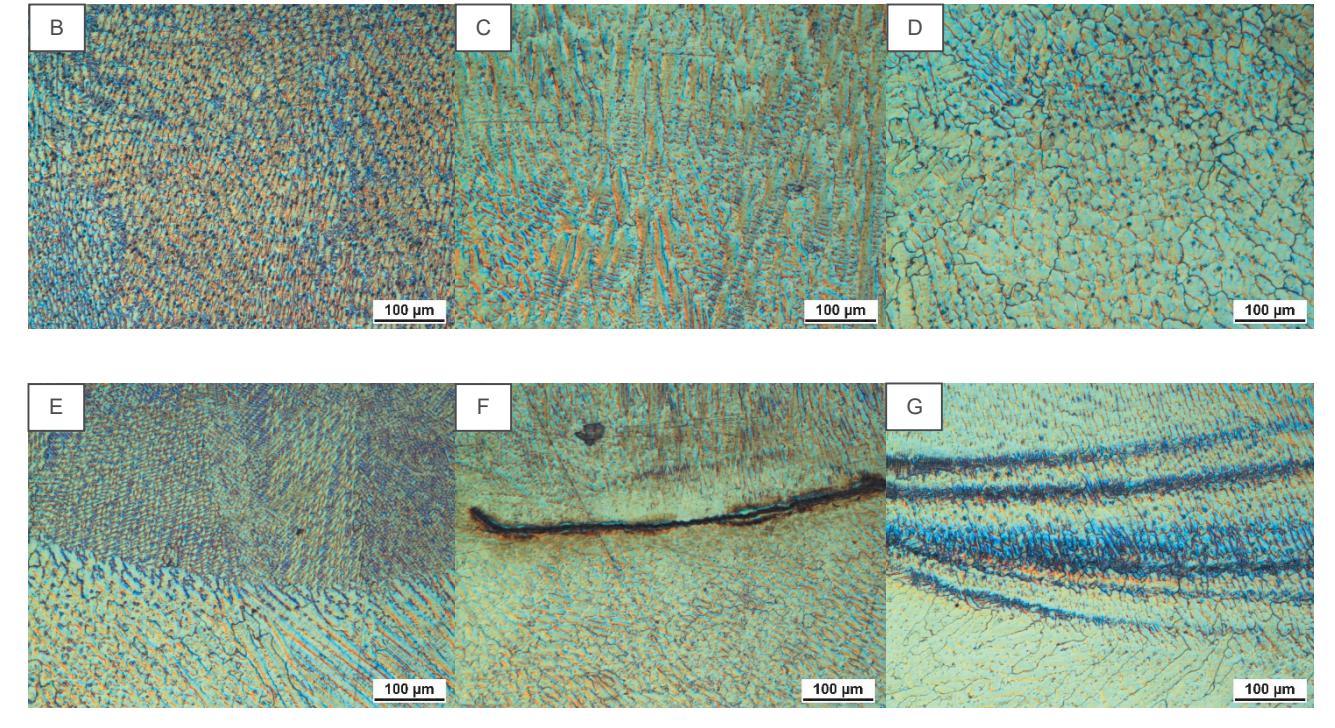
Fig. 4 Cut the weld with the finding of defect. A) Overview image; B-G) detailed images marked in 4A by red squares

The overview image in **Fig. 4A** documents the different anisotropy of welded joins and the position of the upper surface defect weld bread. It also shows the arrangement of dendritic structures in melting weld zone with different dispersions and different local orientation of dendrites. Locally at the top of the weld bead are several thin discontinuities (microcracks character).

In **Fig. 4B** we can see micro structure of upper weld bead with very fine grain, directionally oriented towards the surface of the weld. **Fig. 4C** shows significantly dendritic structure oriented toward to the surface of the weld. The austenite dendrites are predominantly uniaxial with an average length of 100 μ m and maximum of 200 μ m. In **Fig. 4D** there is almost purely austenitic structure (single phase) with grain size number according to ČSN 420462 6-7 [5], i.e. 0.035 to 0.04 mm. The structure in the upper part (**Fig. 4E**) is comparable to the very fine-grained two-phase area (**Fig. 4B**). This structure is the result of complicated temperature conditions during cooling and re-heating of the lower and upper solidification and cooling of weld bead. **Fig. 4F** shows the area which is a continuation of zone seen in **Fig. 4E**. This is the interphase between the solidifying dendritic structure of upper weld bead and again heated (annealed) structure of the bottom weld bead. In the upper part of **Fig. 4G**, there is visible fine-grained austenitic structure with elongated grains in the direction perpendicular to the joint of the two weld bead. In the bottom part of this **Fig. 4G**, there are three narrow bands of carbides (or even formations having δ -phase character).

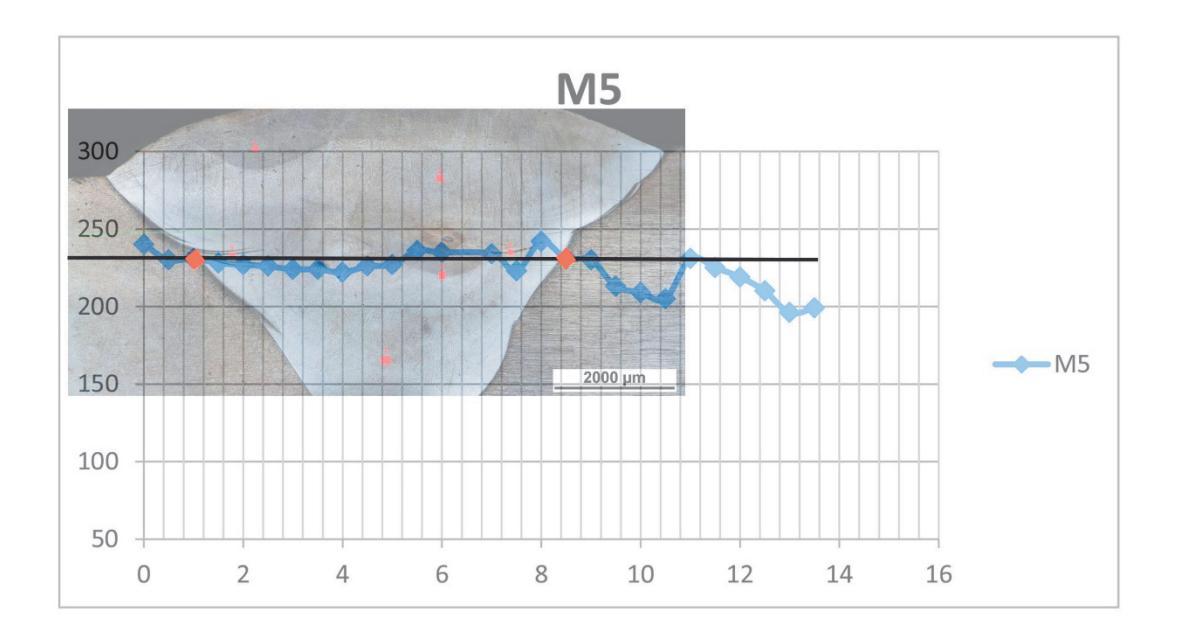
For metallographic sectioning was conducted perpendicular cut of the weld, then the sample was grinded on sandpapers grit of 320, 1200, 2000, polished (polishing canvases, diamond pastes of 9, 3 and 1 μ m) and followed by etching by Rollason (5g FeCl₂ + 50 ml HCl + 100 ml H₂O). Melting zone (laying weld bead) and heat affected zone were assessed. For observation and photo-documentation was used optical microscope (see Fig 4). The hardness gradient was measured according to EN288 (**Fig. 5**) [4].

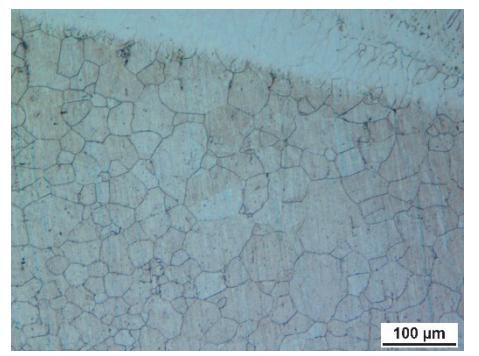
Fig. 6A crossing-weld matrix.

Fig. 6A represents transition of the weld zone into the tube matrix material. The area of recrystallized grains is followed by coarse of austenite grains (ČSN, No. 3), which gradually passes into the finer parts (ČSN - 4-5). Sometimes we can see on grain boundaries small Carbide formations.

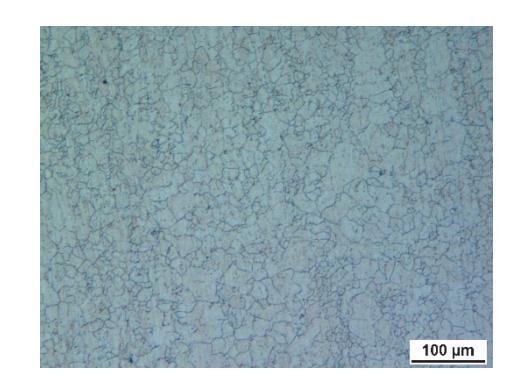
Fig. 6B matrix.

On the image (**Fig. 6B**) is captures the heterogeneous austenitic structure in the heat-affected zone tube with large differences in grain size - sometimes no. 3-4, or 5-6, which gradually turns into a of fine- heat unaffected grain zone grained area with grain size no. 7 to 8.
