INFLUENCE OF THE ZINC GALVANIZING ON FASTENERS CRACKING

SZŁAPA Ilona^{1,2}, JĘDRZEJCZYK Dariusz², SKOTNICKI Wojciech²

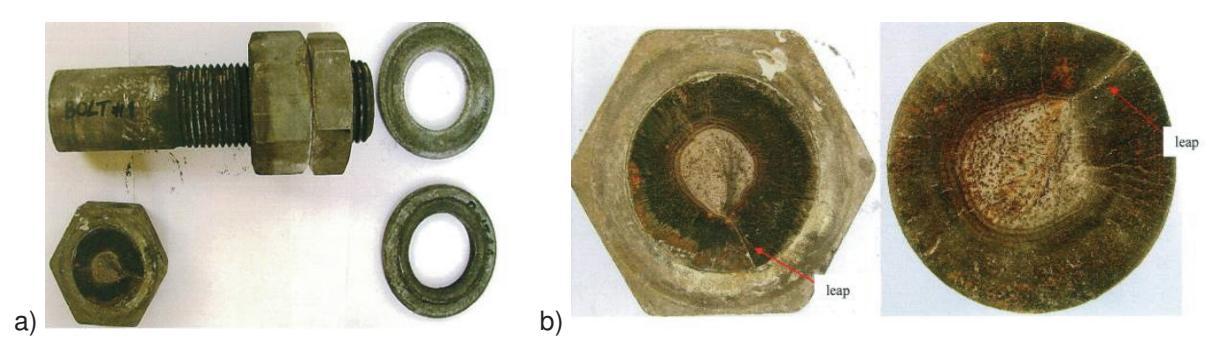
Figure 2 Appearance of damaged bolts M60 x 260 mounted in a shipyard in South Korea; a) whole damaged screws, b) head and spinal screws fracture enlargement

Cyclical internal stresses acting on the fastener of steel constructions can contribute to the occurrence of fatigue corrosion. [7]. Both fatigue and hydrogen corrosion are responsible for the sequence of construction disasters. Improper selection of joint elements and its fixing method can much hasten the creation of corrosion centres, and in consequence to cause reduction of the mechanical strength of the entire construction [8, 9, 10, 11]. The simultaneous influence of stresses and the corrosion in screw joint can accelerate the micro-cracks propagation in material. For example, in **Figure 2** a broken bolt M60x260 is presented as a result of such interaction.

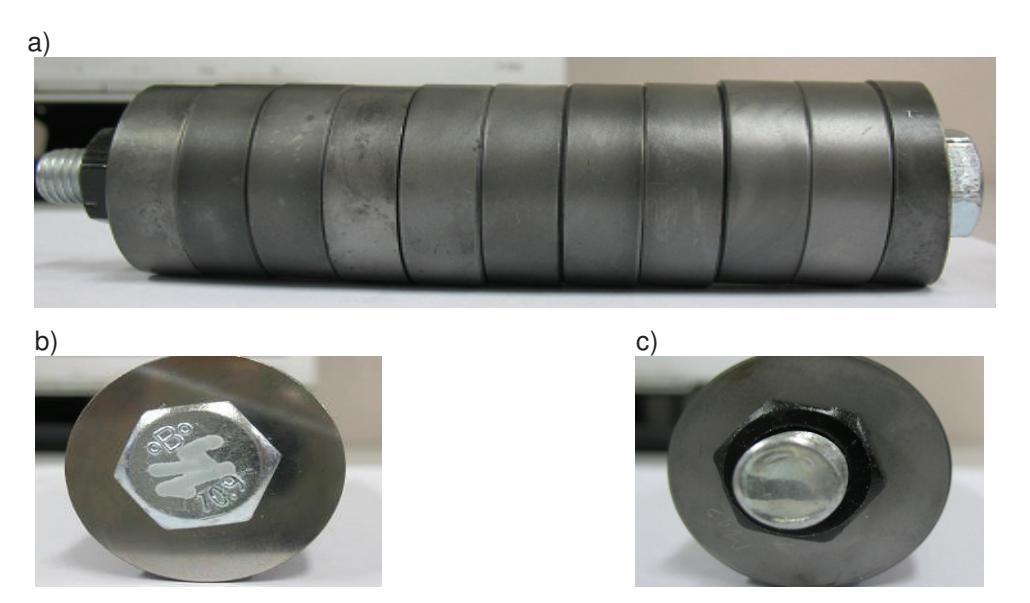
During examinations 15 screws from one lot were subjected to the verification, and none gave the negative result, i.e. after the secondary load adjustment, after 48 h there was no traces of cracking initiation. **Figure 3** presents the screws during the test.

Figure 3 General view of tested screw - a), view of screw assembling from the top and bottom - b), c), acc. to PN-EN ISO 15330 standard [own research]

The performed trial - the hydrogen embrittlement test acc. to PN-EN ISO 15330 standard didn't confirm it occurrence in the examined part of material. However, when mounting the last sleeve with the surface inclination angle of 6 degrees, 5 of the 15 tested screws have been broken near the head within 24 h.

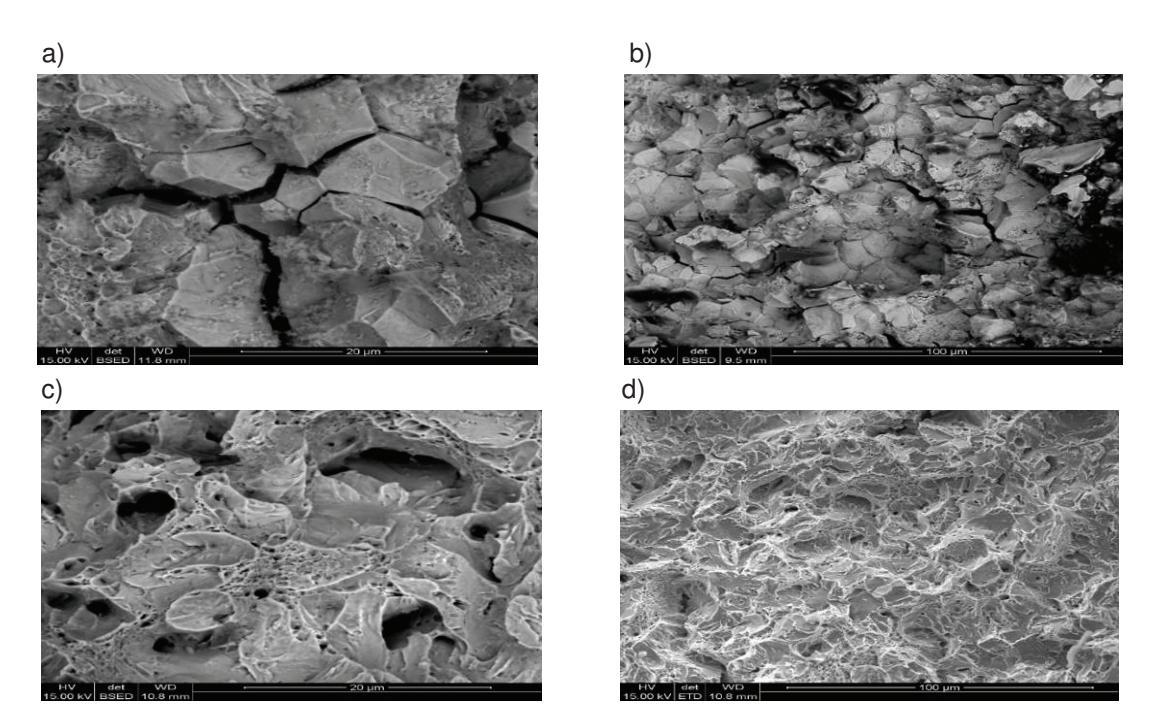
Figure 5 The fracture observed under scanning microscope - sample 1, a),b) - brittle fracture, c), d) - plastic fracture

Observation was conducted with application of the scanning microscope - on the fractures resulting from spontaneous breakage of samples. Results of observation are presented in **Figure 5**. An appearance of fractures observed under the scanning microscope - **Figure 5 a**), **b**), explicitly points out to brittle, inter-

crystalline cracking which can be caused by the increased hydrogen content. The area where the brittle fracture was observed along the grains boundaries is about 25% of the total surface, the remaining part seen in **Figure 5 c)**, **d)** is a plastic fracture.

- The initiation and propagation of created cracks could be caused also by too high hardness of inspected screws in the core (453 HV), in comparison to specification requirements that amounts to 385-435 HV for the core,
- Fracture examination with application of scanning microscope confirms existence of the structure characteristic for brittle, inter-crystalline cracking. Additionally, measured hydrogen content values (18-20 ppm) are much higher than typical and can cause the so-called hydrogen brittleness,
- Location of brittle fracture near the outside screws surface may be indicative of the hydrogen transport direction inside the material during the dehydrogenation process. Fracture differentiation indicates that the screws grade 12.9 made of 42CrMo4 zinc electroplated steel require heating dehydrogenation time longer than 4 hours.
