SAFETY OF RAIL TRANSPORT IN THE ASPECT OF THE PROCESS OF PLACING IN SERVICE RAILWAY VEHICLES

¹Andrzej CHUDZIKIEWICZ, ²Anna STELMACH, ³Wojciech WAWRZYŃSKI

Warsaw University of Technology, Warsaw, Poland, EU

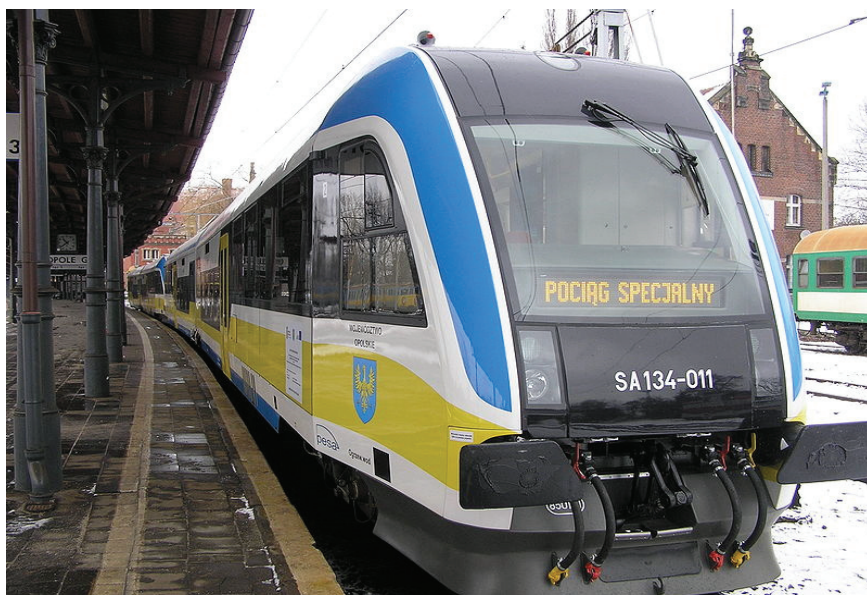
On 22nd December 2015, in the afternoon, along a route Opole Zachodnie - Nysa, in the town of Komprachcice, a passenger train, operated by a vehicle of SA134 type (**Figure 1**), after passing the railway crossing at km 6.171, where the speed limit was 20 km/h, accelerated to a speed of 25.5 km/h and derailed on the left curve of the track with the second axis of the middle bogie on the right side towards the direction of riding.

Figure 1 Passenger train [own study]
