## INFLUENCE OF RESIDUAL STRESS LEVEL ON FATIGUE LIFE OF ALUMINUM ALLOY SPECIMEN AND METHODS OF SPECIMEN PREPARATION

### Abstract

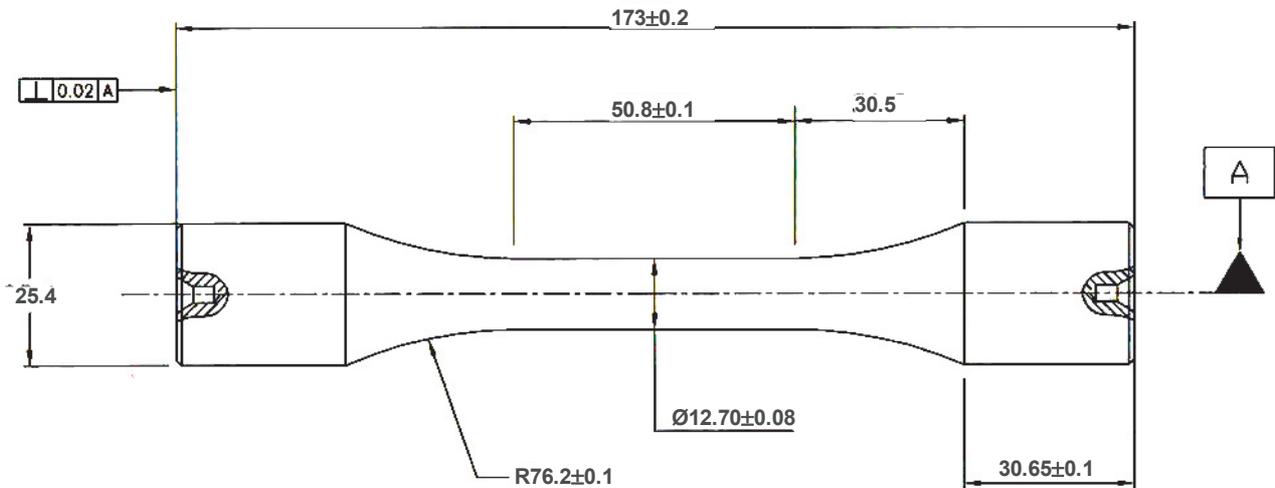
Four blanks are removed from each aerospace aluminum alloys plate. The plates are made from alloys 7050T 7451, 7475T 7351 and 7075T 7351. Thicknesses of these plates are between 38.1 to 240 mm. Machining and test is performed according to specifications BMS, MEP, AMS, etc. The test specimen is simple round sample of 12.7 mm diameter (**Fig. 1**).

Fig. 1 Test specimen [2]

The specification describes the machining process and requests some steps. The final machining pass must be less 0.38 mm and Ra less 0.9  $\mu\text{m}$ . The polishing must be longitudinal and min. 50  $\mu\text{m}$  must be removed. This layer must be removed in three steps by 400 and 600 grit paper and crocus cloth [2, 3].

The test must be performed according to ASTM E466. Purpose of the test is material's quality (casting and rolling issues - porosity, inclusions...). The test conditions are load control fatigue test, sin waveform, R ratio 0.1, frequency at 20 or 30 Hz, max. stress 241 MPa and run out 300 000 or 800 000 cycles [2], [3].

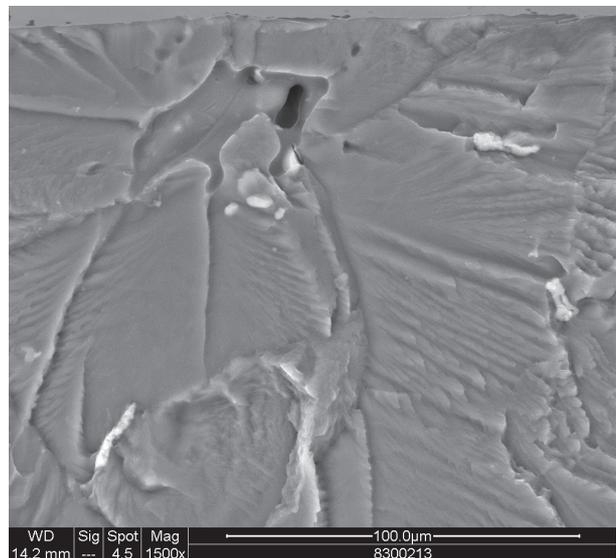
Although the machining process is described in specifications in a very detail way, the first results were approximately 10 % lower than those of expected. It was caused by the initiation from the specimen surface. The crack initiation should start from internal defects like porosity (material's quality check). It is expected, that the internal defect will be greater than approximately 50  $\mu\text{m}$  (Fig. 2).

Fig. 2 Internal defect

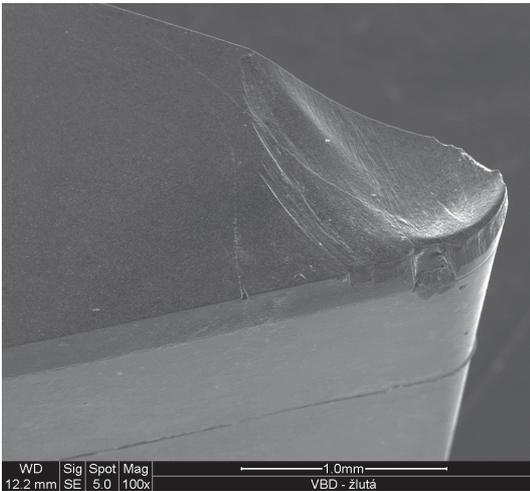
**Fig. 3** Modified diamond tool tip

At the beginning of the program it was incorrectly expected that the compression residual stress is caused by polishing; later on has emerged that it is caused especially by turning. Next steps were focused on the testing of different types of tool tips and their geometry. These tests still did not bring satisfactory results. It led to the first tests of our tool tip modification (**Fig. 3**). These tests of controlled modification were based on Exova Glendale Heights laboratory experience. The tool tips were modified on Inco 718 at first and later on steel bars as well. In 2011 we started cooperating with Hofmeister Ltd. Company, who is capable to machine diamond tool tips by laser technology with a very high repeatability.

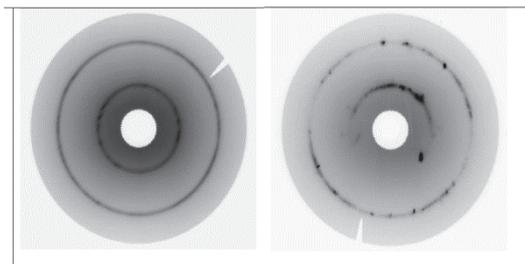
**Fig. 4** Diffraction patterns without and with rotation [6]

Because the reference material was not available in sufficient quantity, it was very difficult to perform the comparative fatigue test on a reasonable number of samples. That is why the cooperation with the Czech Technical University in Prague (ČVUT) was started. X-ray diffraction analysis was used for the evaluation of macroscopic residual stresses. The evaluation of diffraction patterns was difficult, because of the grain size and rolled structure of material (**Fig. 4**). ČVUT developed a method of residual stress measurement for our round aluminum samples and turn by the specimen during the measurement. At least one sample was machined by each modified tool tip and analysed by ČVUT subsequently.

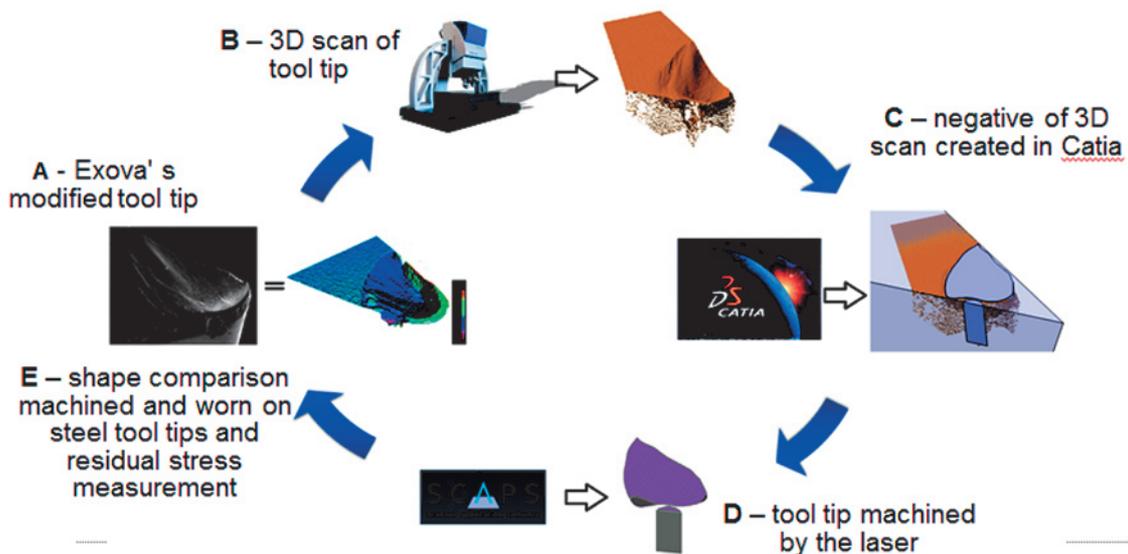
On **Fig. 5** is the description of the process from A to E. It means from worn tool tip to machined tool tip by laser. Both tool tips are always scanned and the shapes compared.

**Fig. 5** Process from the wearing of tool tip, up to laser made tool tip [4]

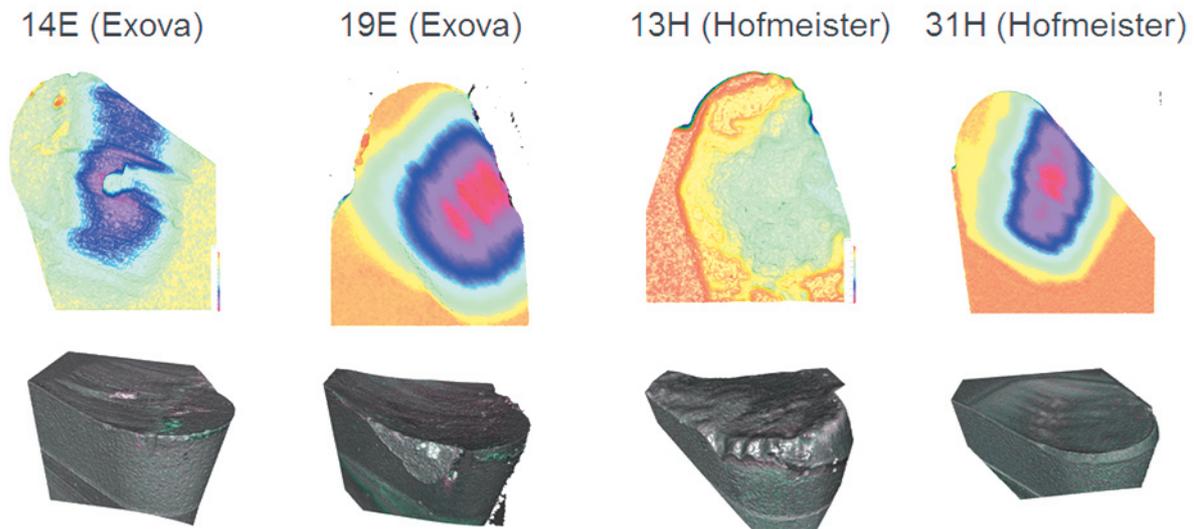
When we started the cooperation with the Hofmeister company, we started scan all tool tips after their modification. Exova modified (worn) appx. 50 tool tips. Specimens were turned by these tool tips and residual stresses were measured. Depends on results we chose some tool tips, which were scanned and the shapes were compared. Based on shape similarities, we defined the shape for modification by laser. After the laser modification shapes were compared, specimen machined and residual stress measured again. On **Fig. 6** are two scanned tool tips modified by Exova and two by Hofmeister. Tool tips 14E and 19E worn by Exova had smooth tool face. One of the first laser modified 13H tool face was very rough. During the time Hofmeister bought new laser with better resolution and optimal parameters for the modification. One of the latest laser modified 31H tool face is comparable with 19E tool face.

**Fig. 6** Scanned tool tips

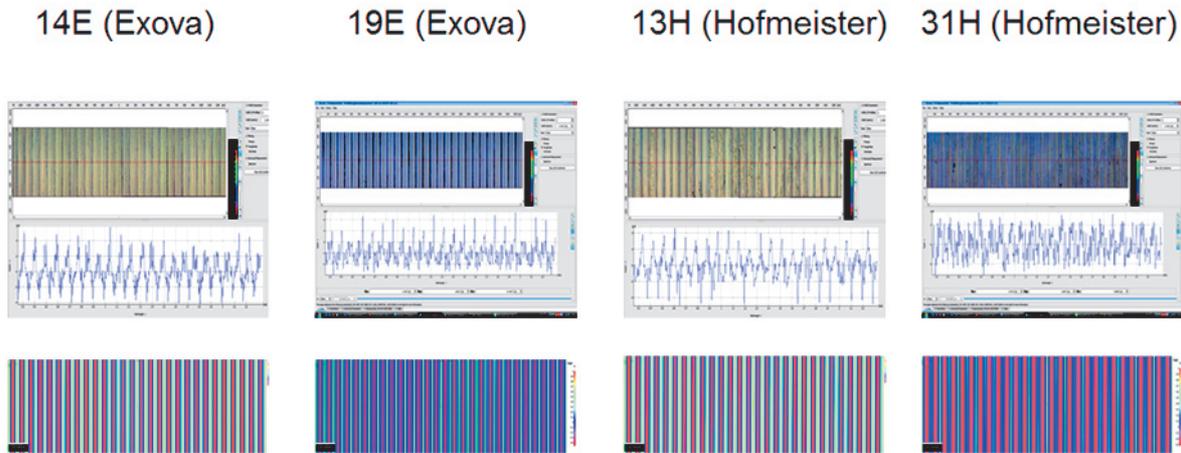
Because the residual measurement is expensive, we would like to find correlation between surface roughness and residual stress after turning. We decided to scan the surface on a turned area in a range 1x3 mm and measure area surface roughness. We received from each measurement appx. 20 values, which describe the area surface roughness. On **Fig. 7** are surface roughness areas for four modified tooltips described above. Based on available small number of results, it is not possible exactly describe the relationship between area surface roughness and residual stress right now.

Fig. 7 Area surface roughness

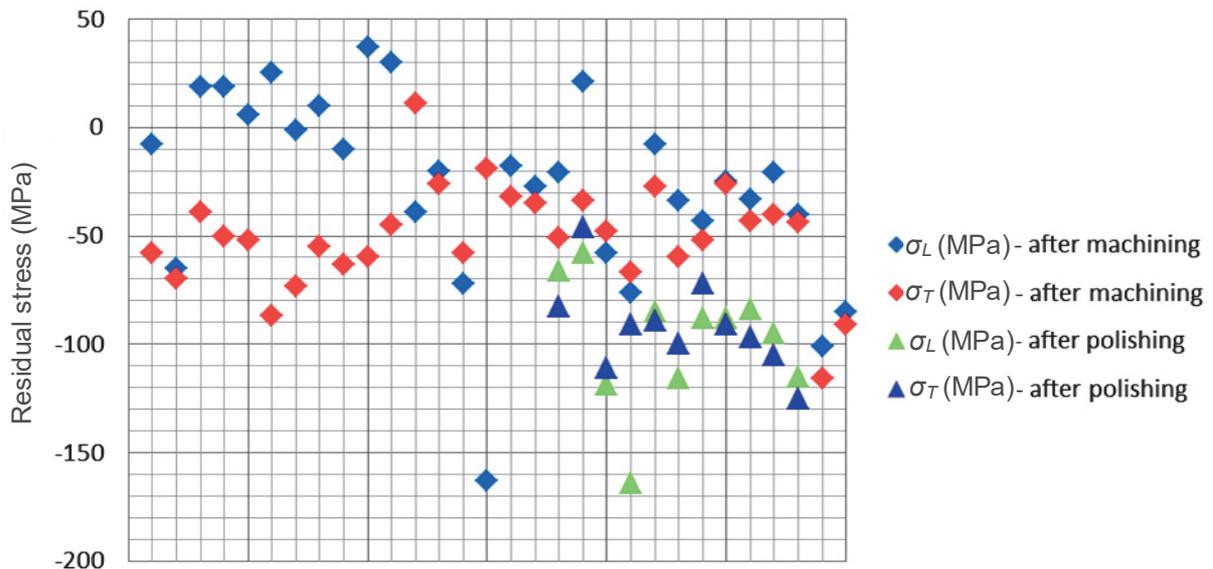
Hofmeister modified more than 30 tool tips. By each one one specimen was turned and residual stress was measured. Results are shown on **Fig. 8**. The first tool tips showed high scatter between  $\sigma_L$  and  $\sigma_T$ . During the time the process was improved and scatter was reduced. We also started polish turned specimen after the first residual stress measurement. The differences between turned and polished values indicate that the residual stress in a depth under the surface has different profile. It was removed appx. 50  $\mu\text{m}$  thick layer during the polishing. It always increased the residual stress compared to turned specimen.

Fig. 8 Process from the wearing of tool tip, up to laser made tool tip
