IMPLEMENTATION OF COATING FOR FAILURE ELIMINATION OF DIAL GAUGES

The target was to define the way of wear elimination of most faulty parts of dial gauges to obtain the maximum possible lifetime with minimal possible costs. Since, the using of more resistant material for producing of faulty part is difficult economically, for eliminating of wear, there was used the coating method for given part. By experimental results, it was choosen suitable way of coating.

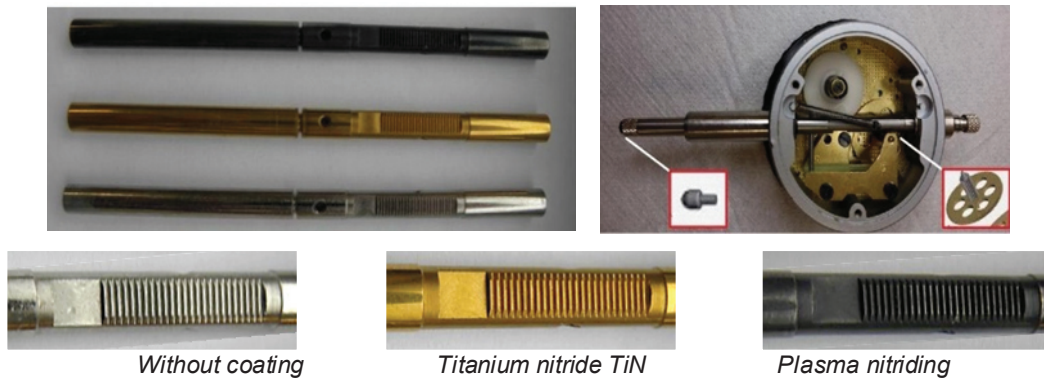
Fig. 3 Surface modifications of measuring rods

Gradually, measuring rods with different surface modifications are installed to the same dial indicator. As the measuring rod is in a direct contact with a toothed wheel and measurement is transferred through a measurement contact, even these parts are constantly changed.

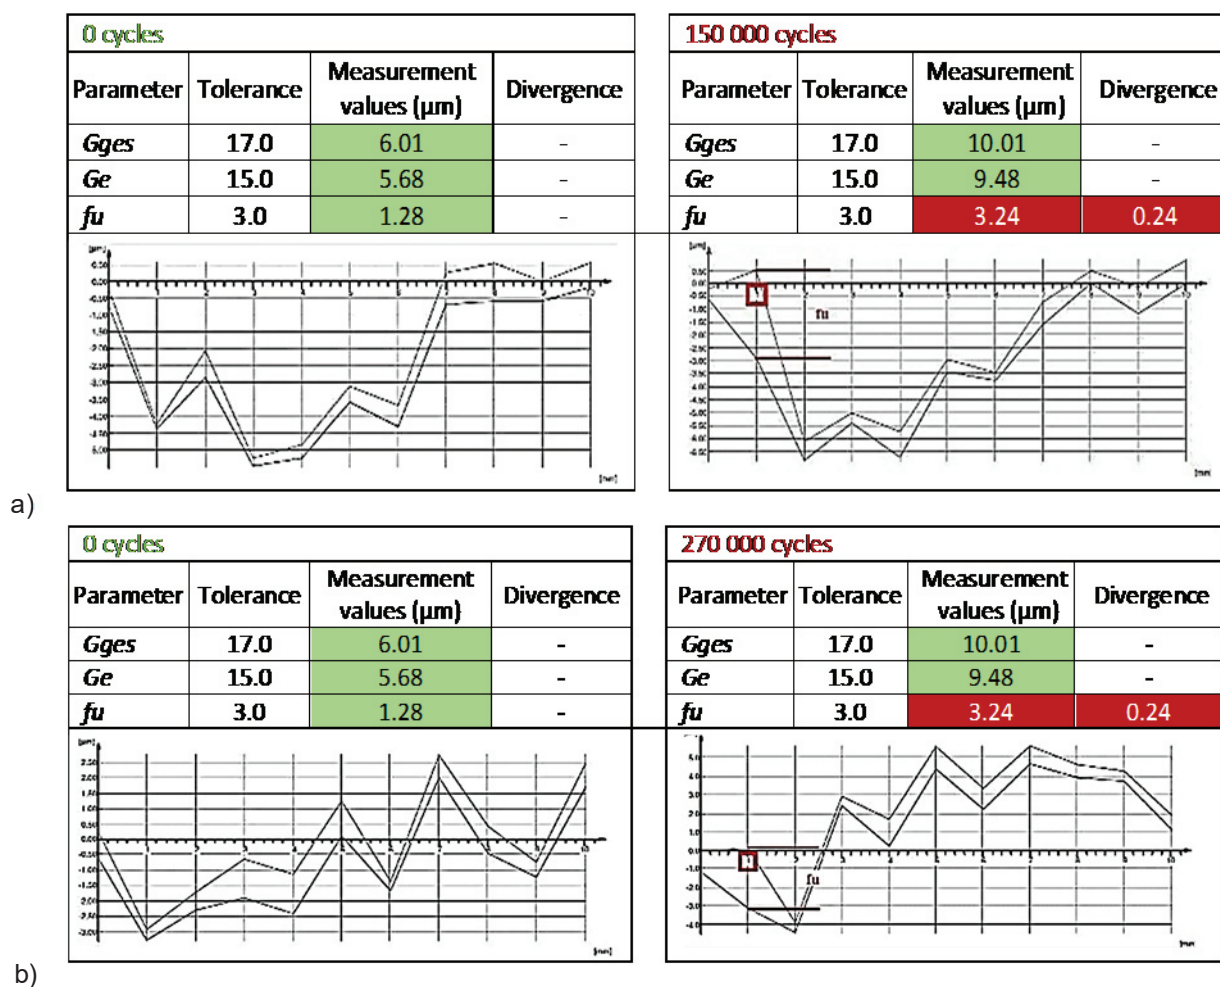
Graphs with measured values - before testing (0 cycles) and after testing, **Fig. 7.**

Fig. 7 A comparison of graphs of a dial indicator with a measuring rod: a - without any adjustment, b - for plasma nitriding, c - for surface modification TiN

From the stated measurements of the individual variants results the fact that the highest depreciation occurred after inserting the measuring rod in the distance of 1 mm in the scale of the indicator and the main reason of a disposal of eligibility was the exceeding of the maximum deviation of a parameter *f_u* - *reverse range* - the maximum deviation in a measured period of inserting and ejecting (μm).

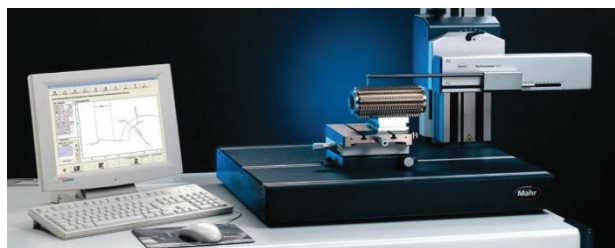
As the toothed measuring rod is in a direct contact with the toothed wheel, the both parts must be measured. The amount of loss of material caused by depreciation on the most corrupted part of the toothing is compared. The *MarSurfXC 20 Contour Measuring system* is used to measure and evaluate the level of depreciation of the toothing, **Fig. 8.**

Fig. 8 The *MarSurfXC 20 Contour Measuring system* [12]
