REMAINING LIFETIME ASSESSMENT OF THE BOILER TUBE

Keywords: Creep tests, degradation, boiler tube

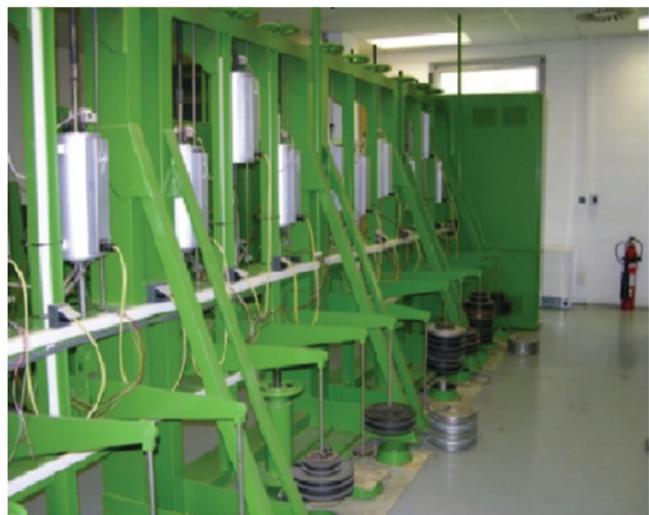
Figure 1 Creep stands

temperatures: ČSN EN 10 291- 6/2001, DIN 50 118 and ASTM E 139. The tests are performed on special testing devices that are called „stands“ (Figure 1).

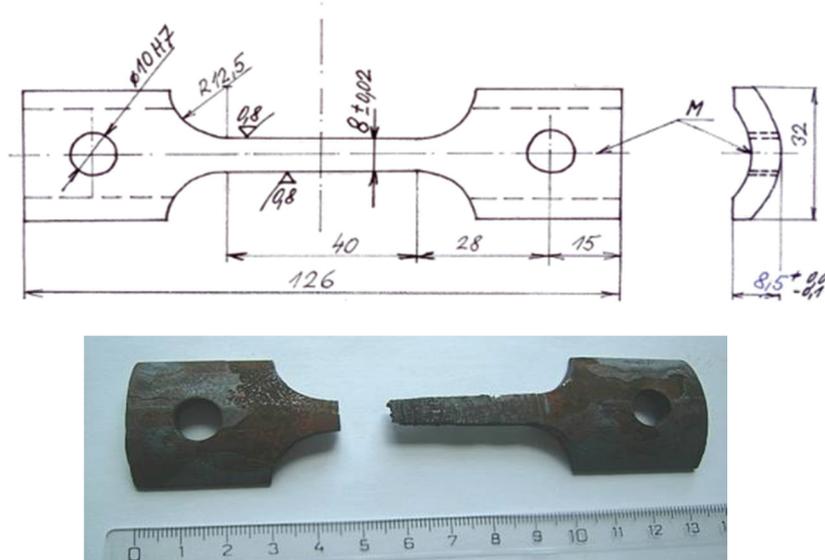
Figure 2 Sample for creep testing

The samples were made from boiler tubes (steel SA 216-T22) with standard dimensions (Figure 2). Evaluation of creep test results - especially stress rupture strength R_mT and creep strength RT - are based on a large number of tests. It can be determined for the following periods of time: 103 h, 5 x 103 h or 105 h (it means that the time duration of a test is more than 10 years). While verifying properties of a new kind of steel up to 30 testing poles need to be evaluated. Total time duration of those tests is approximately (1-3) x 105 h, however, time duration of some testing poles must be more than 104 h.

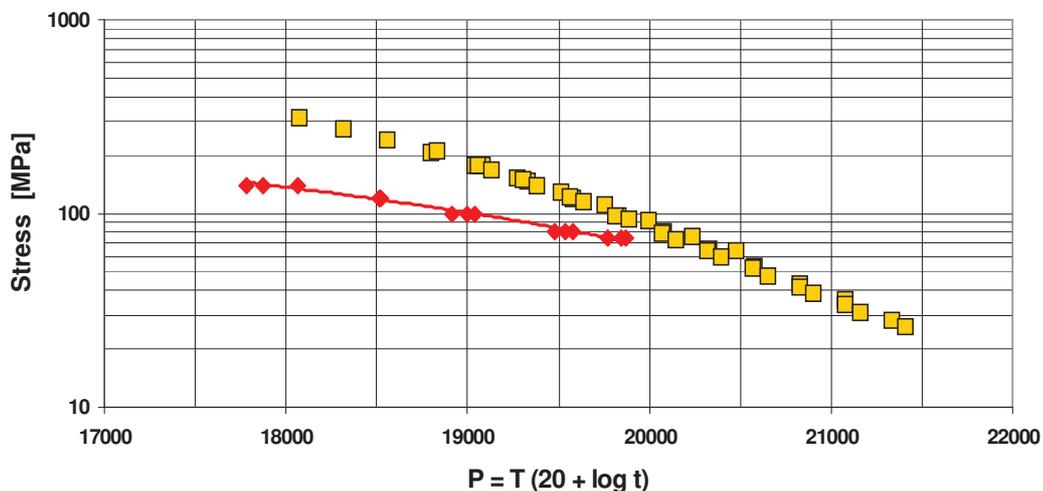
Figure 3 Results of creep tests, steel SA 213 - T22

It means that effect of temperature T1 during test time t1 is equivalent to the effect of temperature T2 during test time t2. Process at a temperature T1 and a very long time t1 can be substituted by a process much shorter but at a higher temperature [1]. Another possibility is a combination of increase or decrease of stress at the same temperature. **Table 1** and **Figure 3** summarize results of creep tests that were performed on the material SA 213-T22 [2] with parameters from eqs. (2), (3).

Superheater: $P_{LM} = 19990$

$$P_{LM} = T \cdot (20 + \log \tau_{rboiler}) \quad (2)$$

Residual lifetime of the boiler steam piping for temperature 539°C is:

$$\tau_{rboiler} = 10^{\left(\frac{P}{T} - 20\right)} = 10^{\left(\frac{19990}{539 + 273,15} - 20\right)} \cong 41085 [h] \quad (3)$$

The results of the creep tests of the material tested presented in this paper indicate that the residual lifetime is approximately 5 years which is in an agreement with the microstructure status classified according to two microstructure degradation standard scales. This problem deserves a comprehensive approach because of a major economic benefits can be expected due to the possibility of non-destructive replica testing [4, 5, 6].

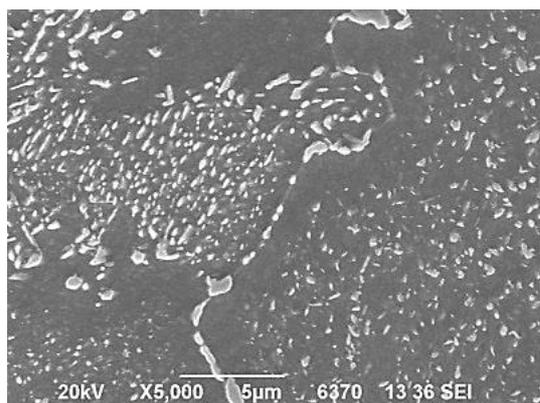
Figure 4 Microstructure before creep tests

The microstructure of the samples before the creep testing consisted of ferrite-pearlite with uniformly distributed carbides which were spheroidized (**Figure 4**). The structural elements were aligned in bands as a result of cold working (**Figure 5**, **Figure 6**) and there were also noticeable thin decarburized layers (circa 30 μm) in areas which were close to the inner and outer surfaces of the pipes (**Figure 7**). Classification of the microstructure before the creep testing is **3** (1-5) and **IV** (I-VI) according to the scales in [7].

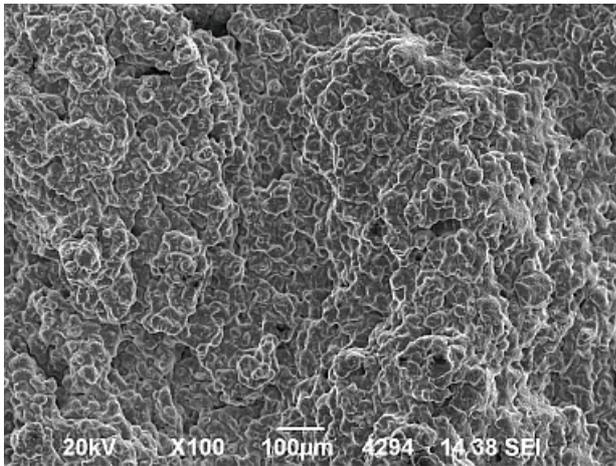
Figure 8 Fracture area after creep test

especially close to the intergranular fracture (**Figures 9, 10, 11**); these cavities coagulate and form macro-cavities. The carbide particles are much coarser and are precipitated on the grain boundaries. The fracture area was analyzed by electron microscope but because of the heavy oxidation of the crack surfaces it was impossible to get any qualitative characteristics (**Figure 8**). Classification of the microstructure before the creep testing is **5** (1-5) and **VI** (I-VI) according to the scales in [7]. The material is at the end of its lifetime.

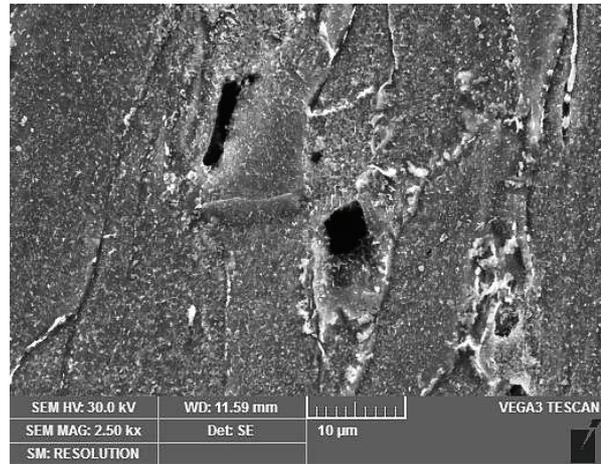
Figure 9 Cavities after creep test

The microstructure was observed also after the creep tests. The creep tests were carried out at the temperature of 580 $^{\circ}\text{C}$ and the strains from 75 MPa to 140 MPa. It is possible to observe a large number of cavities
