MODELING CONDITIONS SUITABLE FOR INITIATION OF STRESS CORROSION CRACKING IN THE HEAT AFFECTED ZONE OF THE CROSS WELD OF AUSTENITIC STEEL PIPES

Abstract

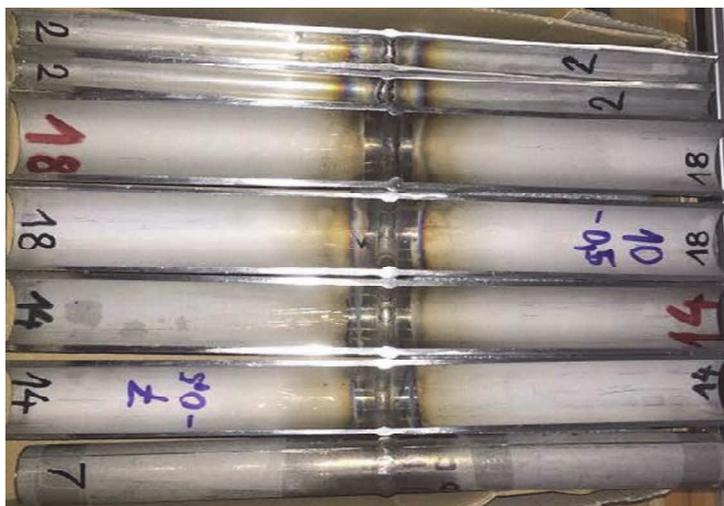
For the analysis were used tubular bodies of steels EN 1.4541 and EN 1.4571 with transverse weld. Longitudinal cuts of pipes are shown in **Figure 1**. Specimen numbers 2, 7, 14 and 18 identified the individual tubular bodies. **Table 1** shows the basic dimensions of the tubes and the dimensions of artificially created defects. Artificial defects were created by electrical discharge machining.

Figure 1 Tubular bodies after longitudinal cutting
