THE PROPERTIES OF WEATHERING STEEL IN CONTEMPORARY ATMOSPHERIC ENVIRONMENTS

Abstract

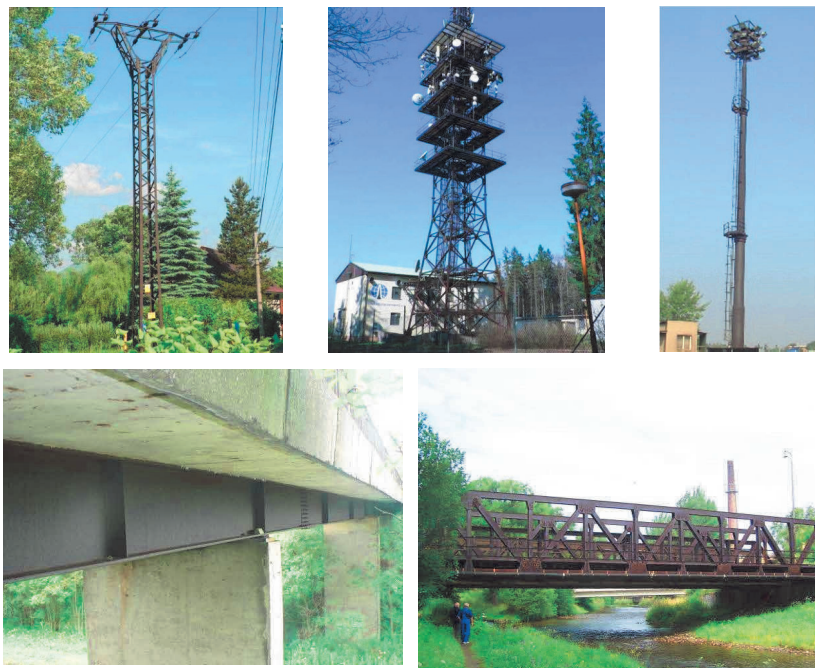
Figure 1 Examples of steel structures built in 1970ties from weathering steel

The first studies of corrosion losses of weathering steel performed in the Czech Republic had been performed in 70 and 80 ties of last century mainly as standardized atmospheric tests on atmospheric test sites and in specific microclimates too. In that time the first steel structures had been built using this type of steel (electric distribution poles, lighting mast, bridges, building cladding, etc. - **Figure 1**) and their corrosion behaviour was followed for 10 years [2 - 10]. After year 1980 about 20 weathering steel bridges were built - their periodical evaluation of the corrosion effects had been performed and causes of defects were defined. In 1990ties the effect of design and local specific pollution had been identified as the main reason for damage of protective patina forming and higher localised corrosion attack of structures [11 - 14].

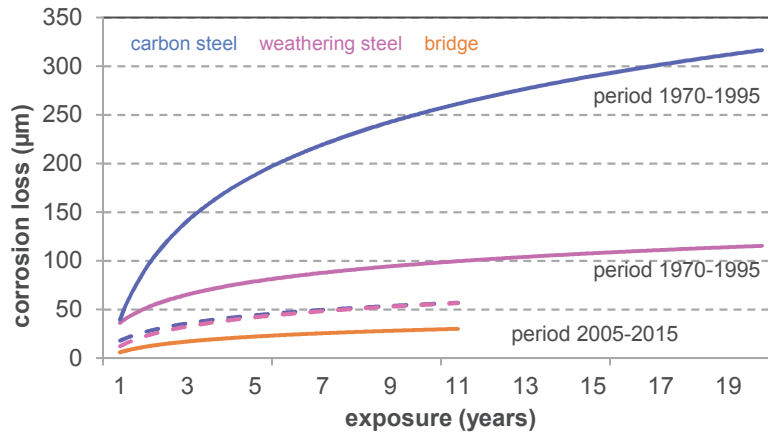
Atmospheric corrosivity of the atmospheres in Europe as same as in other industrial developed countries in the past was very high due to high level of acidic pollution, mainly SO₂. In **Figure 2** there is a long-term corrosion behaviour of weathering steel according to the field test performed in period 1970-1995 in the Czech Republic. Long-term exposure realized at 80ties showed the trend of decreasing of corrosion rate to steady state rate after ca 5 years of exposure. Since 1995 and later since 2005 the significant decreasing of SO₂ in air led to decrease of corrosion rate of weathering steel and increase time needs to develop protect patina. In **Figure 2** the comparison of corrosion loss of weathering steel at industrial environments of the Czech Republic is shown in different corrosivity, resp. SO₂ pollution level. There are data from standard flat samples exposed according to EN ISO 9223 at atmospheric test sites. The difference between corrosion rate of mild carbon steel and weathering steel is evident after 15 - 20 year and in environments with SO₂ higher than 10 - 15 µm³.

Figure 2 Corrosion of weathering steel in industrial environment of the Czech Republic

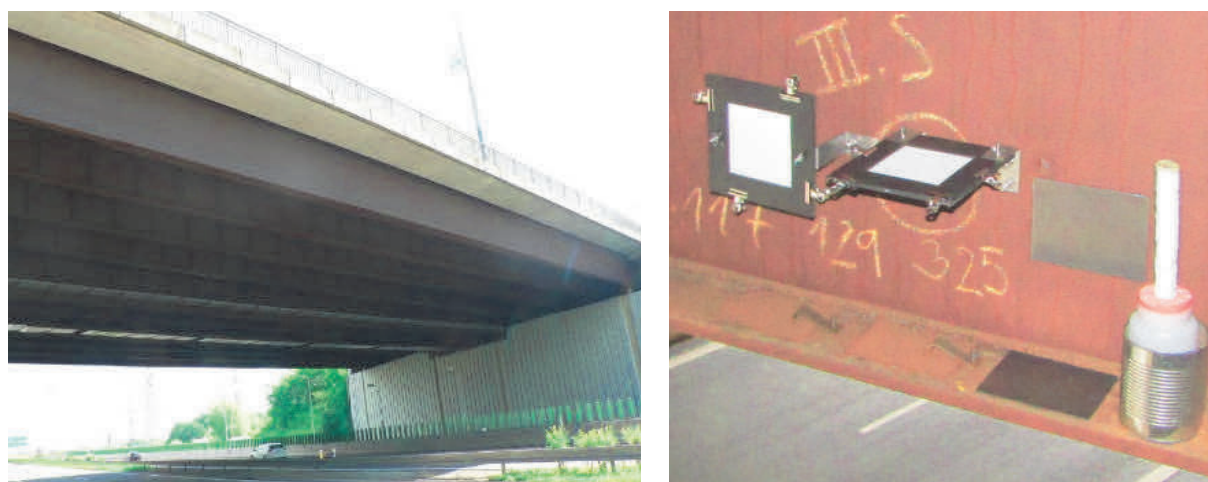
Since 2013, the program of corrosion specimens installed on 10 weathering steel structures on 97 specific surfaces in the Czech Republic started (**Figure 5**) [27]. The corrosion specimens were installed on the bridge structures in such a way to simulate realistic behaviour of the investigated structural element surface (**Figure 5**). There were choosing typical location, e.g. outside wall of main beam, upper surface of bottom flange and bottom surface of top flange. For structures or parts of structures where the use of de-icing salt is likely to lead to substantial deposits of chloride on steel - on such bridge structures the chloride deposition is measured by wet candle and dry cloth methods according to EN ISO 9225.

Figure 5 Views of a tested bridge structure

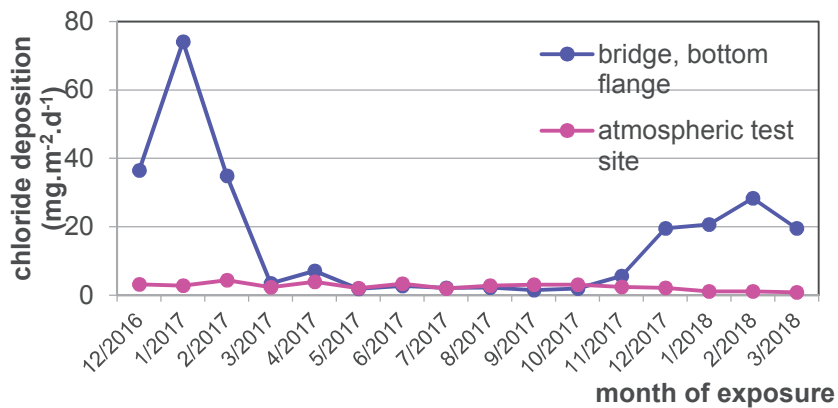
The chloride deposition on these surfaces is higher only in winter months but during other seasons of the year is practically the same as at atmospheric test sites not affected by traffic - **Figure 7**. The yearly average value on the bridge bottom flange surface (steel structure with the traffic under the bridge) is only 13.1 mg / (m²d).

Figure 7 Chloride deposition measured by the wet candle method
