## THE EFFECT OF ANOTHER PROCESSING ON ADHESION OF HDG

The steel structure segments with HDG coatings are subject of another processing before steel structure assembly and usage. The parameters of these processing's may affect the adhesion of zinc layer - mainly the cutting edges and surface preparation as sweeping. The paper presents some results of practical study of these parameters.

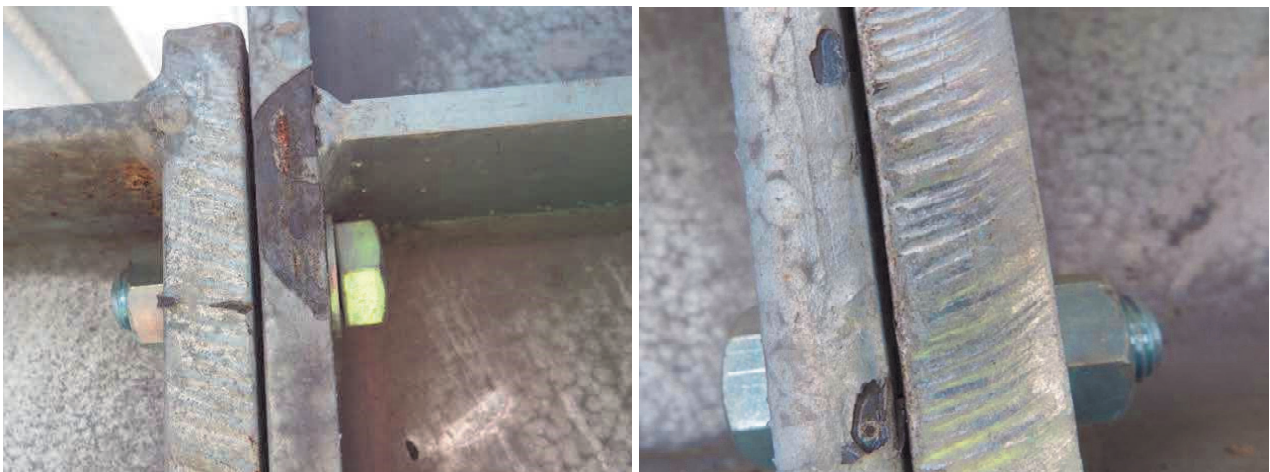
With reducing width of beam the HAZ width increases but with increasing rate the HAZ width is reduced. E.g. during plasma cutting the material is heated in HAZ to the temperature of phase transformation in Fe-C diagram - ferrite-perlite structure changes onto martensitic structure with different hardness till 0.5 - 0.8 mm depth from surface [2]. The zinc coating formed on these surfaces has non typical properties (thickness, structure) and so standard EN ISO 14713-2 recommended removing this layer. In HAZ the  $\gamma$  phase of zinc coating does not create to obtain basic adhesion of zinc coating to steel. The hardness of steel in HAZ on cut edges is higher than 400 HV10 (steel with carbon equivalent CE  $\geq 0.4$  %) which means it does not fulfil requirement from EN 1090-2 *Execution of steel structures and aluminium structures - Part 2: Technical requirements for steel structures* specifying maximum allowed hardness 380 HV10. Defects of zinc coating on cut edges is shown on **Figure 2** illustrating that two edges treated by different technology have other adhesion.

**Figure 2** The example of zinc coating on cut edges

The adhesion of zinc coating was tested by impact test (ASTM A123 *Standard Specification for Zinc (Hot-Dip Galvanized) Coatings on Iron and Steel Products* (removed in 1989 edition) and DIN 50978 *Prüfung metallischer Überzüge; Haftvermögen von durch Feuerverzinken hergestellten Überzügen (Testing of metallic coatings; adherence of hot-dip zinc coatings)* [4]. The appearance of samples after test is on **Figure 5**. The effect of grinding was in the most cases negative - the adhesion of zinc coating was poor. The higher effect then hardness of HAZ of surface has the profile of cut edges. The cut edge without grinding had “anchoring” profile for zinc coating adhesion - see **Figure 2**.

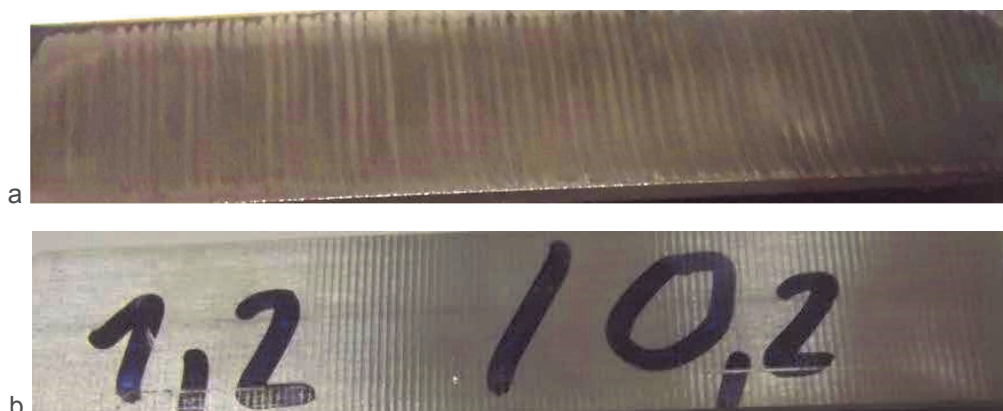
The hardness of cut edges was measured by Time Hardness Tester TH 130 and by Microhardness Tester FM-700, Future-Tech Corp., according to standard EN ISO 6507-1 *Metallic materials - Vickers hardness test - Part 1: Test method* on all 4 edges - **Figures 3** and **4**. The samples had been galvanised in the same conditions and zinc coating properties had been evaluated - appearance, thickness and adhesion.

**Figure 3** The example of cut edges - laser cut (a) and grinded (b)

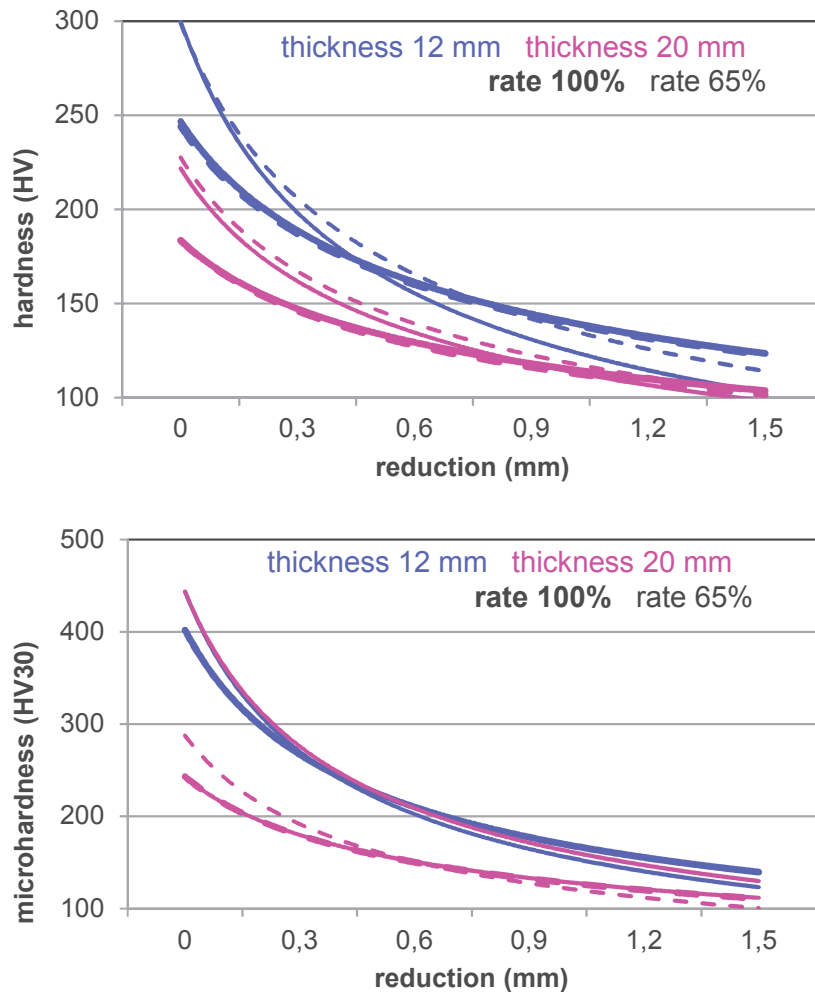
The results show that the lower rate of laser cut more effect the cut edge but neither on these cut edges the hardness did not exceed the maximum allowed hardness for galvanising - 380 HV (**Figure 4a**). The higher effect was found for thin samples when temperature is higher. Just after the first reduction of 0.3 mm the hardness value had been decreased for 50 % and was measured in range 120 to 180 HV.

The microhardness values are significantly higher, but all other trends are same as for hardness measurement. In case of thin samples the microhardness was higher than maximum allowed value - it was ca 440 HV (**Figure 4b**).

**Figure 4** The decreasing of hardness and microhardness of cut edges after grinding reduction
