HIGH-TEMPERATURE TRIBOLOGICAL PROTECTION OF LASER CLADDING MATERIALS FOR POWER GENERATION COMPONENTS

Petra ČEJKOVÁ, Antonín KŘÍŽ, Karel BROM, Petr STEIDL

University of West Bohemia, Pilsen, Czech Republic, EU LaserTherm spol. s r.o., Vejprnice, Czech Republic, EU

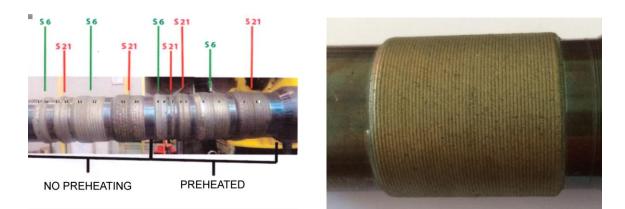
Figure 1 Left: photograph of a shaft with laser claddings S6 and S21 (Stellite 6 and Stellite 21), right: specimen 18 of Stellite 21, detail, narrow bead of 1 mm deposited without pre-heating

The company Lasertherm produced 18 different claddings [3], as shown in **Figure 1**. The differences between them included the cladding material, the use of pre-heating and the bead width. Four specimens were selected for analysis: 2S21P2S, 11S21P2S, 13 S6 B2S and 18 S6 B2U, as listed in **Table 3**.

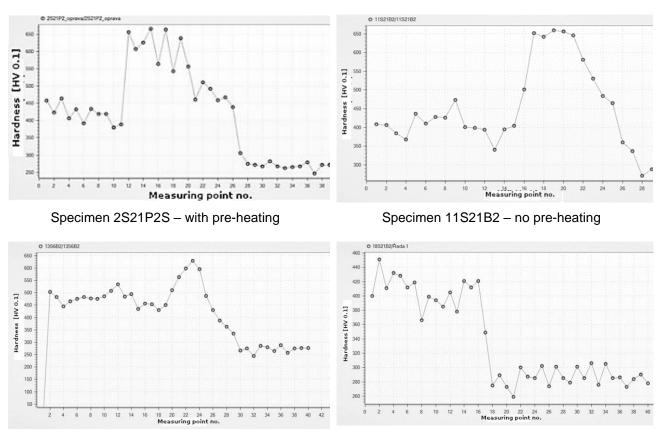
Figure 2 Hardness profiles HV0.1 in specimens 2S21P2S, 11S21P2S, 13 S6 B2S and 18 S21 B2U

On all the selected samples, microhardness number HV0.1 was measured. **Figure 2** shows depth profiles of hardness from the cladding surface toward the base material. In Stellite 6, microhardness is slightly higher than in Stellite 21. The presence of tungsten carbides contributes to it. The plots show that the HAZ is a transition region for hardness which changes from the value 400 HV0.1 in the cladding to 600 HV0,1 in the HAZ. The specimens in **Figure 2** identified as 2S21P2S – with pre-heating, 11S21B2 – no pre-heating and 13 S6 B2S – no pre-heating exhibit very similar hardness profiles. Specimen 18 S6 B2U – no pre-heating, has a step change between the HAZ and the base material. [4]

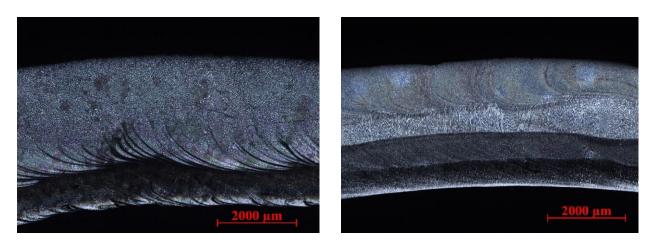
Figure 3 Macropicture of laser cladding, etched, magnification 20×, left: Stellite 6, right: Stellite 21.

Macrostructure in **Figure 3** show two-layer claddings. Stellite 6 is on the left, Stellite 21 on the right. Etching has revealed the different microstructures in them. No cracks or lack of penetration can be seen in the micrographs. They show the structure of the bead produced by the Marangoni convection in the melt pool.

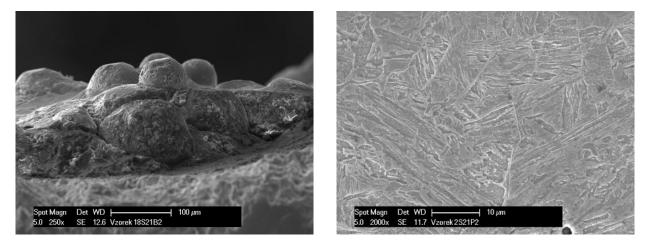
Figure 4 Specimen 2S21P2 – chemical composition of V2P11 at 46 micrometres below the cladding in the base material – melting at grain boundaries is visible.

Two specimens were selected for scanning electron microscopic observation: 2S21P2 and 18S21B2 in order to identify differences between the claddings and dilution patterns produced with and without pre-heating. Both specimens were laser clad with two layers of Stellite 21. Specimen 2S21P2 was prepared with the use of pre-heating at 450 °C. **Figure 4**, left, is a microstructure of the cladding surface on specimen 2S21P2. There is an oxide layer which was also confirmed by chemical analysis. Globular particles of incompletely melted powder can be seen. The surface of the cladding is to be removed by grinding. These oxides will therefore be removed before the shaft is put into operation. **Figure 4**, right, is a detail of specimen 18S21B2. It shows a region where grain boundaries became melted in the base material. This fusion region can be traced to a depth of 80 micrometres below the surface of the base material. After pre-heating and cladding, the depth of fusion was 96 micrometres. Without pre-heating, the depth was 80 micrometres.
