## BREAKAGES OF SØDERBERG ELECTRODES DURING SUBMERGED ARC FURNACES START-UP

This article presents a technological issue related to the operation of self-baking electrodes in six-electrodes submerged arc furnaces during the process of smelting high-grade silicon alloys with iron and other elements by carbothermal reduction, carried out in Re Alloys ferroalloys plant. Particular attention is paid to technological problems related to the use of Søderberg electrodes during start-ups of electric furnaces after shutdowns. The impact of furnace shutdowns and starts-ups on thermal conditions disturbance of electrode sintering process, formation of microcracks, and thus deterioration of mechanical strength of the electrode leading to increased risk of breaking, is presented. Actual examples of electrode breaking during SAF start-up, causes of breaking, and possible ways to avoid them are described in the article.

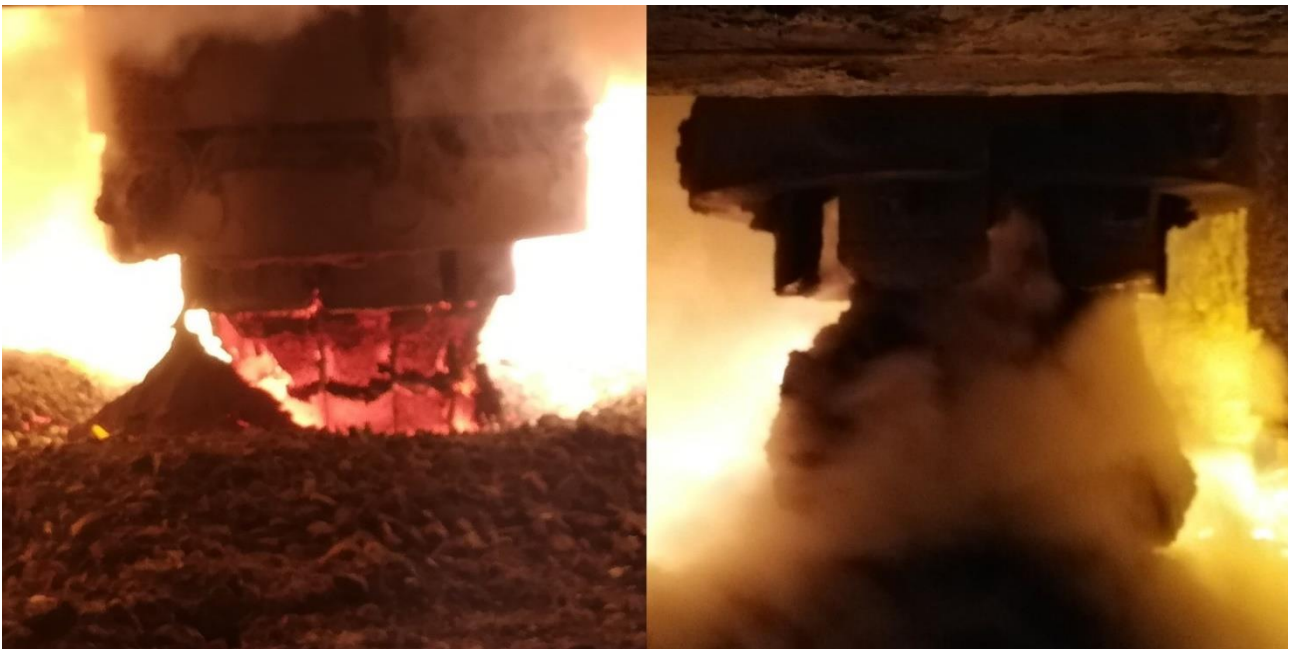
When certain right methods were developed operating self-baking electrodes does not cause problems. However, in some cases, e.g. start-up of the SAF, failures do occur. The worst consequences of such failures are breakages of the Søderberg electrode. There are two types of breakages: soft and hard. The main reason for soft breakages during SAF start-up is an anomalous electrode slipping when the current does not recover and critical 500 °C isotherm goes under the lower edge of contact clamps [3]. Unbaked liquid electrode mass goes out of steel casing, what in **Figure 1** is presented.

**Figure 1** Stages of self-baking electrode soft-breakage

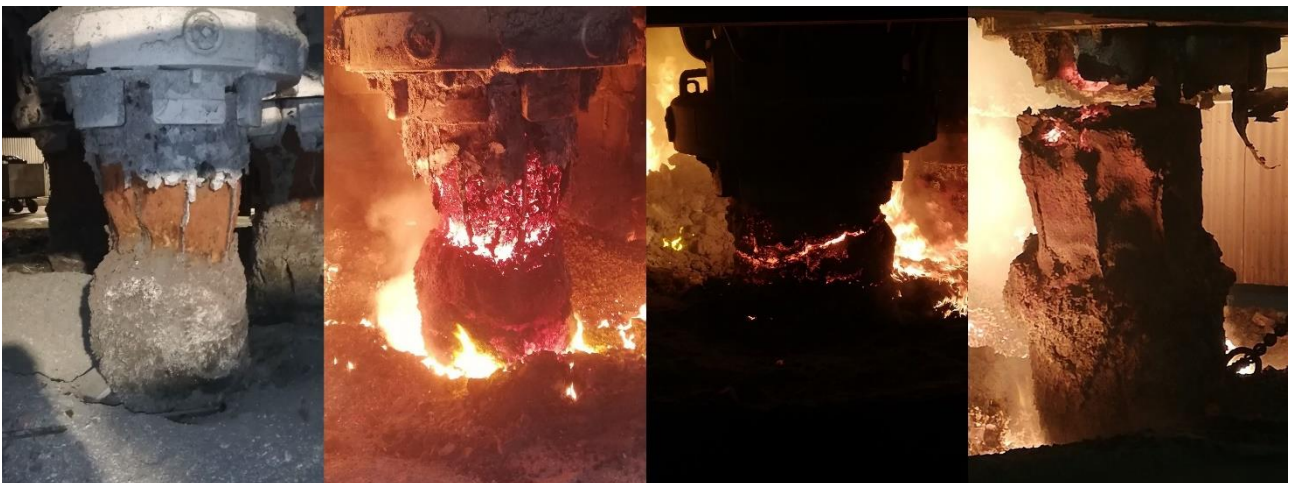
Hard breakages are provoked by thermal stresses in the electrodes caused by dynamic temperature changes during the shutdown and start-up of SAF [4]. In **Figure 2** the way leads to hard breakage during SAF start-up is presented.

**Figure 2** Stages of self-baking electrode hard-breakage

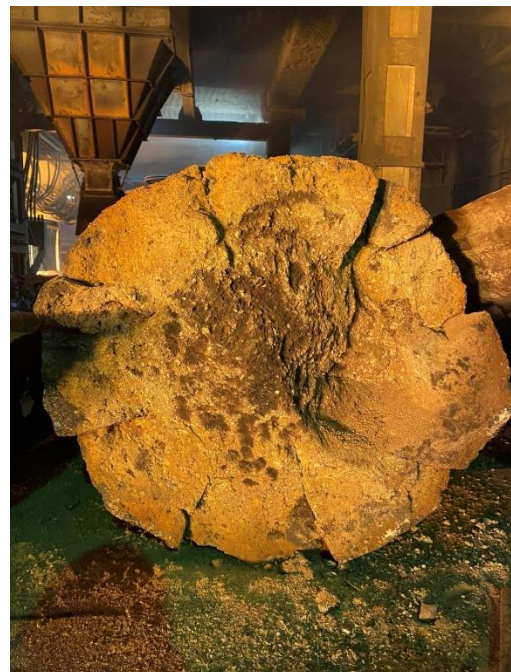
**Figure 4** Fracture of self-baking electrode hard-breakage

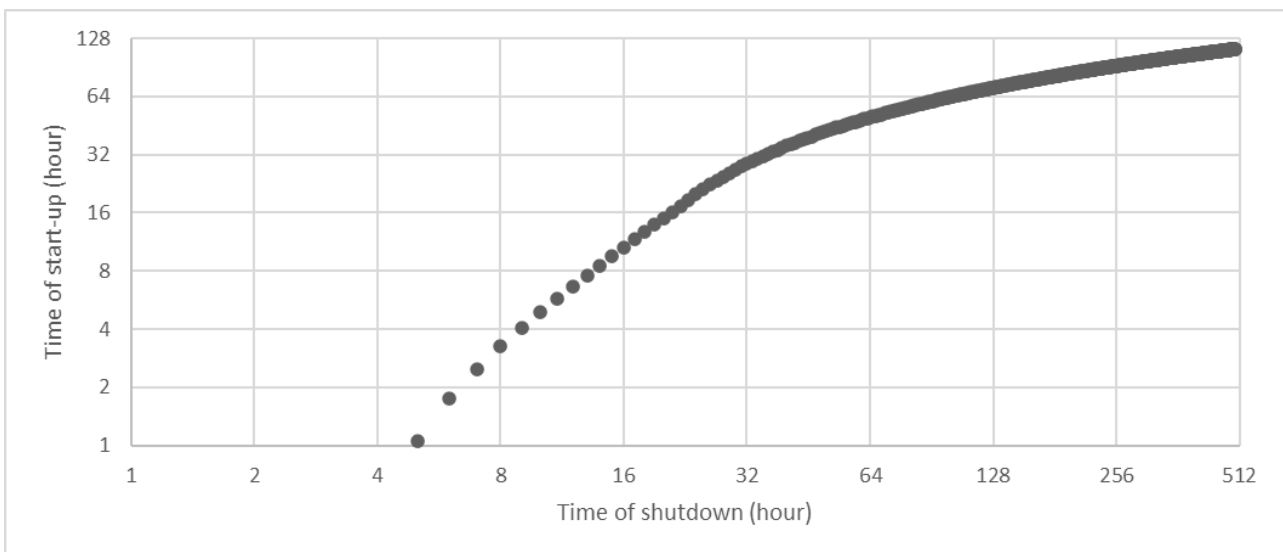
In the period from 2014 to 2022 at ferroalloys plant Re Alloys LTD 136 numbers of electrodes breakage occurred. 75 of them happened during SAF start-ups, therefore a decrease in breakage is one of the main problems to be solved by R&D staff as part of the program of technological progress in ferroalloys [5]. As a supplement to the applicable guidelines for the operation of self-bonding electrodes, which consist in determining and observing the conditions of softening and melting of the electrode mass, the permissible current load of the electrode, and the electrode wear, the relationship between the duration of the furnace start-up and the standstill time was determined on the basis of previous experience. The implementation of new guidelines for the preparation for the shutdown and the next start-up of the furnaces made it possible to avoid breakage of the self-baking electrodes after a three-month standstill in 2023 and a lot of short and medium shot-downs during the first half of 2023. Based on experience, calculations, and estimations technologists working in R&D have divided the time of shut-downs into three groups: short (up to 4 hours), medium (from 6 to 12 hours), and long (over 12 hours). Depending on the duration of the shutdown, the parameters of reducing the current load before the planned shutdown, the initial current load after switching on the furnace, and the duration of the start-up are determined. After a short shot-down, the electric furnace can be turned on at the rated electric current without having to plan a start-up. Before a medium stop, a reduction of the current to 80% of the nominal value 2 hours earlier is suggested. The furnace should be started at 50% of the nominal amperage. At least four hours before a long stop, a gradual reduction of the current to 60% of the nominal value is advised. After that, starting the furnace should be with 20% of the nominal current. The duration of the start-up depends on the duration of the shot-down and is determined in accordance with the developed by R&D department diagram presented in **Figure 5**.

**Figure 5** The relationship between the start-up duration and the shutdown duration

The results from this research show the reasons of soft and hard breakages of self-baking electrodes during SAF start-ups and implemented solutions to avoid them. Breakages mostly were caused by disobeying procedures of properly preparing electrodes for the SAF shut-down, overload electrodes during the SAF start-up, incompatible between current and slipping, and too short start-up causing too fast increase of current density in the cross-section of the electrode. Most of these reasons could be minimized by improving the technical equipment of electrodes, systematically providing training for SAF operators, and continuously
