FAILURE ASSESSMENT IN A H10 HOT DIE FORGING TOOL RELATED TO THERMAL FATIGUE

AMONDARAIN Zuriñe[1], MENDIA Leire[1], PEREZ Iñaki[1], LACHMANN Stefan[2]

[1]TECNALIA Research and Innovation, Industry and Transport Division, Derio (Bizkaia), Spain, EU,
zurine.amondarain@tecnalia.com
[2]Schmiedewerke Gröditz GmbH, Gröditz, Germany, EU,
stefan.lachmann@stahl-groeditz.de

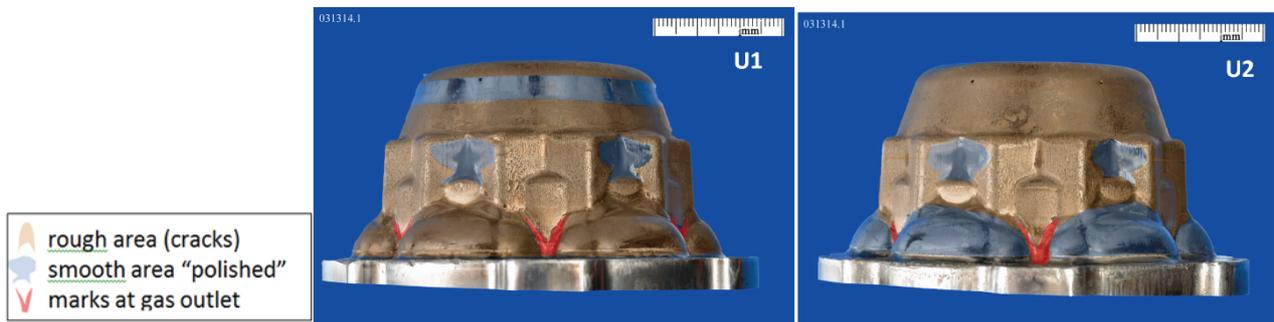
To evaluate the importance of each failure mechanism a full analysis has been performed regarding a macroscopic inspection, dimensional control, surface analysis by scanning electron microscopy (SEM), metallographic analysis, mechanical and chemical characterisation. The used punches (U1 and U2) present different types of defects (**Fig. 1**) on the working surfaces: surface roughness, cracks, marks related to the area of the gas outlet and a dark colouration on the whole surface due to oxidation. Areas with a polished appearance are also visible and this is coherent with the operation of wear mechanism related to the tool movement and the friction created between the tool and the part.

Fig. 1 Defectology present in the working surfaces

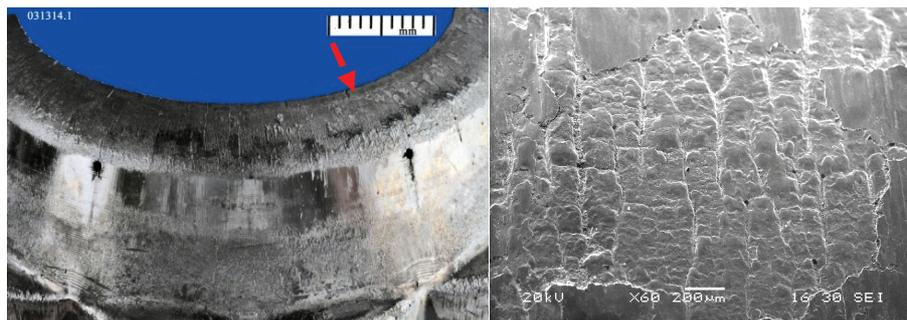
Areas with a higher roughness have a crazed appearance and given the working conditions of the parts (temperature and stress cycles) the cracks that appear in these areas are related to thermal fatigue. In fact, SEM analysis reveals cracks of different sizes that form crack nets and they are not only longitudinal but also transversal. The finer crack nets are associated to areas with a polished surface which probably only affects the oxide layer while the areas with high roughness have coarser crack nets which suggest a greater length of the cracks (**Fig. 2**).

Fig. 2 SEM micrograph of cracks net and oxides on ref. U1

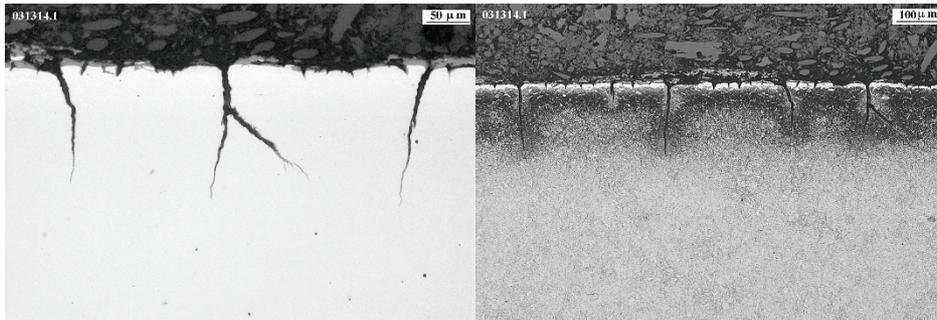
The presence of cracks with different sizes points to the operation of a mechanism extended in time as it is the case of thermal fatigue. Moreover, the transversal analysis of some sections of the punches have revealed the presence of cracks in all of them. The triangular morphology of the cracks, their progression perpendicular to the surface and the presence of oxides inside them confirm the operation of a thermal fatigue or heat checking process (**Fig. 3**). Due to the intensive thermal cyclic loads, produced by the alternate heating and cooling of the tool surfaces, the material is alternately tensioned and compressed whereby thermal stresses arise resulting in a network of cracks producing thermal fatigue. In fact, there is a greater thermal expansion at working surfaces than in the inner side of the die. This expansion difference causes plastic deformation at the surface which results in tensile stresses and cracking during cooling. In addition, the presence of cyclically

variable mechanical loads lead to fatigue processes, which intensify as the network of cracks caused by thermal fatigue appears, resulting in macrocracks. Since the mechanisms of thermal fatigue and those of mechanical fatigue are mutually dependent, they are considered jointly as thermomechanical fatigue. This is a kind of wear in which a local loss of cohesion and the resulting material loss are caused by material fatigue due to the cyclic action of stresses (generated by high pressures, i.e. mechanical loads and temperature gradients) in the forging die surface layer [3,4,5].

Fig. 3 Light micrographs of ref.U1. Left image: presence of triangular cracks and oxides filling them. Right image: etch condition, presence of a nitrided layer

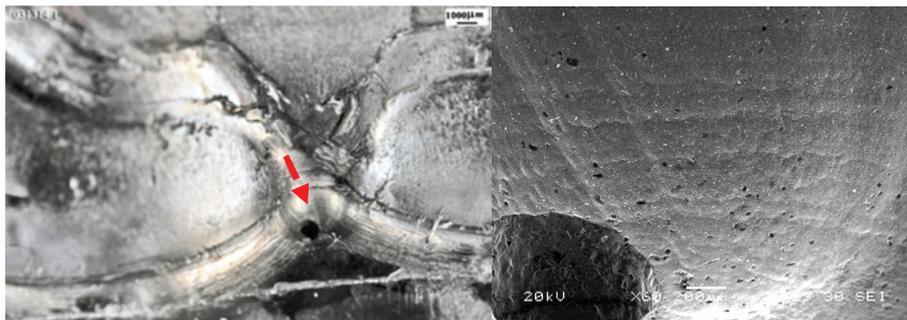
Fig. 4 SEM micrograph. Presence of marks attributed to an erosion process

Some other defects are found in the area close to the small holes that serve as gas outlet (gas channels). Due to the morphology of the marks and cavities analysed by SEM (**Fig. 4**), it is confirmed that these surface defects correspond to an erosion failure mechanism. In order to evaluate the level of wear and the presence of plastic deformations a dimensional control has revealed no significant change dimensions after use which concludes a minimum effect of a wear mechanism and plastic deformation. However, at microscopic scale the punches surfaces present patterns characteristic of the operation of this mechanism: plucked away material, plastic deformation of asperities and marks aligned with the relative movement. The nitridation layer depth of the punches is approximately 0.16 mm and has a diffusion layer with a similar thickness along almost all the surface. This fact confirms the minimum effect of the wear mechanism. However, there are some areas where the white compound layer is eliminated and the hardness is reduced.

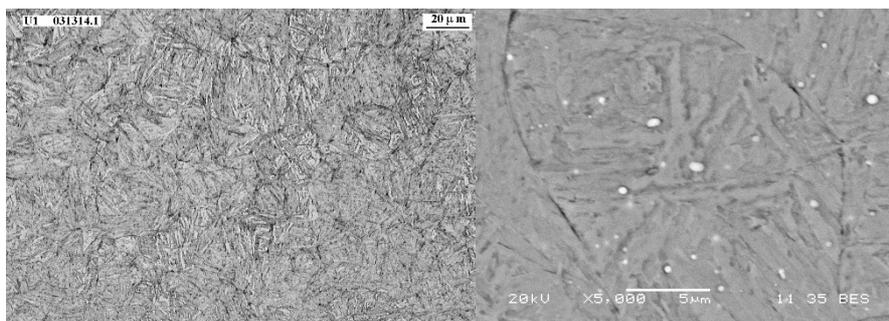
Fig. 5 Left image: light micrograph of a longitudinal sample ref.U1: martensitic and bainitic microstructure. Right image: presence of carbides

The metallographic analysis reveals that the microstructure of the new punch corresponds to a quenched and tempered material (3 times) that has a martensitic and bainitic structure with finely dispersed carbides. When examining the microstructure of the used punches no visible evolution due to thermal cycling is found, the matrix remains being martensitic and bainitic as shown in **Fig. 5**. EDS analysis of the carbides reveals that they are formed mainly by molybdenum carbides, with presence of chrome and vanadium.

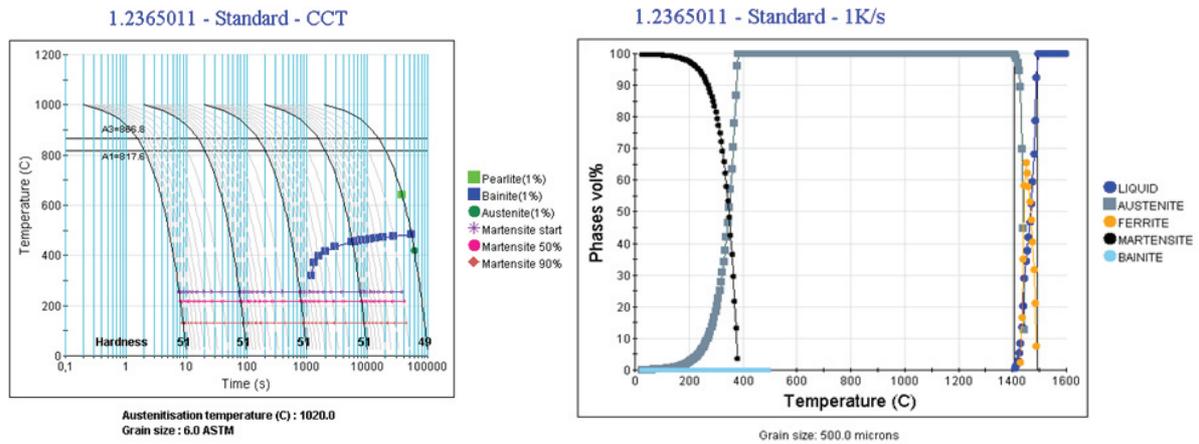
Fig. 6 CCT-diagrams and phase stability diagram of 1.2365 (JMatPro Calculations)

If during quenching, besides martensite, also bainite and pearlite are obtained, toughness and tempering resistance might be reduced. Further triple tempering has the purpose of (i) to transform retained austenite, if present (ii) changing the martensitic structure towards quasi-equilibrium where carbides are formed and (iii) stress relieving introduced by quenching and as a result proper toughness and ductility is obtained. As said before, martensite plays an important role in the evolution of tool steel microstructure by presenting a supersaturated matrix structure for carbide precipitation and secondary hardening.
