## THE PROBLEM WITH THE ZINC COATING DIVERSIFICATION OF THE HOT-DIP GALVANIZED STEEL

Sylwia WĘGRZYNKIEWICZ

BELOS-PLP SA, Bielsko - Biała, Poland, EU, [sylwia.wegrzynkiewicz@belos.com.pl](mailto:sylwia.wegrzynkiewicz@belos.com.pl)

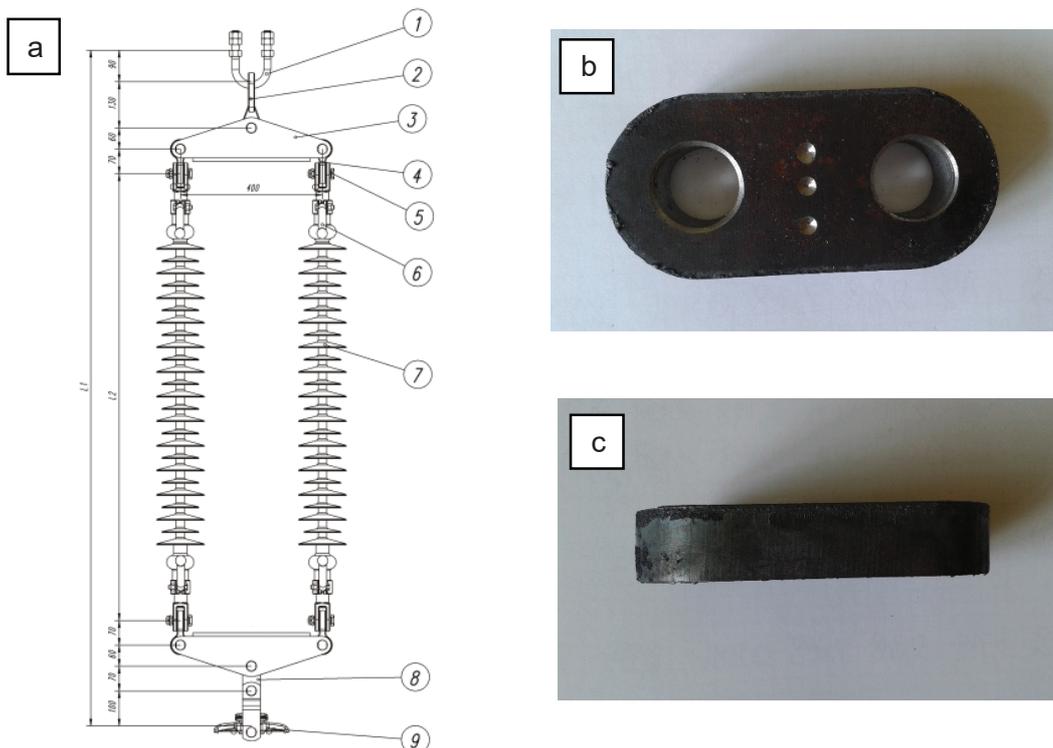
**Fig. 1** Fittings for overhead power line: a - double tension insulator string (ŁO2 110kV) 1 - hinge U-bolt type, 2 - double eye link, 3 - yoke triangular, 4 - double eye link twisted, 5 - bolt, 6 - arcing horns, 7 - insulator, **8 - double eye link type SLINK**, 9 - suspension clamp, L1, L2 - dimensions depends of the length of the insulator; b - the flat surface of link type SLINK, c - the side surface of link type SLINK
