INFLUENCE OF THE ZINC GALVANIZING ON FASTENERS CRACKING

SZŁAPA Ilona^{1,2}, JĘDRZEJCZYK Dariusz², SKOTNICKI Wojciech²

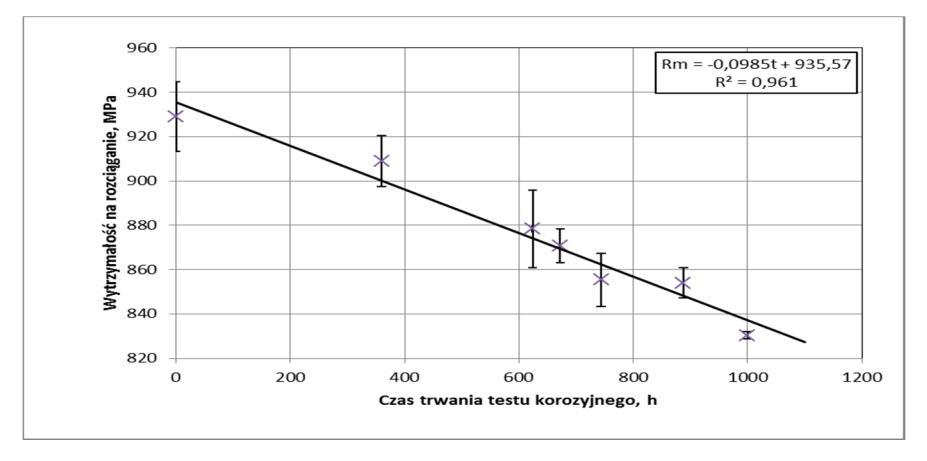
Figure 1 Influence of the corrosion process on the value of permissible stress change of screws M8 x 80, tested inside the salt chamber without zinc coating [own research]

For example in **Figure 1**, the change of the value of the permissible stress value and the pitch diameter of M8x80 screw, tested inside the salt chamber without zinc coating, are presented [own examinations] [6].

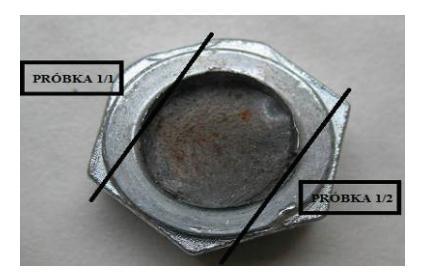
The evaluation of the hydrogen content was performed in the two samples. Sample no. 1 was cut from the head of the screw taken to analysis, which was broken during the first week of exploitation whereas sample no. 2 was taken from the head of brand new specimen from the same production batch. Both samples contained the outer layer coated with zinc plating, the way of test material preparation is shown in **Figure 4**.

Figure 4 Method of sample preparation to hydrogen content determination, black lines indicate the cutting direction
