FEATURES OF THE RECOVERY OF HIGH CARBON STEEL PRODUCTS USING THE DIRECTED ENERGY DEPOSITION PROCESS

Sergei IGOSHIN, Dmitriy MASAYLO, Alexey ORLOV, Evgenii GYULIHANDANOV

Peter the Great St. Petersburg Polytechnic University, St. Petersburg, Russian Federation,
sergei.igoshin@gmail.com, dmasaylo@gmail.com, orlov_alexey88@mail.ru, bogomolova_ev@spbstu.ru

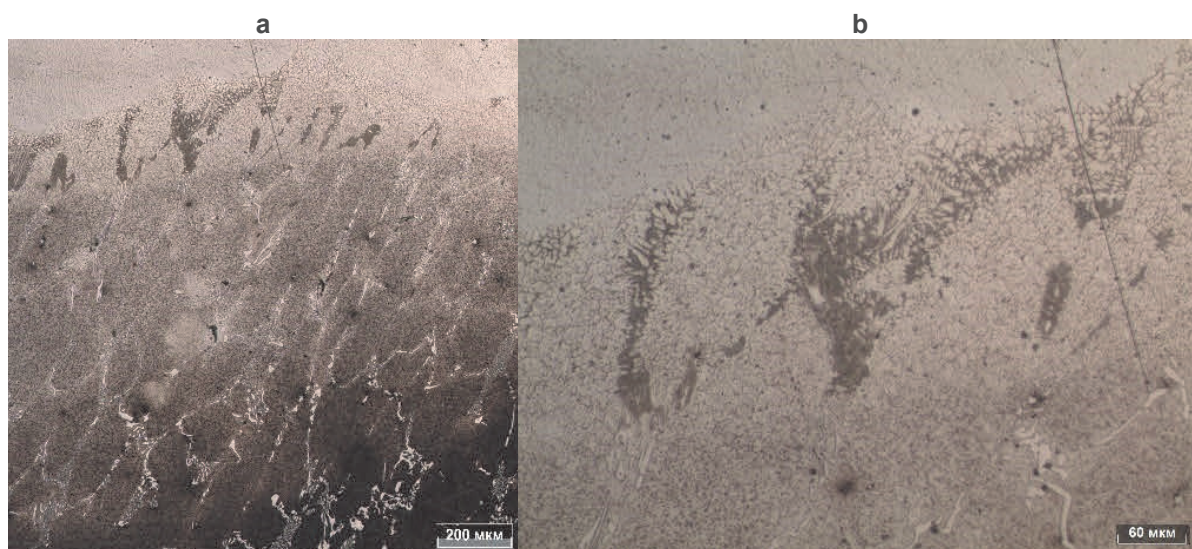
Figure 5 Heat-affected area, a - lower magnification, b - double magnification than in case a

According to the results of measuring the hardness, it is clear that the total hardness of the two materials is approximately the same, but it was also noted that the hardness at the boundary in the heat-affected zone reaches the highest values of 57 HRC, and the average hardness of the weld material is 53 HRC. This

hardness is satisfactory for this product, but still this value is rather low. As a recommendation, it is possible to suggest surface hardening, or, in the process of surfacing, to use increased cooling conditions to obtain a large proportion of martensitic structure in the AISI H13 surfacing steel.
