## METHODS FOR EVALUATION OF PAINT COATINGS COMPOSITION

Hana GEIPOVÁ<sup>1</sup>, Lubomir MINDOŠ<sup>1</sup>, Pavlína FIALOVÁ<sup>1</sup>, Libor TUREK<sup>1</sup>

<sup>1</sup>SVÚOM Ltd., Prague, Czech Republic, EU, [geiplova@svuom.cz](mailto:geiplova@svuom.cz)

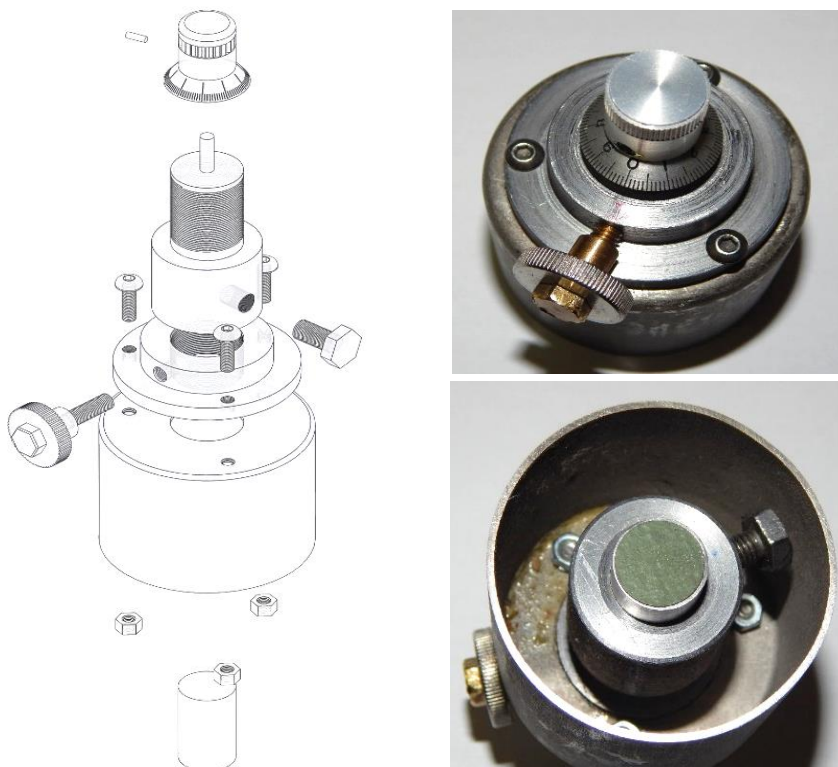
**Figure 4** The special holder for FTIR analysis

The special holder (**Figure 4**), has been developed for FTIR analysis of multilayer paint systems. This holder enables the analyses of individual, gradually removed layers using a very fine sandpaper in a given specific place of paint sample and improve quality of spectra. Holder ensure the measurement of the spectra of individual layers of coating systems exactly by removed 10  $\mu\text{m}$  due rotation of the micrometric screw.
