IN-SITU OBSERVATION OF SULPHIDE STRESS CRACKING (SSC) INITITATION AND PROPAGATION IN 34CrMo4 STEEL BY USE OF ACOUSTIC EMISSION (AE)

Pavel KUČERA ¹, Eva MAZANCOVÁ ², Michal ŠOFER ²

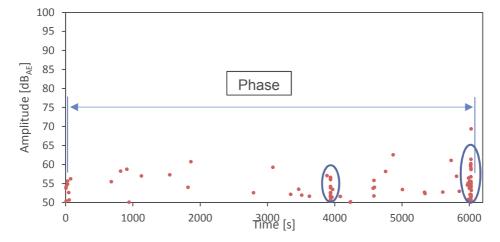
Figure 2 Acoustic emission signals (events) during the exposure of specimen number 1

Second stage of the metallographic observation was the material integrity investigation of sample number 1. This sample was exposed to the corrosive environment and unloaded when first AE signals were detected (see **Figure 2**). **Figure 3** shows cavities and cracks that occurred during the exposure time. **Figure 4** presents data obtained during the loading of the sample until the final fracture. Grain size according to EN ISO643 and micro purity according to ISO 4967 evaluations are shown in **Table 2**.

Presented material 34CrMo4 (high strength low alloyed steel) very similar by properties to the one investigated by Tsai [2] revealed highly consistent results of degradation process (SSC) detected by AE as **Figures 2 and 4** revealed. The crack initiation and propagation stages were clearly distinguishable and were supported by **Figure 3** that clearly revealed certain defects that were previously detected by AE during the accelerated SSC test that highly complies with results obtained in [1,3]. Presented findings (**Figure 6**) of crack initiation and subsequent propagation was also supported by the SEM fracture analysis that showed also the presence of crack initiation stage, propagation and clearly also position where the final crack took place. These finding highly correlate with the work of Calabrese [4] and Filippov [5].

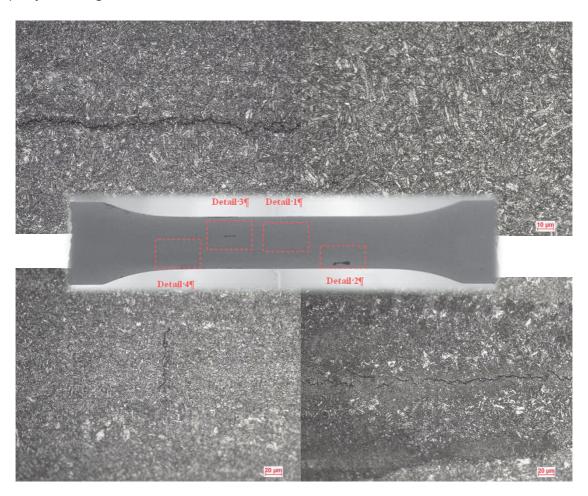
Figure 3 Cavities and cracks in SSC-A sample after before final crack

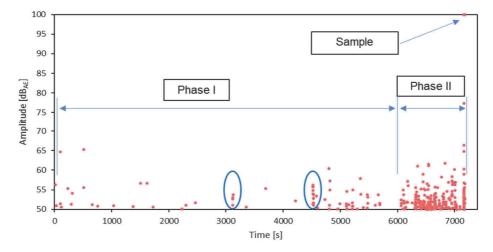
Figure 4 Evaluation of the cracking stages by AE until the final crack stage of specimen number 2

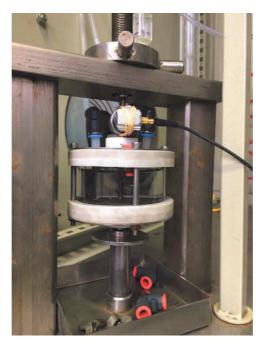
Figure 5 AE Setup of adjusted specimens during the SSC-A exposure

Fourth step of the investigation process (accelerated SSC-A testing) was based on the designing of special extended SSC specimen for the method A according to NACE TM0177-96. Specimen had to fulfil all requirements of mentioned standard plus the upper cylindrical part had to be extended for the AE sensors connection. The overall setup of adjusted specimens in chambers is shown in Figure 5. Three machined samples were subsequently exposed to the solution of distilled water buffered with 0.5 % sodium acetate trihydrate and continuously saturated by the 100 %. The applied load was equal to 0.6 of minimum prescribed YS value of tested cylinder material and pH of corrosion solution was set up exactly to 4.0. This procedure is a proposed combination of two NACE TM0177-96 and ISO 11439 standards to simulate most severe corrosive conditions for seamless high-pressure steel cylinders. Since the beginning of an exposition process, both samples were continuously monitored by use of Vallen AMSY-6 multi-channel AE system, equipped with a passive piezoelectric AE sensor Vallen VS30-V, which is especially suited for tank floor corrosion, leak detection or for partial discharge detection thanks to its flat frequency response within the 20÷80 kHz interval. The AE signal was subsequently amplified using the Vallen AEP5 preamplifiers with 34 dB gain. AMSY-6 AE unit is capable of processing both types of AE signal, namely the burst and the continuous acoustic emission. In this case, the continuous data acquisition approach has been used in order to record any AE activity, whose amplitude exceeded the 40 dBAE threshold. In addition, for each AE hit, there has been created a transient record including the parametric analysis (hit duration, rise time, number of counts etc.). This information has helped us to perform and effective filtering process, which was subsequently applied to the measured dataset.

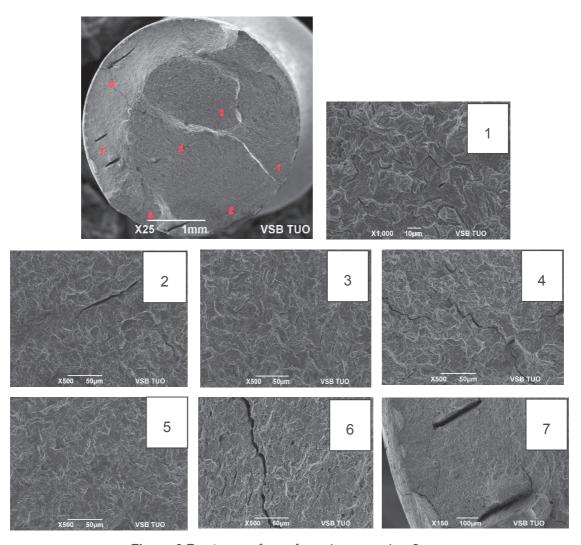
Figure 6 Fracture surface of specimen number 2

Crack surface of an investigated specimen (number 1) revealed typical cracks distribution and fracture surface morphology of specimens after SSC-A test exposure. **Figure 6** shows general fracture surface (SEM) together with details of defects that were revealed.
