## HYDROGEN EMBRITTLEMENT OF TRIP STEEL AFTER PREVIOUS DEFORMATION

### Abstract

**Keywords:** Hydrogen embrittlement, TRIP steel, deformation, fractography

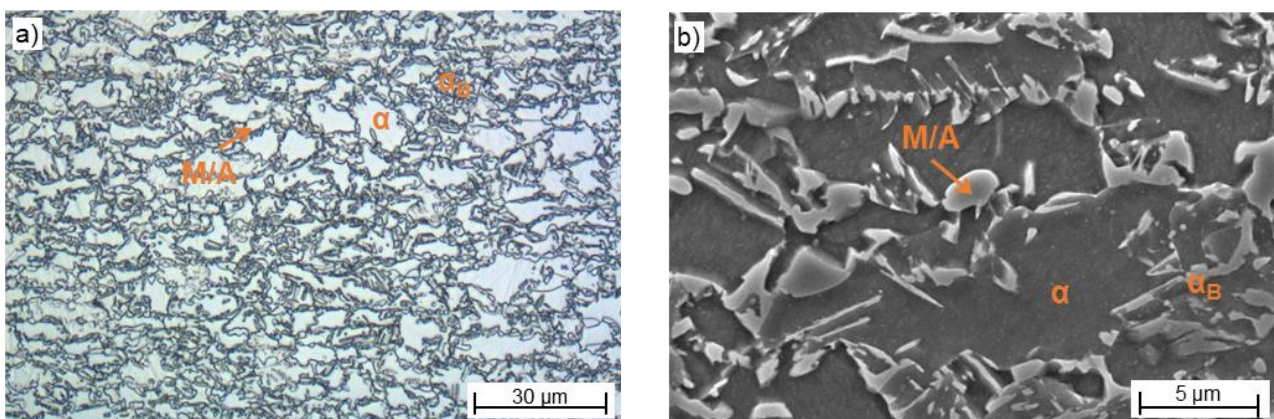
**Figure 1** The microstructure of steel TRIP 780 as delivered, longitudinal direction, etched in Nital, a) LM, b) SEM-SE.

Metallographic sections of the samples were evaluated after polishing and etching in 2 % Nital. Metallographic analysis was performed using an Olympus IX70 light metallographic microscope (LM) and using a JEOL 6490LV scanning electron microscope (SEM) in mode of secondary electron (SE). The microstructure consists of ferrite ( $\alpha$ ), bainite ( $\alpha_B$ ) and retained austenite (RA), resp. M/A constituent (**Figure 1**). The photo documentation of microstructure by SEM makes possible to observe the microstructure at higher magnification

and higher resolution compared to LM, but even SEM does not make it possible to obtain complete information on the occurrence of martensite or retained austenite in structural components referred to as the M/A constituent. The material showed high metallurgical purity. In the microstructure, there were complex inclusions based on alumina and calcium sulphide, inclusions based on aluminium arranged in the rolling direction and sharp-edged inclusions of titanium nitride. The size of individual inclusions was around 5 µm, the size of inclusions in rows reached up to 35 µm. The proportion of retained austenite (RA) in TRIP steel was determined by X-ray diffraction analysis. The proportion of retained austenite was found to be 14.3 vol. %.

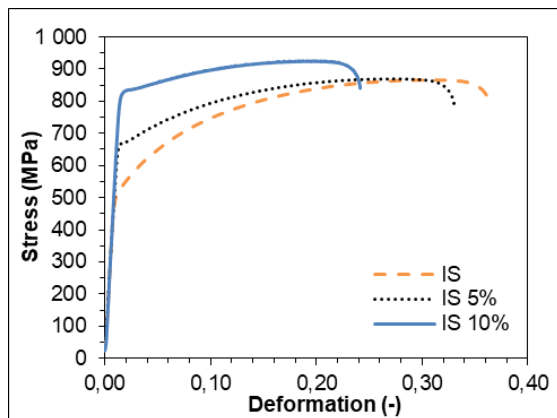
**Figure 2** Tensile diagrams of samples in initial state (IS), in initial state after 5 % pre-deformation (IS 5 %), in initial state after 10 % pre-deformations (IS 10%) without hydrogen

Subsequently, a part of the samples was pre-deformed by 5 % of the total deformation, i.e. extended by 2.75 mm, and a part of the samples was pre-deformed by 10 % of the total deformation, i.e. extended by 5.5 mm, for induction a partial transformation of retained austenite to martensite. The initial measured lengths  $L_0$  of the pre-deformed samples were 55 mm. The pre-deformation was performed at a loading rate of 2 mm·min<sup>-1</sup>, but the fracture test itself took place at a loading rate of 0.1 mm·min<sup>-1</sup>, which corresponds to a deformation rate of 10<sup>-5</sup> s<sup>-1</sup>. Tensile diagrams of these samples are plotted in **Figure 2**. Mechanical properties of samples without hydrogen as yield strength (YS), tensile strength (TS) and the elongation at fracture (A) are given in Table 2. It is clear from the data that the yield strength significantly increases with deformation; by 34 % after 5 % of deformations and 60 % after 10% of deformations compared to the initial state (IS). The tensile strength increases slightly by 2 % after 5 % of deformations and 6 % after 10 % of deformations. On the contrary, the elongation decreases, by 14 % after 5 % of deformations and 32 % after 10 % of deformations.

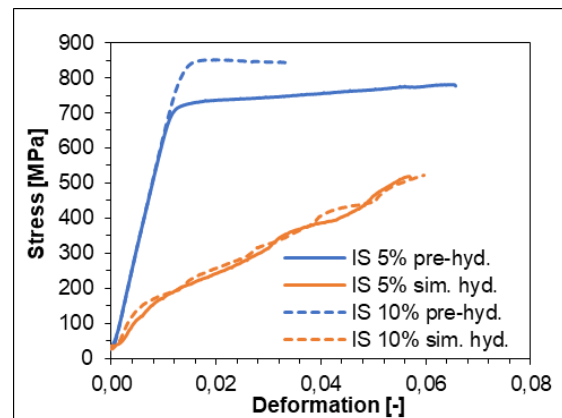
**Figure 3** Tensile diagrams of samples after simultaneous hydrogenation and after pre-hydrogenation and deformation

It can be deduced from the tensile diagrams (**Figure 3**) that during the simultaneous hydrogenation and deformation it was not possible to determine the yield strength YS. Comparing the samples after 5% pre-deformation without hydrogen and after pre-hydrogenation show that the YS increased by 41.2 MPa, the tensile strength TS decreased by 104.9 MPa and the elongation at fracture At decreased significantly by 23.2 %. The hydrogen embrittlement index was equal to 76.2 % for simultaneous hydrogenation and to 78.1 % for pre-hydrogenation. Similar to 5% pre-deformation, the analysis was also performed for 10% pre-deformation, namely: the yield strength decreased by 28.8 MPa, the tensile strength decreased by 68.0 MPa and the elongation at fracture At decreased by 22.2 %. The hydrogen embrittlement index was equal to 86.2 % for pre-hydrogenation. The values of mechanical properties found during their simultaneous hydrogenation are for information only.

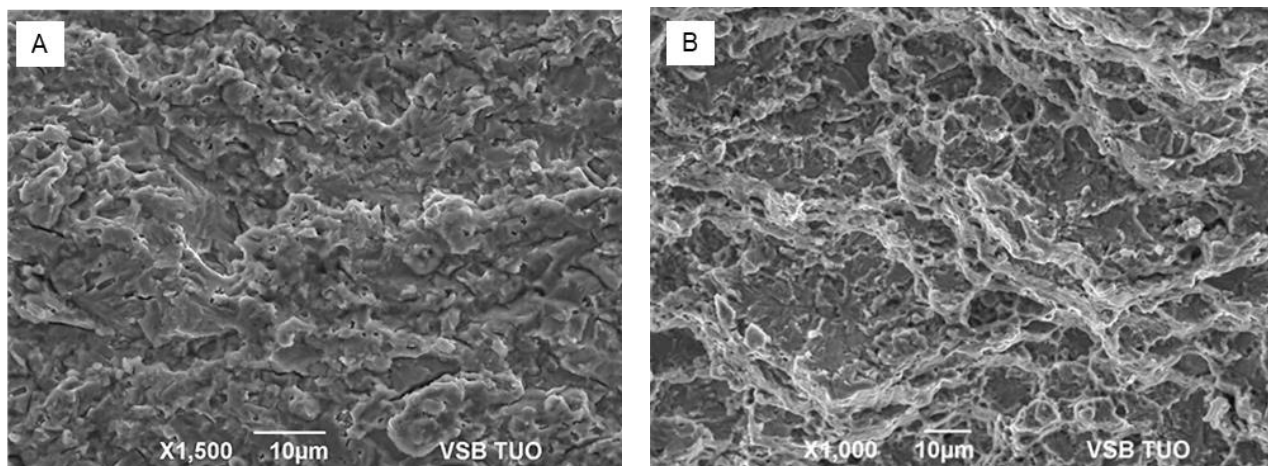
**Figure 4/1** Fracture area of samples after 5 % pre-deformation, simultaneous hydrogenation and deformation

**Figure 4** shows the fracture surface of samples that were 5 % pre-deformed and then simultaneously hydrogenated and loaded to fracture. In detail A it can be seen there is mainly a quasi-cleavage fracture on the edge, which is formed by finer facets compared to the common cleavage fracture and is typical for hydrogen embrittlement. In further details transgranular mixed fracture is visible (detail B), but quasi-cleavage fracture is predominant in the centre bands of the sample (detail C). Fisheyes (detail D), which are characteristic for hydrogen embrittled steels, occurred on fracture surface almost all hydrogenated samples. Fisheyes are formed in the presence of larger inclusions, around which a quasi-cleavage fracture spreads and which passes mainly into a transgranular ductile fracture. The samples, which were 5 % pre-deformed, pre-hydrogenated and then loaded, showed a very similar character of fracture surfaces. In the samples pre-hydrogenated with 10 % pre-deformation, a part of the fracture surface was formed by a purely transgranular cleavage fracture.

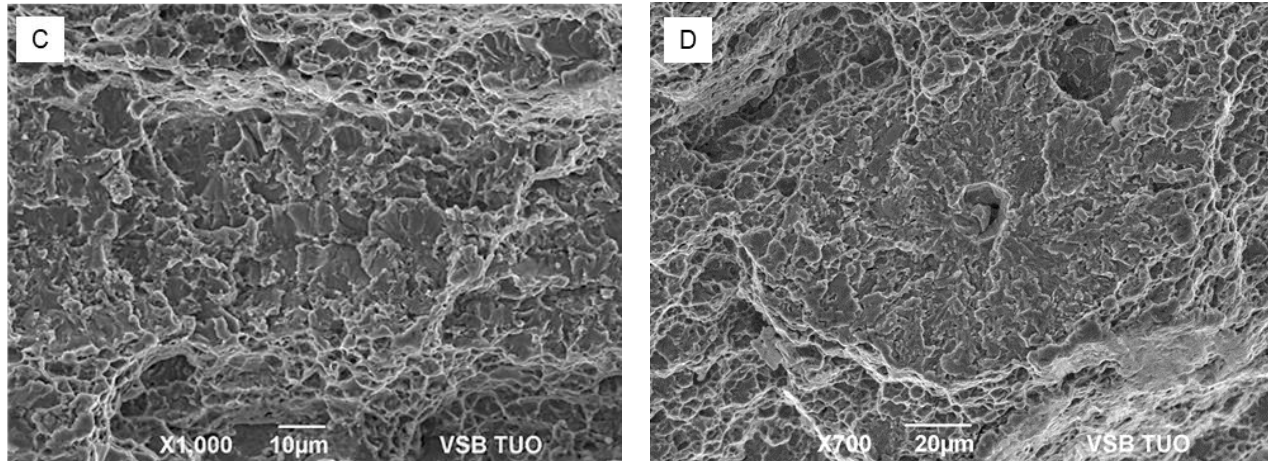
**Figure 4/2** Fracture area of samples after 5 % pre-deformation, simultaneous hydrogenation and deformation
