A STUDY OF MICROSTRUCTURE AND FATIGUE BEHAVIOUR OF A3003 ALLOY

A study of A3003 aluminium alloy in H12 temper regarding microstructure analysis, tensile testing, fatigue loading and fractography of fracture surfaces was carried out. Specimens were cyclic loaded at five stress amplitude levels of 62, 68, 70, 72 and 76 MPa so that the results for both the low cycle fatigue and high cycle fatigue are obtained. During loading of the specimens at the highest stress amplitude the specimens resembled quasi-static fracture with necking usually seen in tensile testing. In our case, the stress amplitude of 72 MPa can be considered transient as the failure went from quasi-static fracture to fracture with typical signs of fatigue. The 68 MPa stress amplitude appears as a transition from LCF to HCF. Testing at the lowest stress amplitude was stopped after 10^7 cycles without failure of the material so it can be regarded as fatigue limit for this alloy. Wrought microstructure was observed using optical microscopy and present phases were identified by EDX analysis as Al_6FeMn and $\alpha-Al_{12}(Fe,Mn)_3Si$. The microstructure of H12 temper was compared with the same alloy in F state.

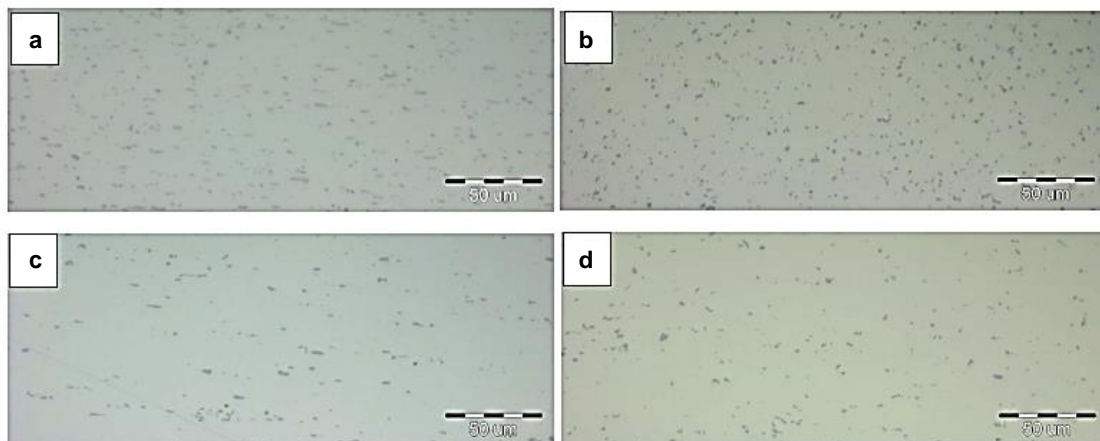
Figure 1 Microstructure of the specimens: a) longitudinal section of H12 temper, b) cross section of H12 temper, c) longitudinal section of F temper, d) cross section of F temper

Selected specimens were subjected to the microstructure and phase analysis using both OM and SEM. When comparing the longitudinal cuts of the tested specimens, small phases elongated and oriented in the forming direction can be seen for both H12 and F tempers (**Figure 1a** and **Figure 1c**). The cross sections of the specimens show similar results with phases and grains having in most cases approximately equiaxed shape (**Figures 1b** and **1d**).

The F temper contains fine particles of the similar size to that in H12 temper, but their distribution seems to be denser for the H12 temper. The phases observed were analysed using EDX analysis which confirmed the presence of $\alpha\text{-Al}_{12}(\text{Fe},\text{Mn})_3\text{Si}$ and $\text{Al}_6(\text{Fe},\text{Mn})$ particles. The distribution of the phases can be controlled by alloy composition and heat treatment so called “6 to alpha” transformation [2, 3], which supports growth of the $\alpha\text{-Al}_{12}(\text{Fe},\text{Mn})_3\text{Si}$ phase with higher strength, while the $\text{Al}_6(\text{Fe},\text{Mn})$ particles dissolve. Complete dissolution of the phases mentioned is very complicated due to danger of melting at higher annealing temperatures [4]. Both phases can affect recrystallisation and precipitation processes and through of this fatigue resistance of the alloy. Finding detailed information about the effects of the phases mentioned above on fatigue behaviour of the alloy is very difficult. When looking at OM images of colour etched samples, it can be clearly seen that the grains have been elongated in the direction of forming as mentioned before (**Figures 2a, 3a**). The F temper shows much more profound deformation of the grains, which can be attributed to the fact, that recrystallisation annealing was not applied and the grains remained in deformed state (**Figures 3a, 3b**). We can also observe differences in size of the grains in the H12 temper (**Figure 2b**). The difference can be caused by thermo-mechanical history of the H12 temper and possible dynamic recrystallisation processes occurring during extrusion [5].

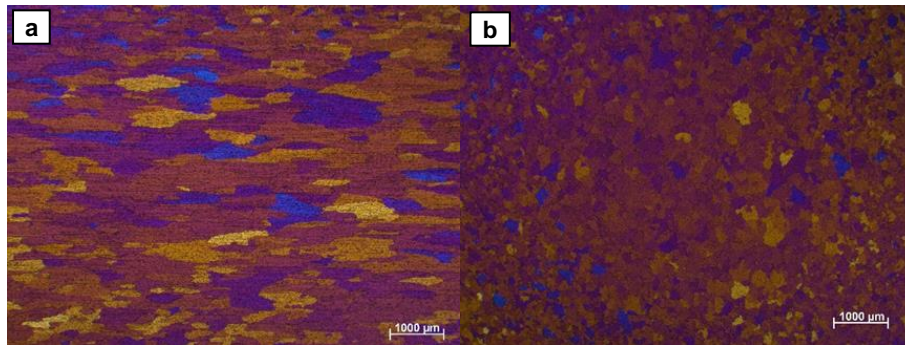
Figure 2 Colour etched microstructure of H12 temper: a) longitudinal, b) cross section

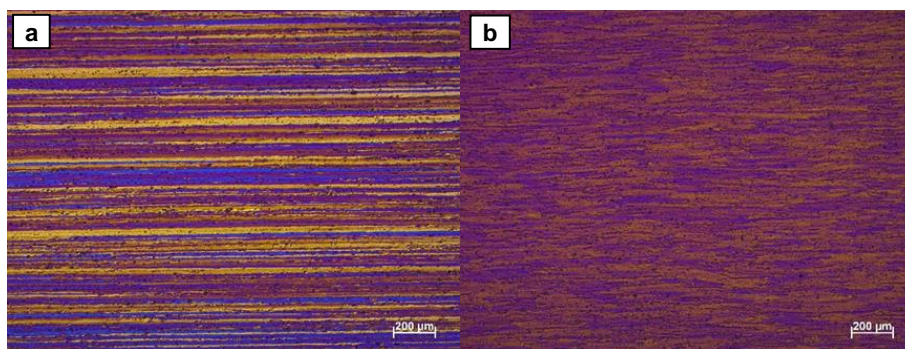
Figure 3 Colour etched microstructure of F temper: a) longitudinal, b) cross section

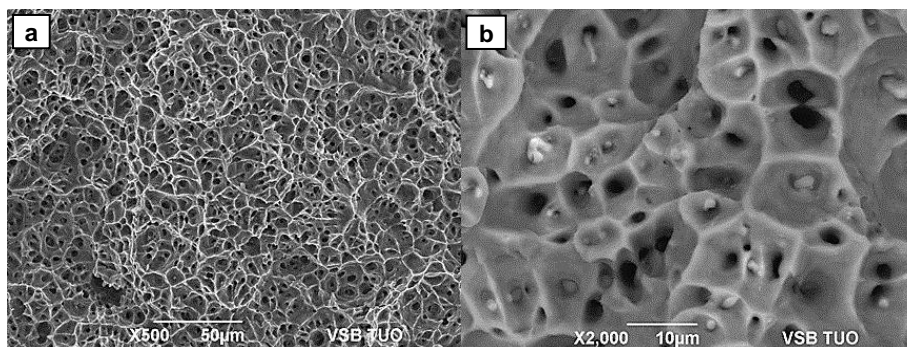
Figure 4 SEM image of fracture surface for the specimen 1 after tensile testing: a) surface with ductile dimples, b) detail of remaining phases observed in SEM BEI mode

During the tensile testing, all specimens have been deformed with typical necking in the area of final rupture. As it can be seen in **Figure 4a**, fracture surface shows signs of ductile character with dimples and no visible grain boundaries which points out to ductile transgranular fracture. The image performed in backscattered electrons mode (SEM BEI) shows remaining phases inside the dimples which probably acted as initiation sites for the failure (**Figure 4b**).

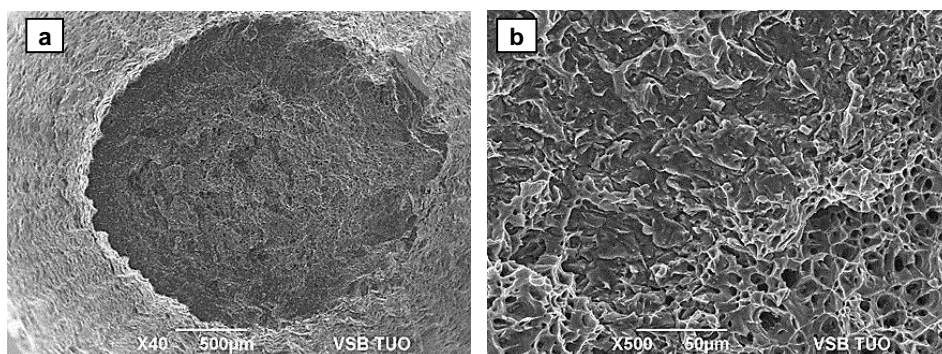
Figure 5 SEM fractography for the specimen 2 after fatigue loading at 76 MPa: a) general view of the fracture surface, b) detail of the surface with two different mechanisms of crack propagation

In the column of cycles executed some fluctuation of the results is evident. The widest range of values was obtained for the 68 MPa stress amplitude. The most probable cause is some defect in the surface layer, which significantly reduced the time (number of cycles needed) for microcracks propagation for the sample 5 or 6. Specimens tested at the highest stress amplitude (76 MPa) have been fractured with presence of necking similar to the tensile testing, without typical signs of fatigue on the fracture surfaces (**Figure 5**). The deformation of these samples reminds cyclic creep (ratcheting) even without the presence of nominal stress for which the ratcheting is typical [7].

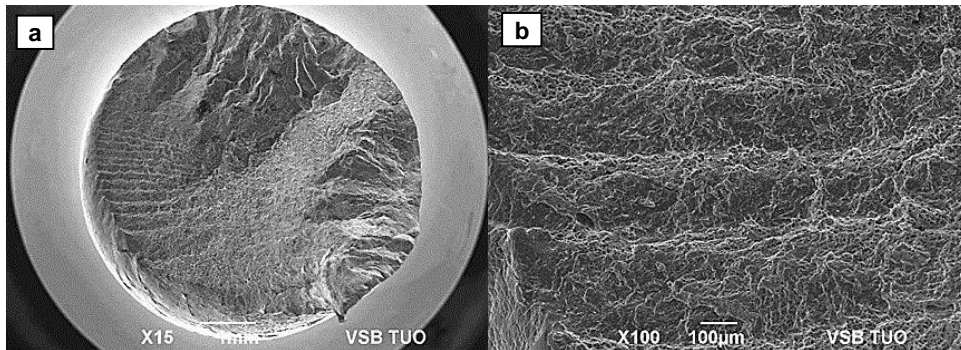
Figure 6 SEM fractography for the specimen 11 after fatigue loading at 72 MPa (LCF): a) general view of the fracture surface, b) detail of alternating crack propagation mechanisms

The stress amplitude level of 72 MPa could be considered transitional as two results were obtained: one type of fracture was similar to the ones obtained at the highest stress level amplitude and the second type was typical fatigue fracture with radial steps, beachmarks, striations and final overload fracture (**Figure 6**).

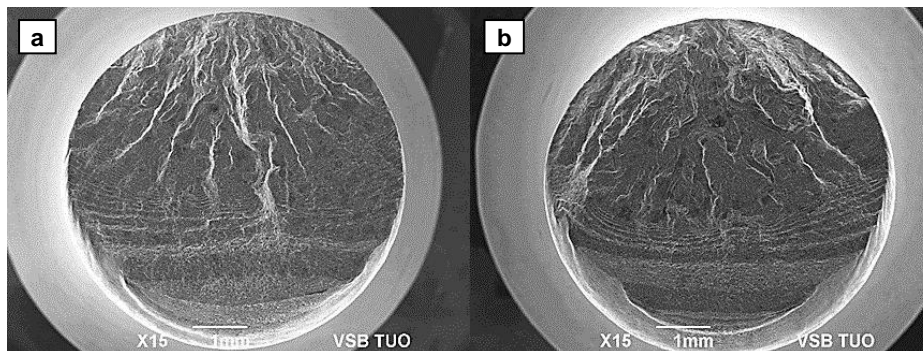
Figure 7 SEM fractography for the specimens after fatigue loading at 68 MPa: a) specimen 1 (after 10^6 cycles), b) specimen 5 (after 10^5 cycles)

In this case, the 68 MPa stress amplitude level could be considered as a transition from LCF to HCF with the number of cycles in magnitude of 10^5 to 10^6 . Even though there is massive difference in the number of cycles, the fracture surfaces look very similar (**Figure 7**). This is in accordance with the theory behind the big difference in the number of cycles executed. While more than 90% of lifetime of the material during fatigue loading is consumed by microcracks propagation, the process of fatigue crack propagation after the initiation is relatively fast [8].

Important difference in fracture feature of the specimens loaded at 72 MPa or 68 MPa consists in ratio of ductile and brittle fields. Indeed, for the specimen loaded at higher stress amplitude the area of faster crack propagation with alternating mechanism of ductile/brittle crack propagation occupies bigger part of the surface and the individual marks are bigger and further away from each other. Testing on the lowest stress amplitude was ended after 10^7 cycles without failure of the specimens, therefore in these conditions the stress amplitude of 62 MPa can be considered as the fatigue limit for this alloy [9]. Microhardness evaluation showed a trend of slight increasing hardness with increasing amount of deformation accumulated in the material. Nevertheless, the differences in microhardness are relatively small with average HV0.1 values of 48 and 43 for H12 and F temps, respectively.
