**MICROSTRUCTURE AND ELECTROCHEMICAL CORROSION BEHAVIOR OF CaP/PEO
DUPLEX COATING ON AZ31 MAGNESIUM ALLOY**

Abstract

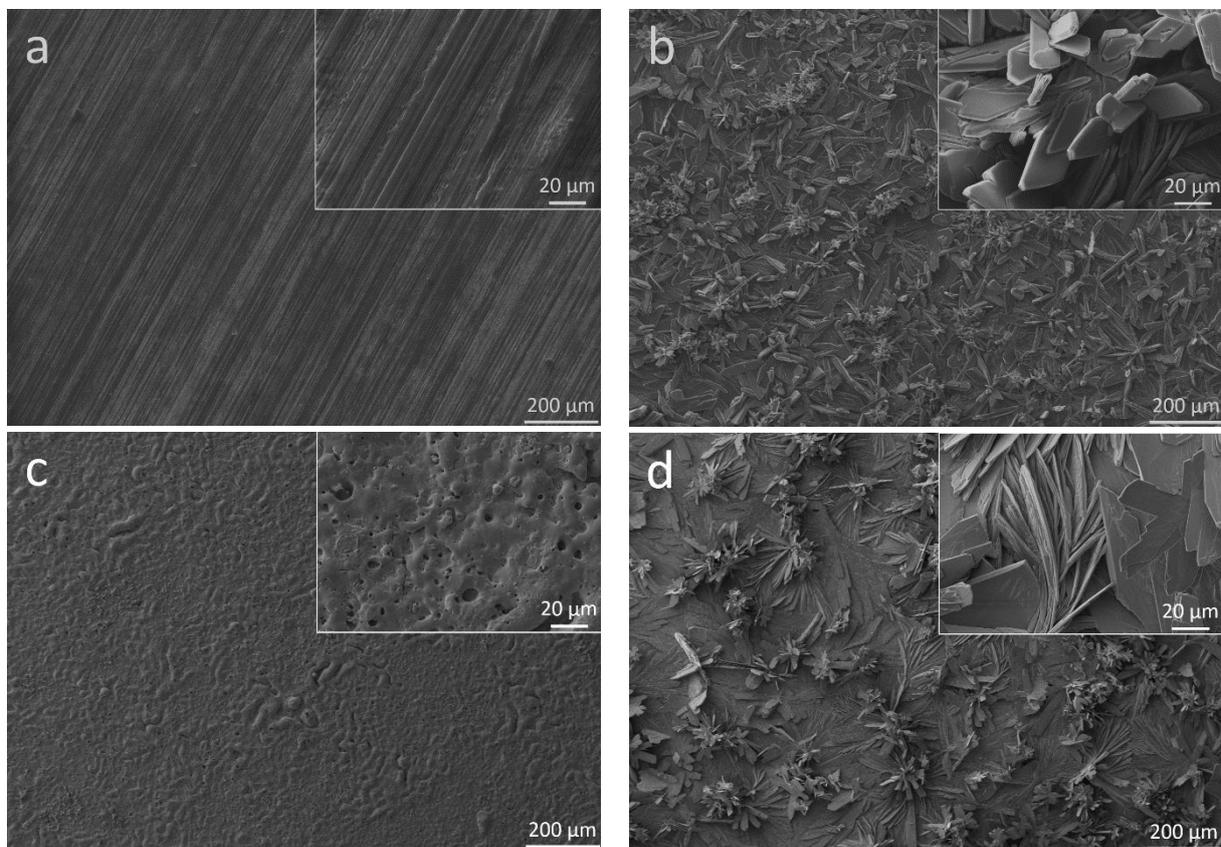
Figure 1 Surface morphology of a) ground AZ31 alloy, b) CaP-coated AZ31 alloy, c) PEO-coated alloy, d) CaP/PEO duplex coating on AZ31 alloy

Figure 1 shows the surface morphologies of ground AZ31 alloy, CaP coating on AZ31 alloy, PEO coating on AZ31 alloy, and CaP/PEO duplex coating on AZ31 alloy. In the case of the magnesium alloy (**Figure 1a**), grinding grooves were observed on the surface.

Figure 1b clearly shows that the hydrothermal synthesis resulted in the formation of the CaP coating with coarse crystals on the ground AZ31 alloy. The deposition completely covered the surface of the alloy. From (**Figure 1b** and the detail of **Figure 1b**) it is evident that the hydrothermally prepared coating was not compact and the resulting calcium phosphate crystals formed clusters of needle and plate-like formations with pores present between them.

The PEO coating on the AZ31 alloy exhibited a smooth appearance surface with open pores and micropores with microcracks around these pores along the radial directions (**Figure 1c**) [6]. Cracks observed on the surface were formed due to the rapid solidification of molten MgO during the fabrication [10]. The size of the pores and other structural defects is strongly dependent on the coating preparation parameters, such as the applied current density [6].

The deposition of CaP coatings on PEO coatings again resulted in a complete overlay of the surface and the formation of needle and plate-like clusters (**Figure 1d**). **Figure 1b** and **Figure 1d** showed a different surface morphology. Compared to CaP-coated AZ31 alloy, a different morphology of CaP crystals was observed in the case of CaP/PEO duplex coating (details in **Figures 1b** and **1d**). In the case of the CaP/PEO duplex coating, the growth of CaP crystals occurred on the previously deposited PEO coating consisting mainly of MgO, Mg(OH)₂, and Mg₃(PO₄)₂ phases, whereas the growth of CaP crystals was occurring directly on the Mg alloy in the case of CaP-coated AZ31.

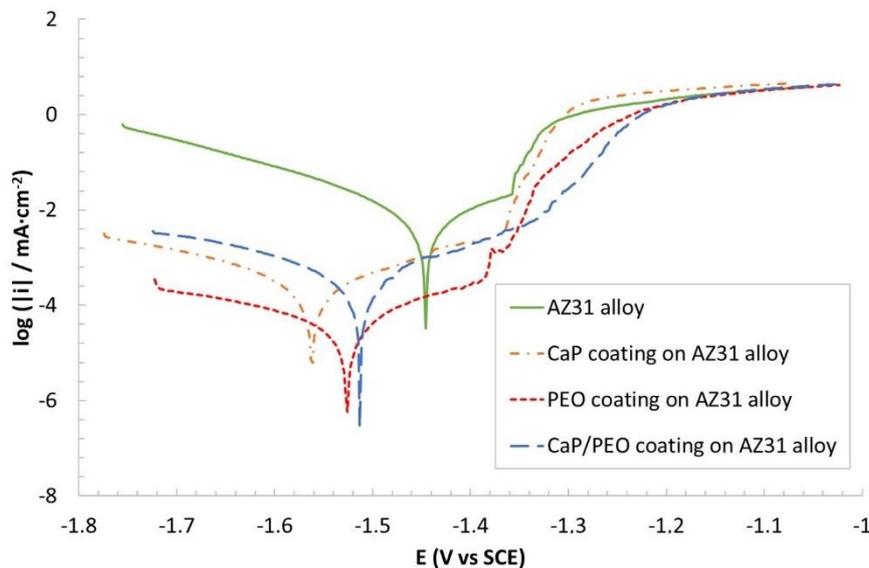
Figure 2 Potentiodynamic polarization curves of measured samples

The potentiodynamic polarization curves of all samples are shown in (**Figure 2**). The corresponding electrochemical parameters including corrosion potential E_{corr} , pitting potential E_{pt} and corrosion current density i_{corr} are shown in **Table 1**.

The deposition of CaP, PEO, or CaP/PEO duplex coating resulted in a decrease in corrosion current density and a shift of E_{corr} to more negative values compared to bare AZ31 Mg alloy. The lowest corrosion current density was achieved for the PEO coating on AZ31 alloy. The measured i_{corr} value was three orders of magnitude lower than that of AZ31 alloy **Table 1**. Unfortunately, the deposition of the CaP coating on the PEO/AZ31 alloy did not improve the corrosion resistance of the PEO coating, although the PEO coating was covered with CaP crystals. The penetration of the corrosive media apparently occurred through the present

However, CaP/PEO duplex coating on AZ31 alloy had the best value of corrosion potentials unlike other coatings. This indicates a lower tendency to corrode from a thermodynamic point of view. The anodic branches of the polarization curves contain a sharp break inducing pitting corrosion [13]. Unlike other samples, CaP/PEO duplex coating on AZ31 alloy did not show a sharp break and its pitting potential value E_{pt} was the highest. The occurrence of pitting corrosion was observed on the surface of the all samples after measuring the potentiodynamic polarization (**Figures 3a-d**).

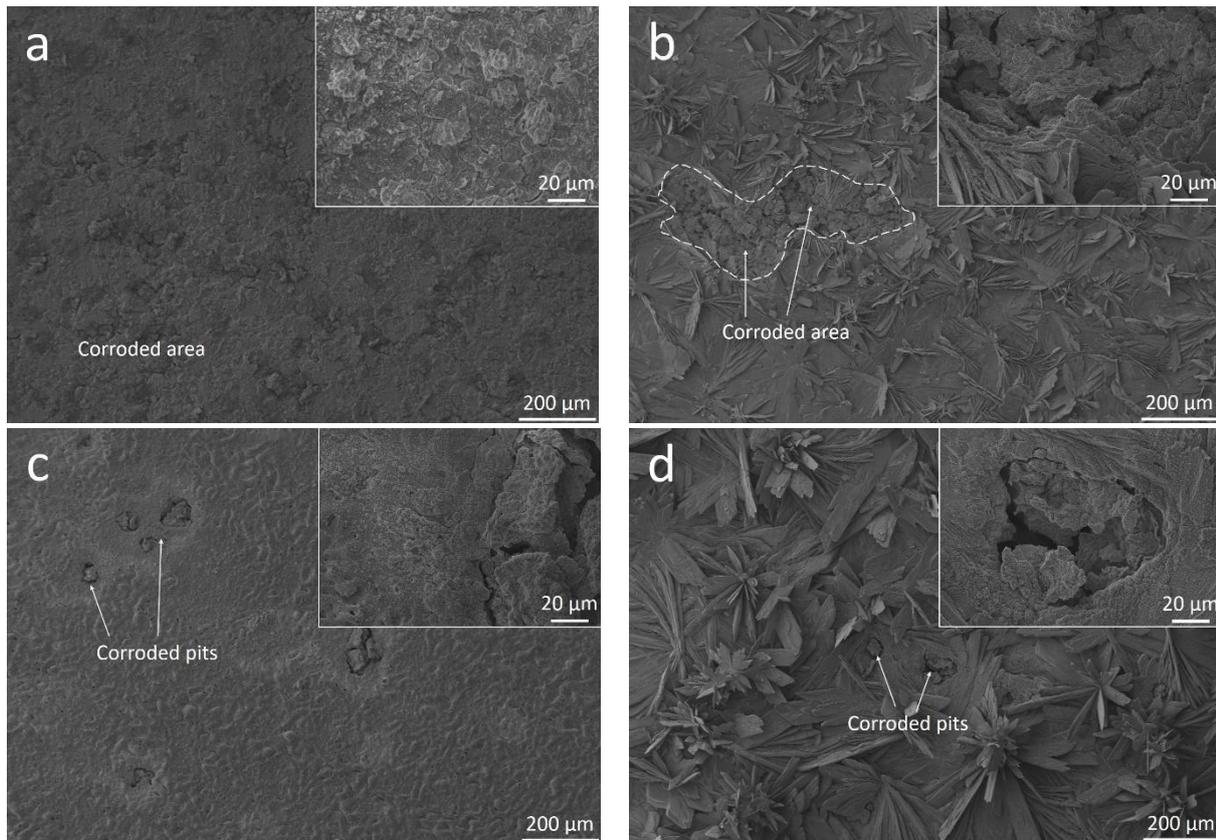
Figure 3 Surface morphology of exposed samples to corrosion media a) ground AZ31 magnesium alloy, b) CaP-coated AZ31 magnesium alloy, c) PEO-coated magnesium alloy, d) CaP/PEO duplex coating on AZ31 alloy

Figure 3a shows extensive areas of corrosion attack including pitting corrosion on the surface of AZ31 alloy. The large localized areas of corrosion occurred on the surface of the CaP/AZ31 alloy (**Figure 3b**). In the case of PEO coatings, the corrosion attack was limited to small pits on the surface (**Figure 3c**).

As shown in (**Figure 3d**) the corrosion was similar to the PEO-coated AZ31; the pitting occurred between CaP crystals. Probably, the corrosion medium pass between the CaP crystals onto the PEO coating, and further to the Mg substrate through the pores present in the PEO coating [14]. The decrease in corrosion resistance may probably be due to the fact that the PEO coating, consisting mainly of MgO, Mg(OH)₂ and Mg₃(PO₄)₂ phases, have been partially attacked by ammonium ions during the hydrothermal synthesis of the CaP coating. According to literature [15,16], ammonium NH₄⁺ ions in the hydrothermal solution may penetrate into the MgO and Mg(OH)₂ phases in PEO coating and dissolve them, according to the Equation (1). As a result, the porosity of the PEO coating increases.
