ISSUES IN MACHINING EPOXY RESIN - NANO REINFORCEMENT COMPOSITE SYSTEMS WITH RESPECT TO SURFACE INTEGRITY AND TOOL WEAR

Artur KNAP

TUL – Technical University of Liberec, Liberec, Czech Republic, EU, artur.knap@tul.cz

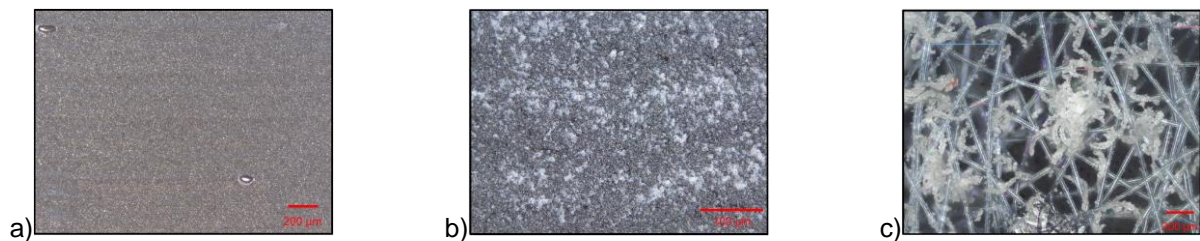
Figure 4 Overall overview of Sample 1. (a) Occurrence of cavities on the surface.; (b) Surface after 30 minutes of the tool in the cut.; (c) Nature of the chips formed – white areas.

In **Figure 2** the wear development of the tool can be observed. When the sample was machined without the addition of nanofiller, almost 80% of the total wear occurred within the first 5 minutes of milling. The wear trend was of increasing character, except at the points corresponding to 10 and 25 minutes in the cut. These decreases were due to the difficulty in positioning the microtool to the initial measuring positions and the presence of post-machining debris (chip clusters) that can visually act as cutting tool material. The dependence of roughness on tool time in cut for Sample 1 (**Figure 2**) shows a slight increasing trend along with increasing magnitude of V_B wear. This can be explained by the area of the sample in which the material may have been ploughed resulting in an increase in the surface roughness, by the deposition of a larger amount of very fine particles of chips or by the greater presence of cavities in the sample. The machining cycles revealed the presence of cavities in the sample (**Figure 4a**), that were created during the production of the blanks for the experimental part, e.g. by insufficient venting during casting. These cavities may increase tool wear due to the interruption of smooth tool engagement. Furthermore, a material surface can be observed where, due to tool wear, ploughing of the material has started to occur and the chip thus separated has then attached to the machined surface (**Figure 4b**). The machining of the specimen, which contains only epoxy resin, produced worm-like chips (**Figure 4c**). The same chip morphology was present during the last machining cycle.
